# Technical Bulletin

**Subject: Poor Throttle Response**

**Number: 03-01**

**Model(s): Golf, Jetta, Jetta Wagon, New Beetle 1998 ➤ 2003  
with 1.9L TDI (Eng. code ALH)**

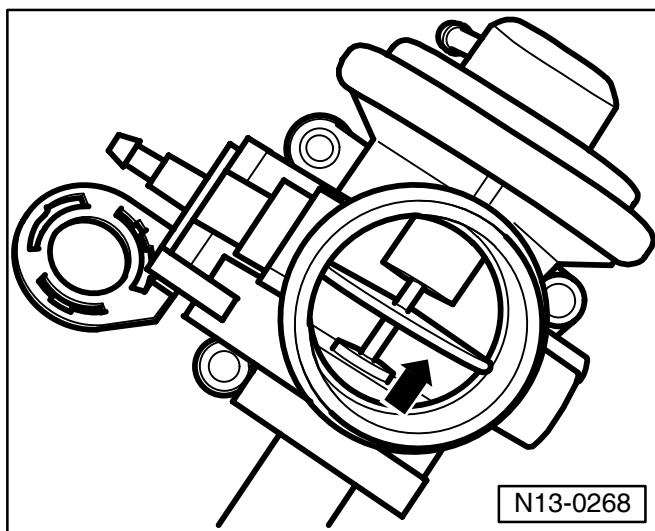
### 5. - EGR valve and intake manifold air flap (integrated in EGR valve), checking:

- Remove intake hose -1- at EGR valve.
- Remove vacuum hose from EGR valve.
- Connect hand vacuum pump V.A.G 1390 to EGR valve.

- Apply vacuum and make sure air flap (arrow) opens and closes freely.

If flap does not open and close freely:

- Replace EGR valve/flap.
