Technical Bulletin

01 07 22 Feb. 19, 2007 2011908 Supersedes T. B. Group 32 number 06-01 dated Aug. 17, 2006 due to additional diagnostic information and update to VAS5051 Vehicle Self Diagnostics Functions with Base 10.01.

MIL ON, DTC P0741, 17125 Stored In Transmission Fault Memory-No Driveability Concern

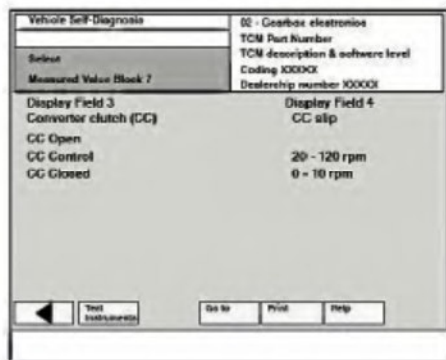
Figure 1

Similar Screen Appears.

- Test drive the vehicle (in gears 3-4-5) observe and record measured value block via guided function or self-diagnosis.
- Compared to figure 1, when the torque converter clutch is in CONTROL and CLOSED modes:
If readings of converter clutch status (field 3) and respective allowable converter clutch slip (field 4) differ from ranges specified in figure 1 AFTER 20 seconds of driving in each gear, the torque converter must be replaced. Only remove the gearbox and replace the torque converter if the values differ from ranges of figure 1.
- Refer to Repair Manual Group 37, Transmission removing and installing for transmission removal instructions.
- Refer to Repair Manual Group 32, Torque Converter for torque converter replacement instructions.
- 01L, 01V transmissions, built after serial codes listed in table, are fitted with an improved torque converter.
