## **Exhaust flap (CBEA) (same on 2009 to 2014 model cars)**

### **Introduction**

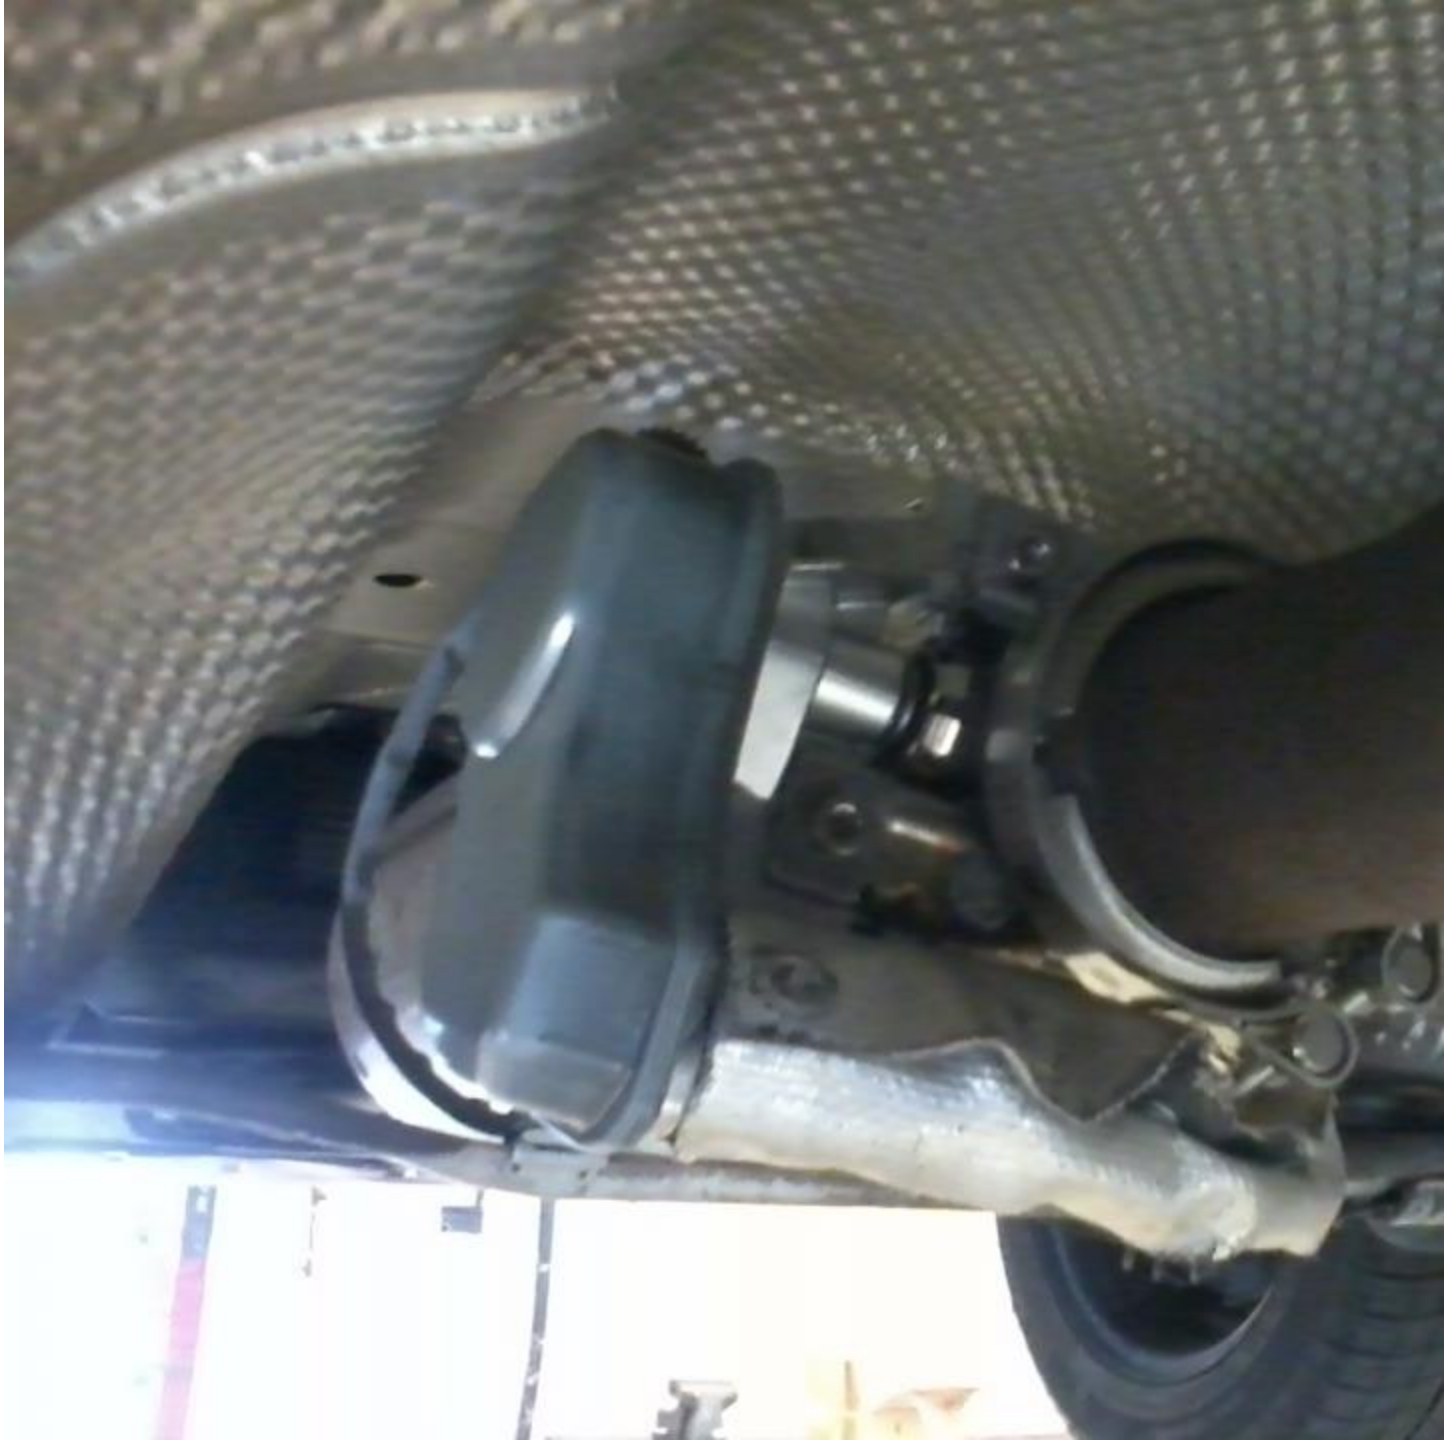
Here is a shot of the flap under the car. note the wiring is protected by wrap which snaps together, and the VW exhaust clamp.

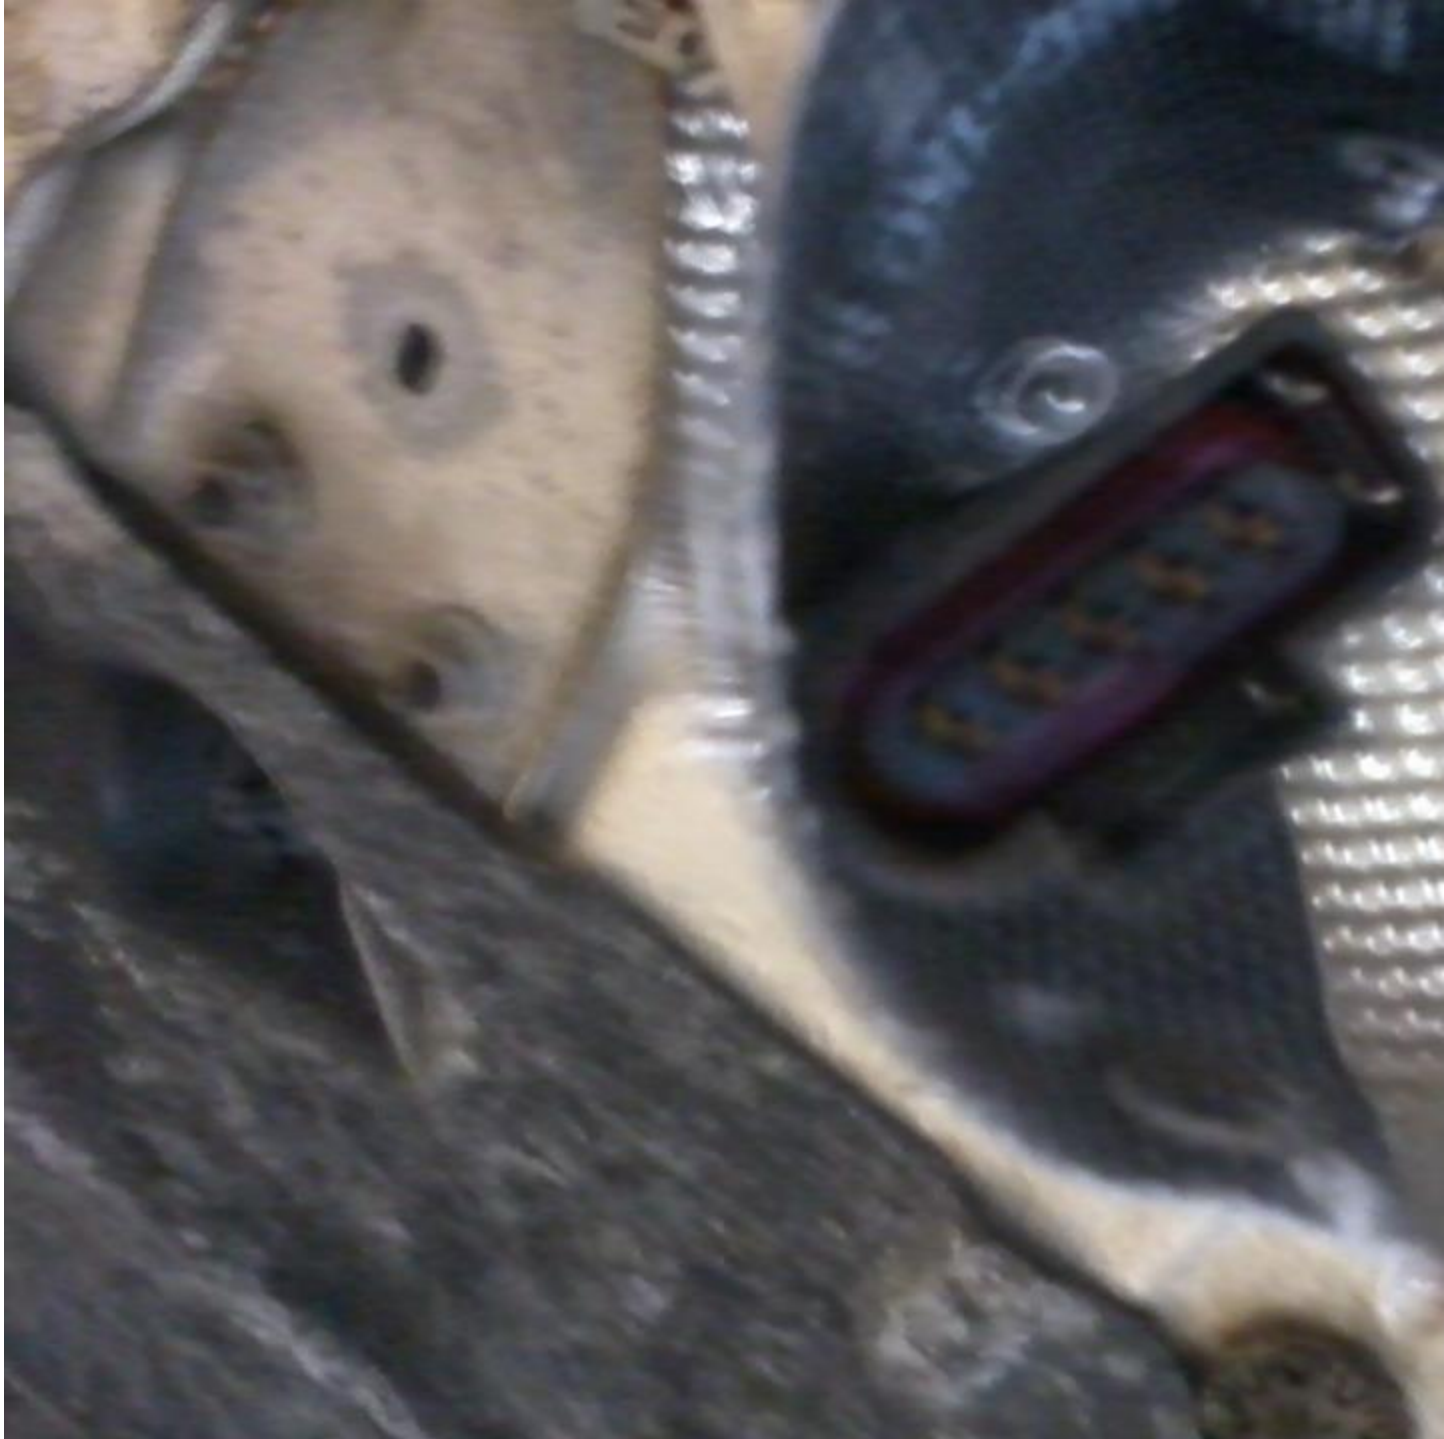
first step is to unsnap and unwrap the connector. this fuzzy offering is the wire end. close look at the connector on the new part can help you figure out how to remove. there is a little clip that holds it in.

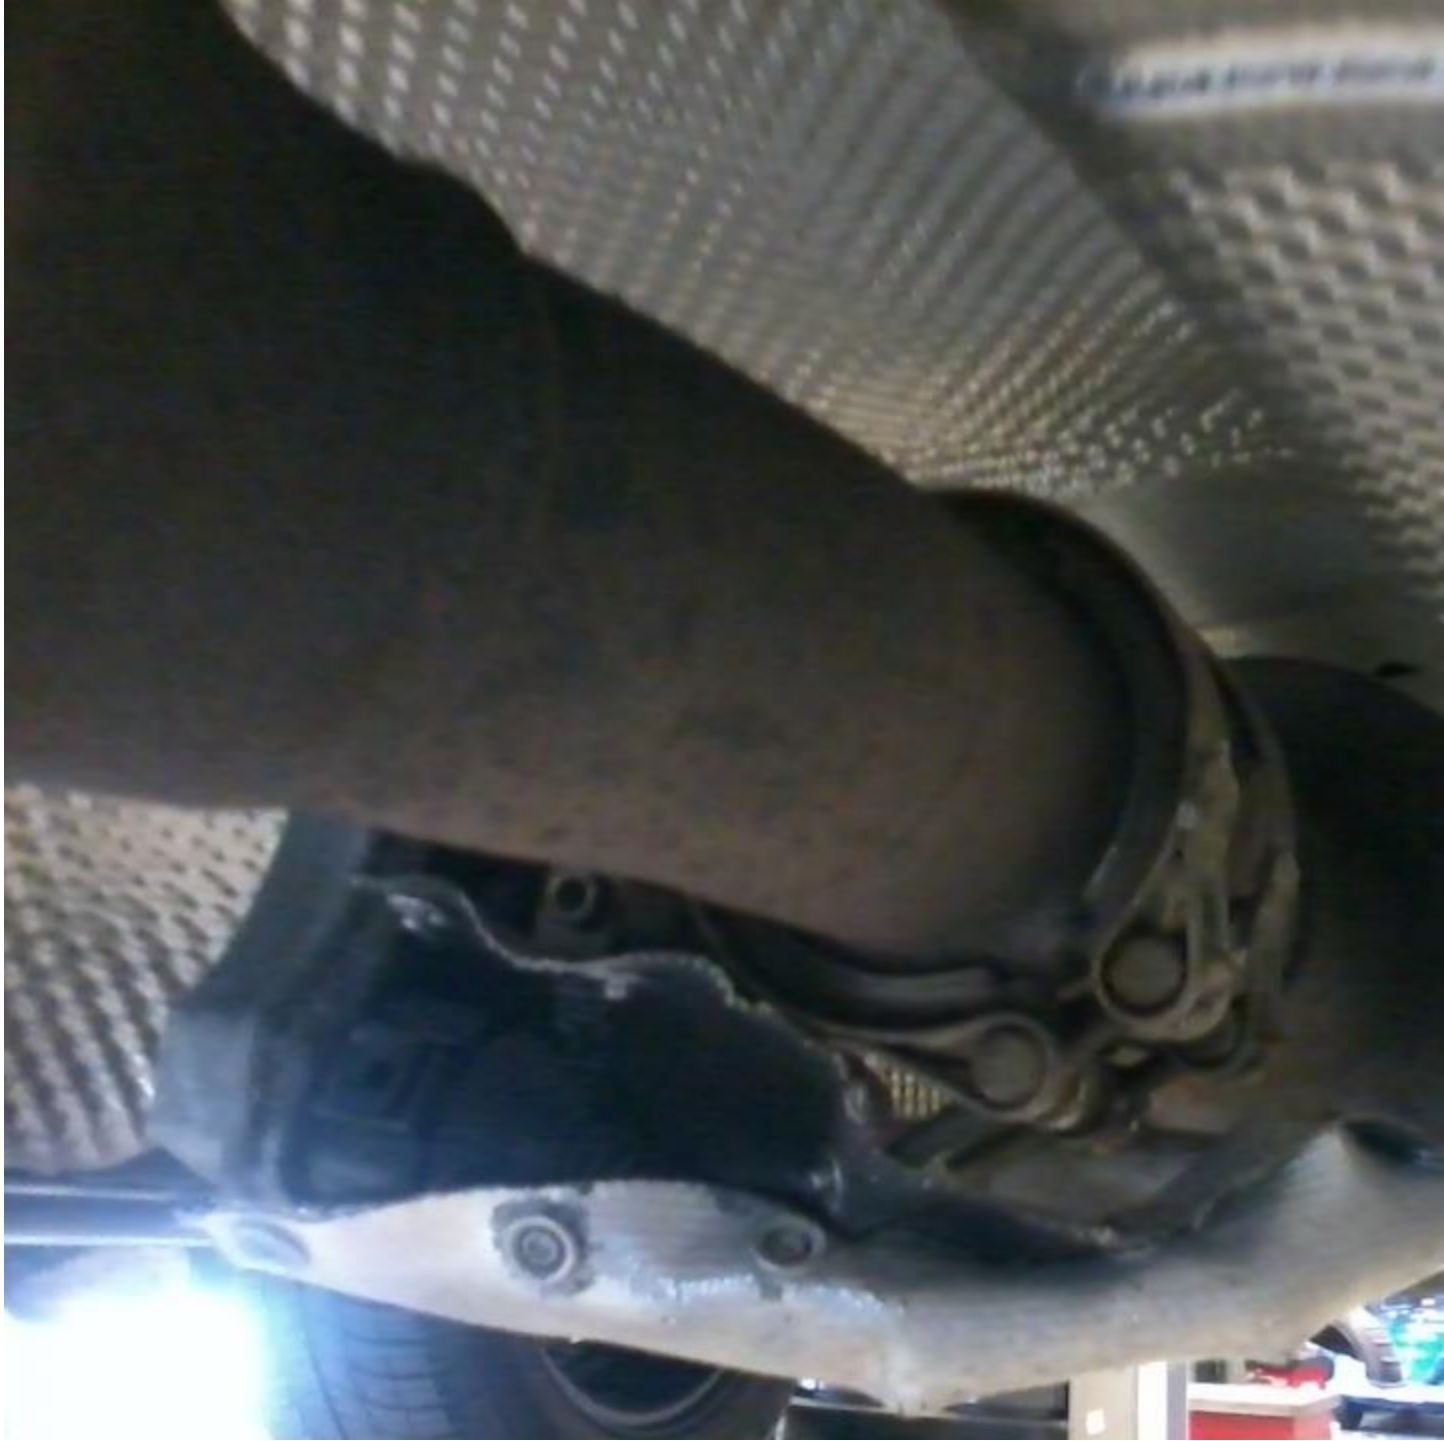
Above shows the protective wrap unsnapped, and shows the two exhaust pipe clamps that hold the flap assy to the exhaust system. a hex head (allen) will let you loosen up the clamp. once loose the head end will swing out of the clamp. The nearest one in this photo snapped as soon as I put the wrench to it, so you may want to apply some thread loosening agent of your choice (PB Blaster for example) if you plan to re-use the clamp.

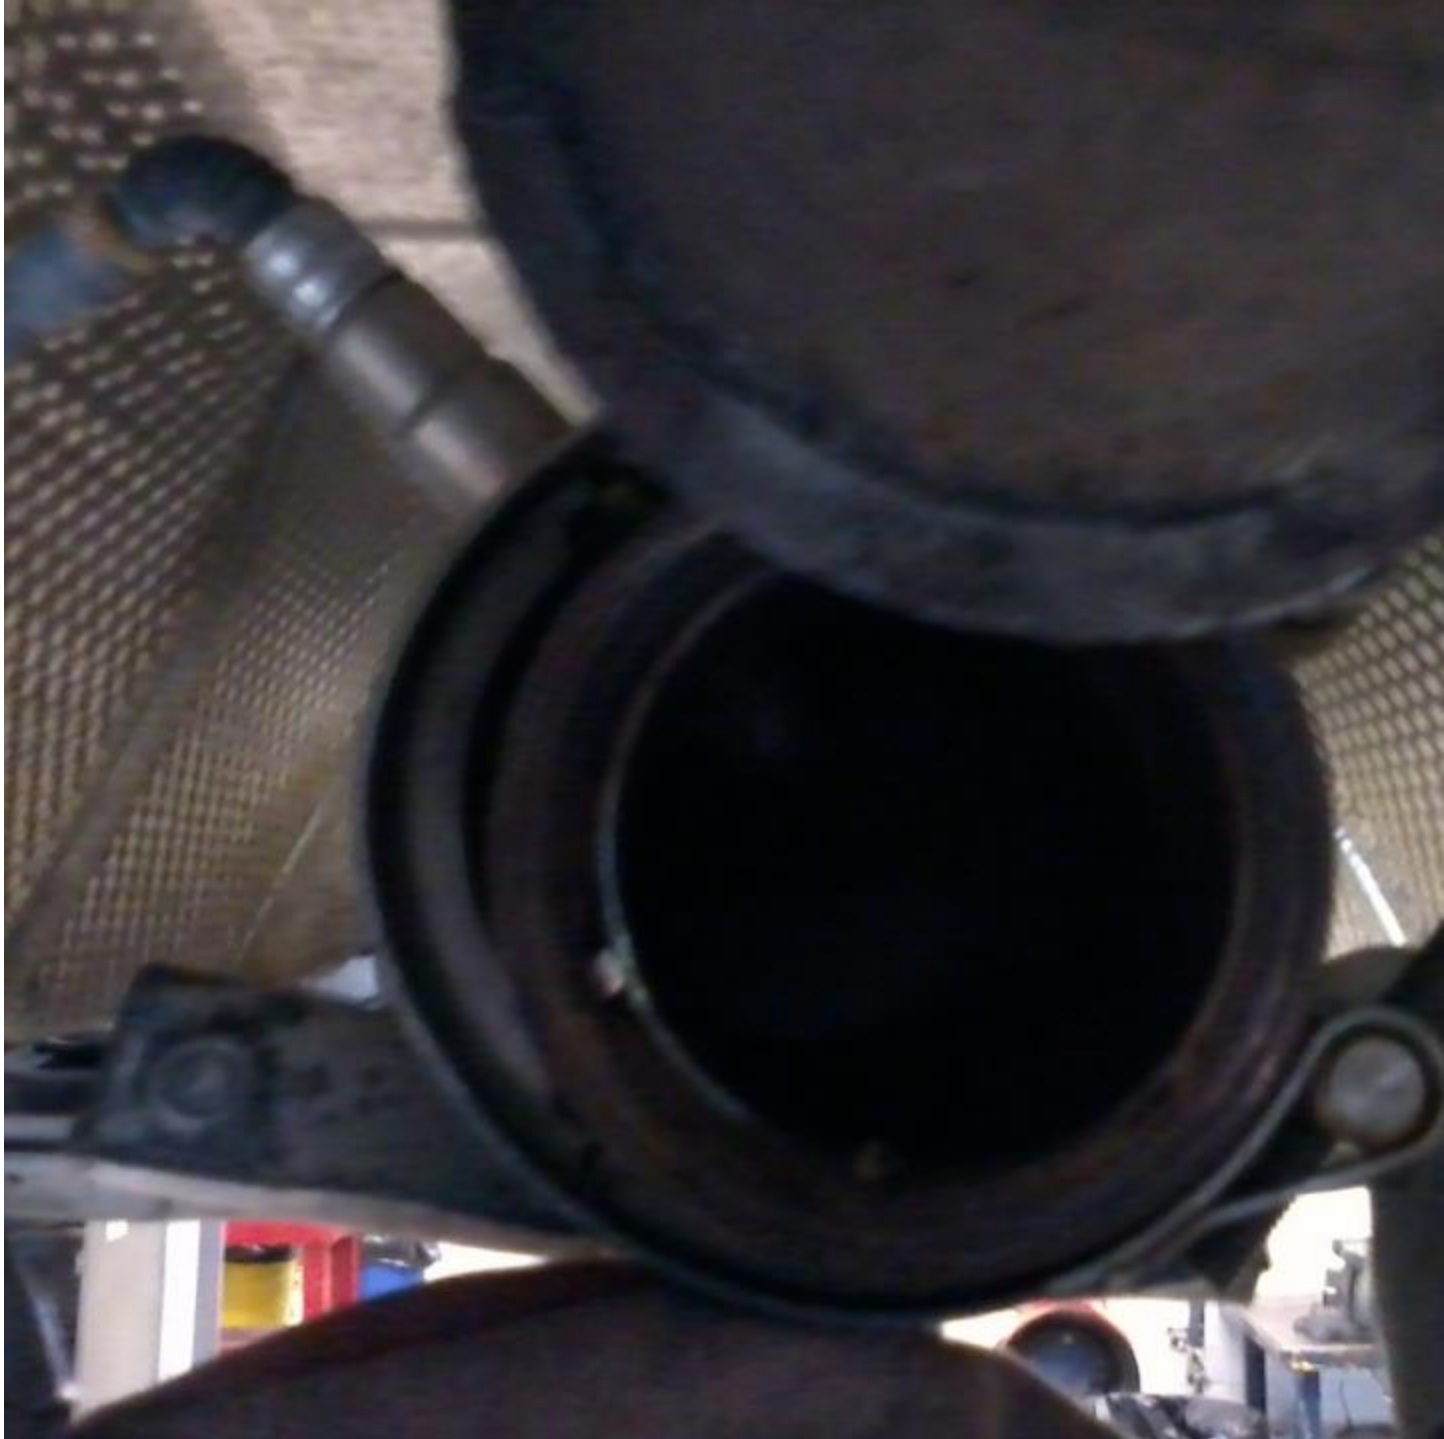
Above you can see how the loosened clamp bolt can be slipped from the clamp, and the clamp loose on the pipe. I gave it a little love tap with a chisel and hammer, applied lightly in the direction tangent to the exhaust pipe. (like the I in d, if you get my drift)

Torque value on the clamp screw is very light, 7 n-m or 5 ft-lb.

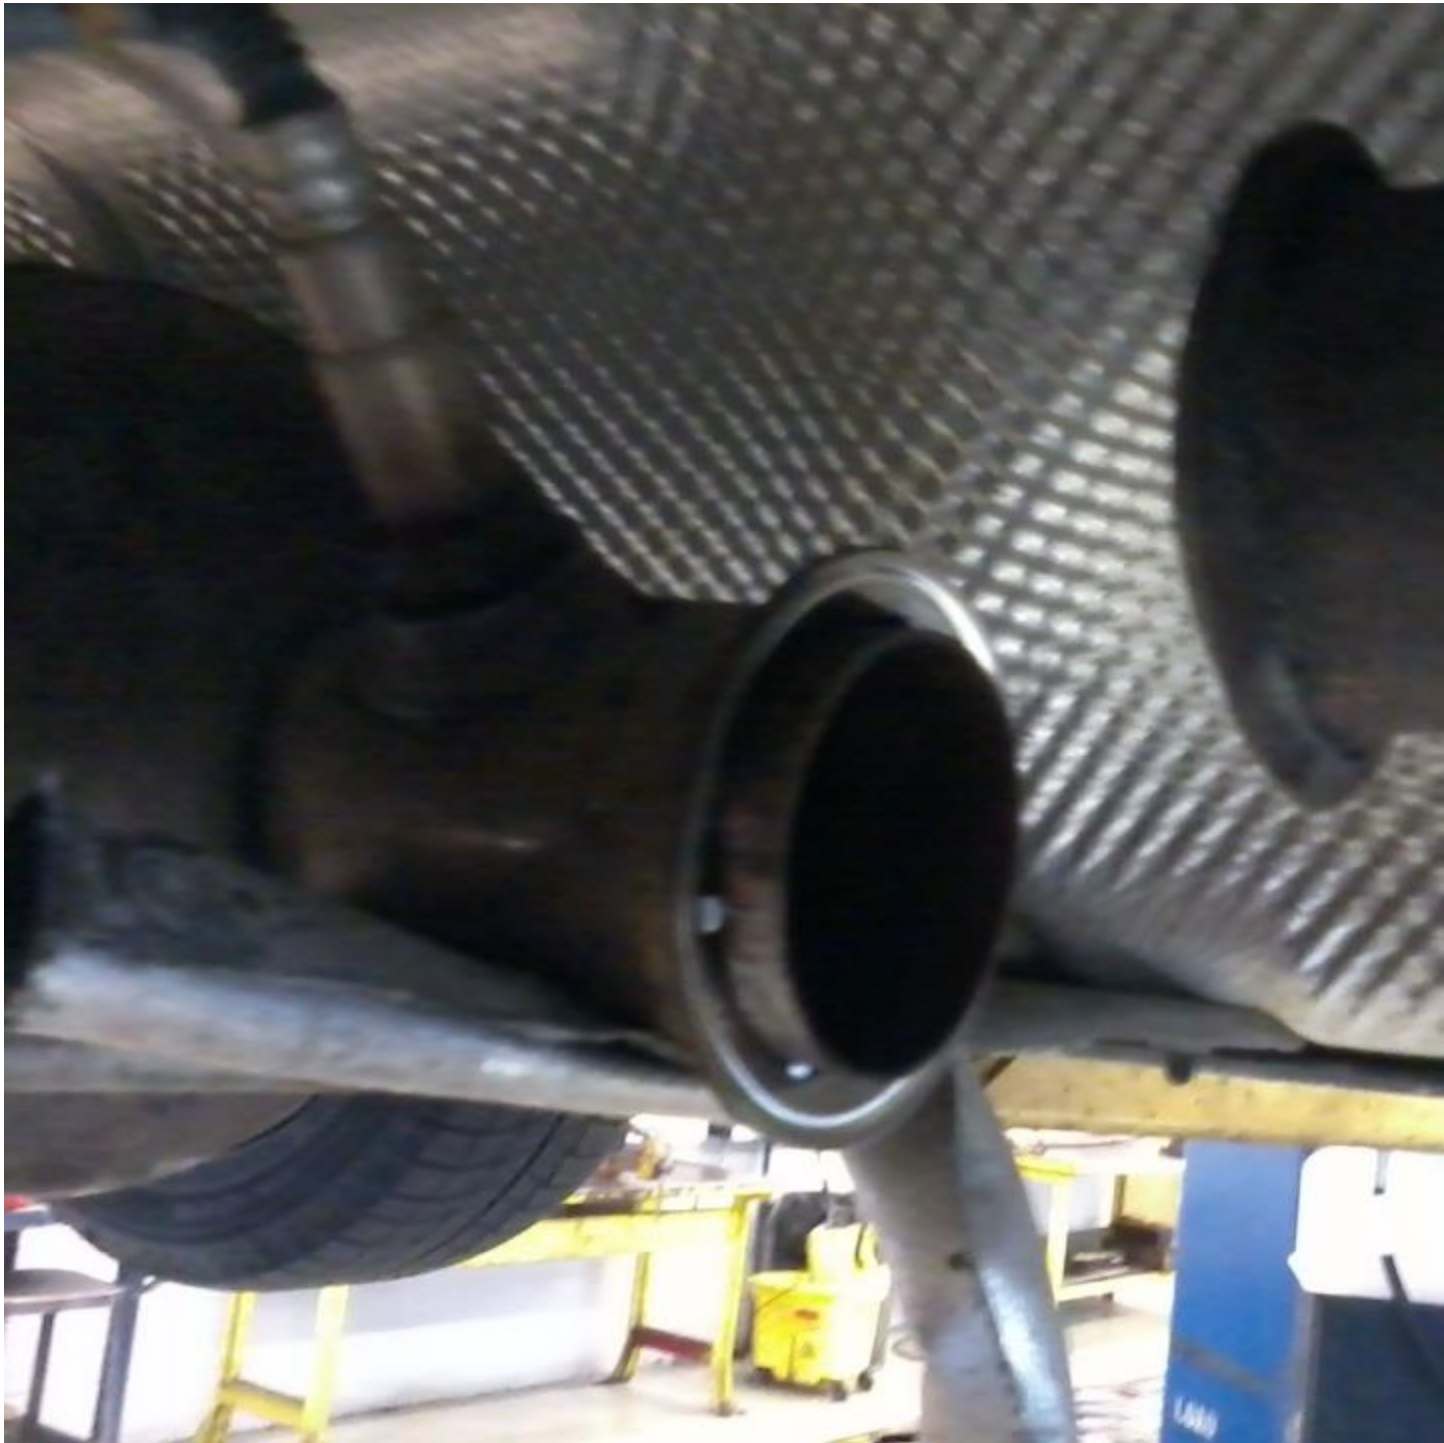
with the valve assy removed, you can see the seal. thin sheet metal part. the seal has tabs to hold to the pipe. Had to push the rear side of the exhaust to the rear of the car, but plenty of give in the hangers to allow enough space to pull the flap assy out.

the flap assy is keyed, as are the pipes, to allow only one orientation for proper fit, and to keep the flap in position.

some folks advise lubrication of this part to postpone failure, with some lock lube or other lube which will not gunk up at exhaust part temps.
