Technical Bulletin

21 11 06 September 06, 2011 2025464 Supersedes T. B. V211102 dated June 14, 2011 to modify warranty table and labor operations for clarification.

Frozen Charge Air Cooler – Engine Will Not Start

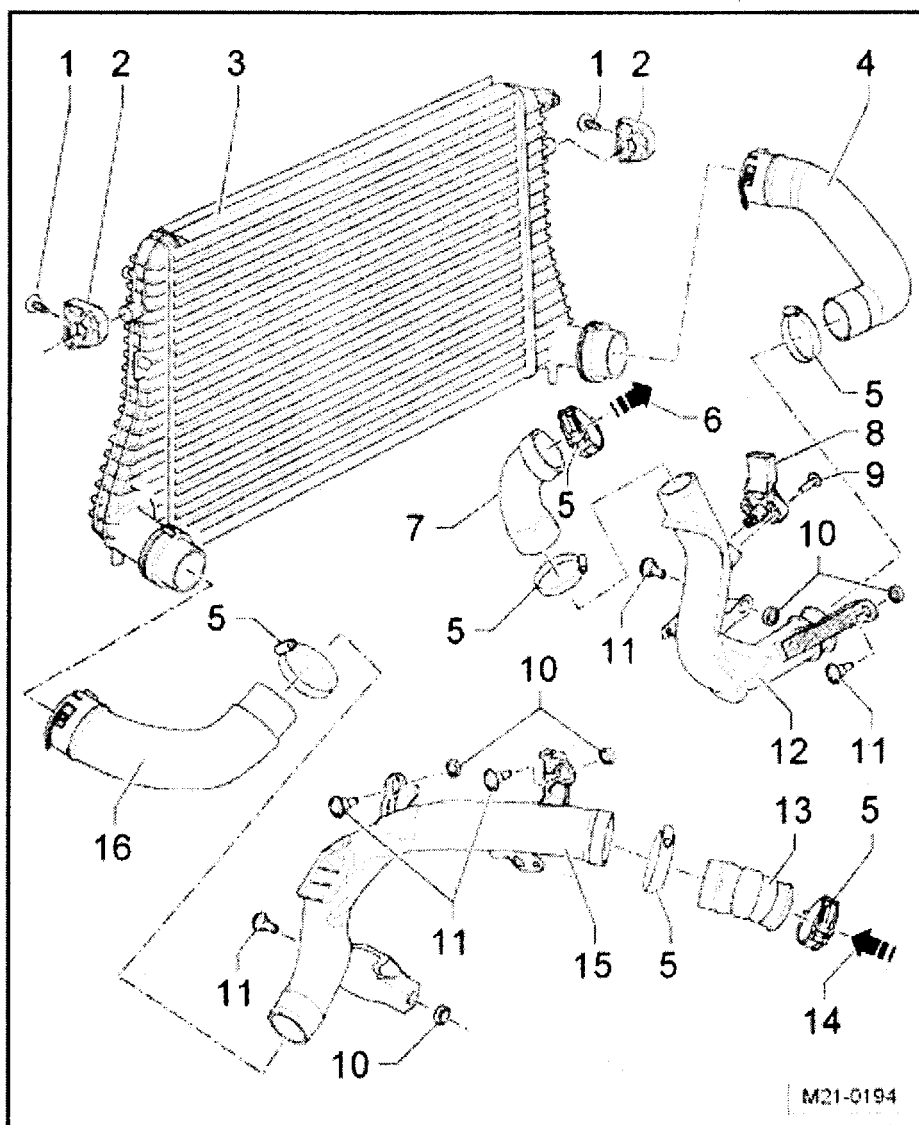
Figure 1

Moisture from the intake air condenses and collects in the charge air cooler. At cold temperatures this moisture can freeze causing blockage of the intake air system.

- Lock carrier in service position. See Repair Manual Group 50 in ElsaWeb.
- Separate A/C condenser from charge air cooler.
- Remove radiator and radiator fan assembly.
- Remove the original charge air cooler (item 3 in figure 1) from the vehicle.

- Remove the lower charge pressure hoses (items 4 and 16 in figure 1) and clean of any moisture or sludge. See Repair Manual Group 21, Turbocharger/G-Charger, Description and Operation, Component Overview, in ElsaWeb.

- Remove cold side charge air pipe (item 12 in figure 1) and pressure hose to throttle valve (item 7 in figure 1).
- Separate the A/C condenser from the charge air cooler.
- Remove the radiator and radiator fan assembly.
- Separate the charge air pressure sensor -G31- from cold side charge air pipe.
- Install charge air pressure sensor -G31- from kit to cold side charge air pipe.
- Loosely fit the pressure hose with new temperature switch to the cold side charge air pipe.

- Install the cold side charge air pipe (item 12 in figure 1) and connect the charge air pressure sensor -G31- electrical connector.
