Technical Service Bulletin  
21-15-02 - Frozen Charge Air Cooler - Engine Will Not Start

Transaction No.: 2025464/7  
Release date: Jan 20, 2015

21 15 02 January 20, 2014 2025464 Supersedes T. B. V211404 dated May 1, 2014 for labor operation update.

**Frozen Charge Air Cooler – Engine Will Not Start**

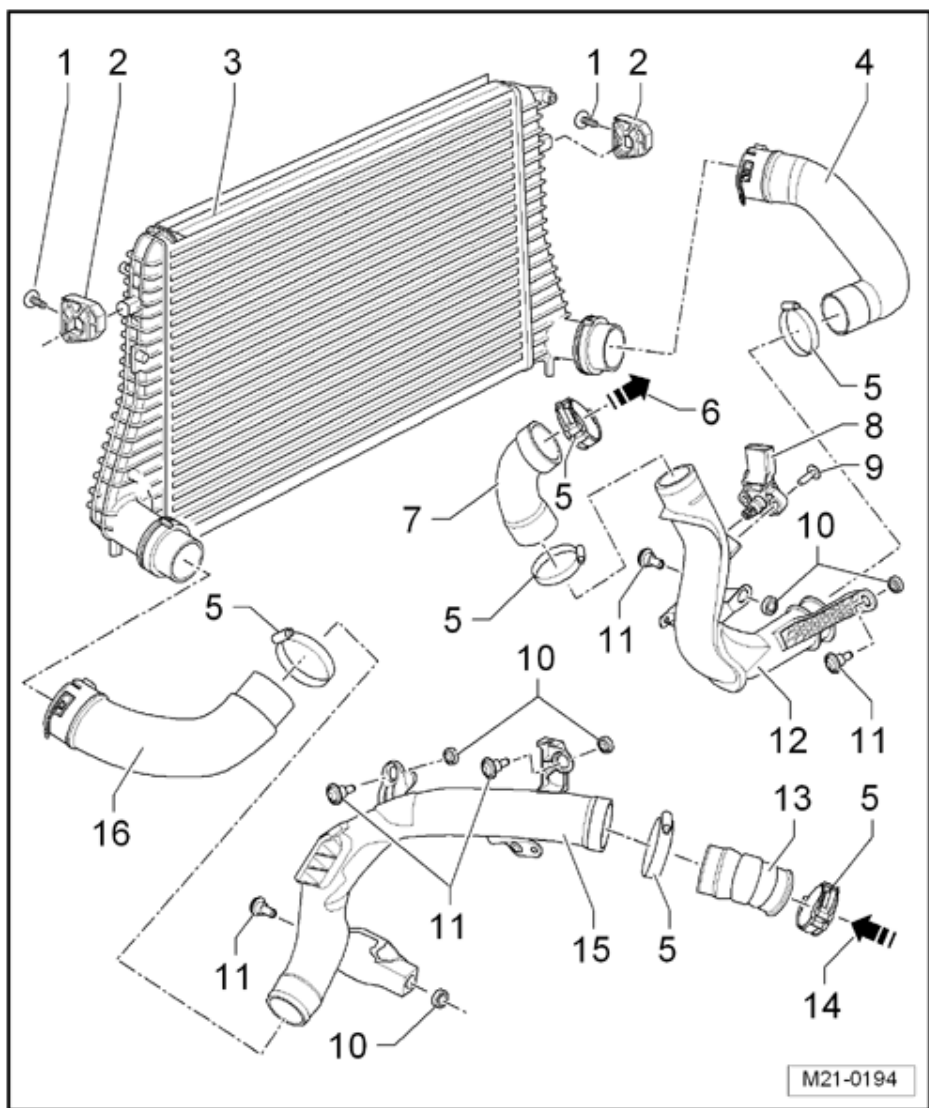
**Figure 1**

- Lock carrier in service position. See Repair Manual Group 50 in Elsa.
- Separate A/C condenser from charge air cooler.
- Remove radiator and radiator fan assembly.
- Remove the original charge air cooler (item 3 in figure 1) from the vehicle.

- Remove the lower charge pressure hoses ( items 4 and 16 in figure 1) and clean of any moisture, ice crystal formation or sludge. See Repair Manual Group 21, Turbocharger/G-Charger, Description and Operation, Component Overview, in Elsa.

- Remove cold side charge air pipe (item 12 in figure 1) and pressure hose to throttle valve (item 7 in figure 1).
- Separate the A/C condenser from the charge air cooler.
- Remove the radiator and radiator fan assembly.
- Separate the charge air pressure sensor -G31- from cold side charge air pipe.
- Install charge air pressure sensor -G31- from kit to cold side charge air pipe.
- Loosely fit the pressure hose with new temperature switch to the cold side charge air pipe.

- Install the cold side charge air pipe (item 12 in figure 1) and connect the charge air pressure sensor -G31- electrical connector.

- Cut vacuum source hose where indicated in figure 7, and install splice.
- Install the revised charge air cooler (item 3 in figure 1) with regulating flap and connect the regulating flap vacuum hose.
- Re-assemble all charge air pipe connections.
- Connect A/C condenser to charge air cooler using fasteners from kit, and install radiator with fan assembly.
- Reassemble front carrier.
- Re-aim headlights.

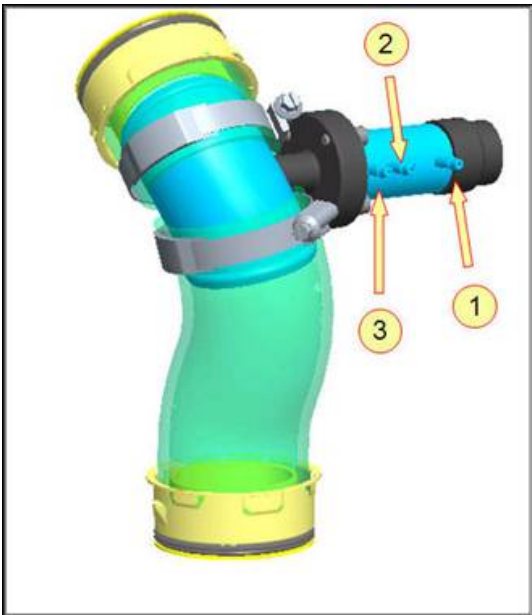
Figure 2

- Note the vacuum hose routing on the temperature switch (figure 2).

1. Ventilation hose to air cleaner
2. Hose to vacuum source

3. Hose to charge air cooler regulator flap

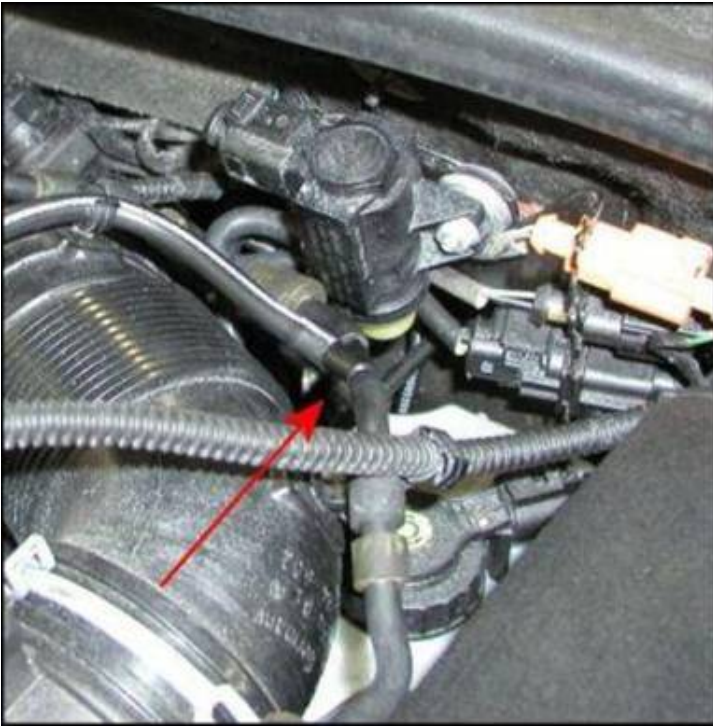
**Figure 6**

Note the white tracer on the vacuum hose in figure 6.

- Install splice as indicated in figure 6.
