Technical Bulletin

Subject: **Blower Motor, Noise or Vibration**

Number: **01-01**

Model(s): **New Golf, New Jetta
New Beetle**

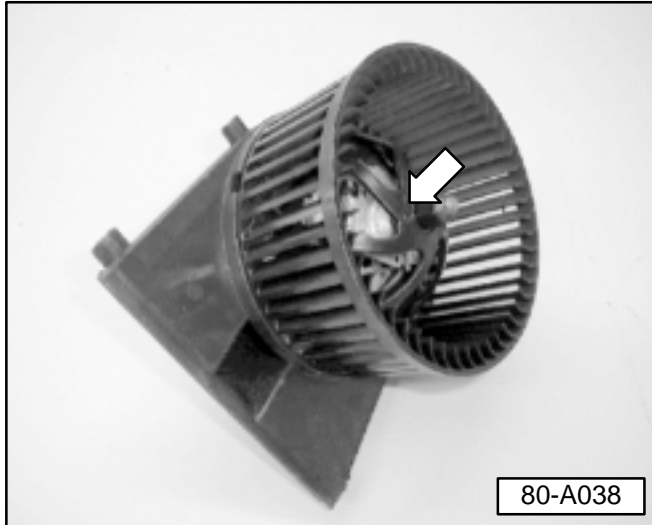
Excessive noise and/or vibration originates
from fresh air blower motor assembly.

- ◀ if either condition is evident, replace the
blower motor assembly with improved unit,
Part No. 1J1 819 021B (identifiable by six
support legs to center hub; see arrow),
