Service Action Circular

Code: P9/66C8

Subject: 2001-2005 Model Year Passat and Passat Wagon
Service Air Plenum Area to Improve Drainage and
Install Improved Pollen Filter Seal

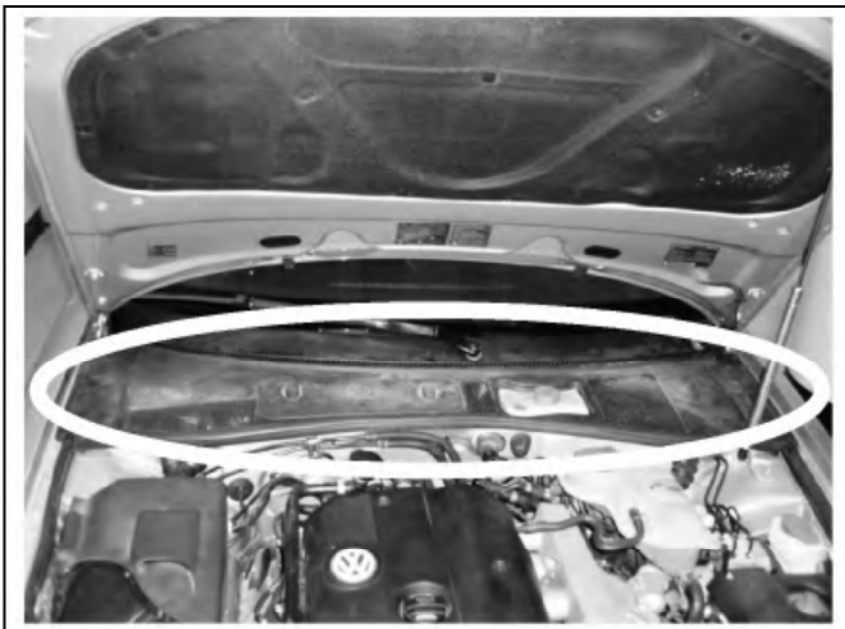
On some vehicles, moist debris might clog the air plenum drain area and water could leak into the passenger compartment. In order to prevent this condition, we will inspect, clean and modify the air plenum drain. We will also modify the sunroof drain (if equipped) and install an improved seal for the pollen filter on your vehicle.

To help ensure that the air plenum area remains clear in the future, we recommend regular inspection and, when necessary, cleaning of the air plenum area shown in the picture below. Please be sure to keep this letter with your owner's manual so it will be available for future reference.

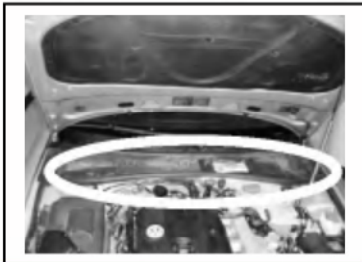
In some 2002 model year Passat and Passat Wagons moist debris might clog the air plenum drain area and water could leak into the passenger compartment and into the brake booster. In rare cases, during cold weather, frozen water may impede proper performance of the brake vacuum assist.

Additionally, to help ensure that the air plenum area remains clear in the future, we recommend regular inspection and, when necessary, cleaning of the air plenum area shown in the picture below. Please be sure to keep this letter with your owner's manual so it will be available for future reference.
