Symptoms:

- MIL : Intake Flap Motor malfunctioning (19559/P3103)
- Vehicle has no “drive-ability” issue (ie. running normal)
- Vehicle does not consume more fuel than normal

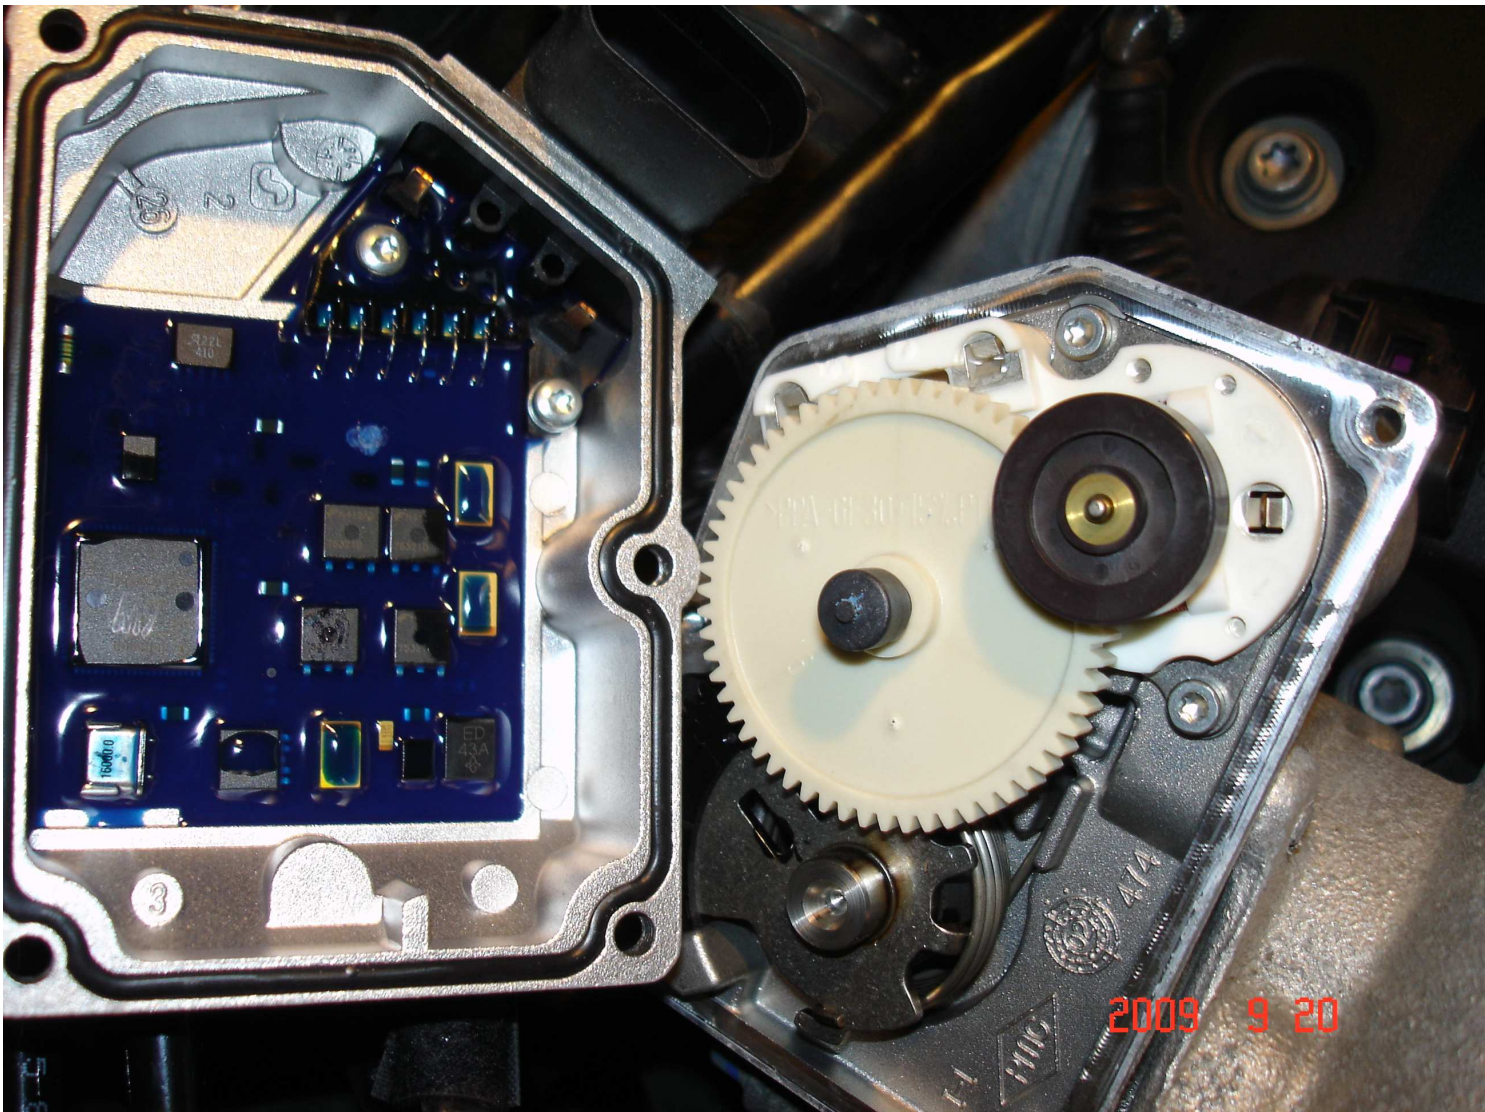
*The top cover part is on the left (pictured below)

- Remove the engine cover. Locate the Intake Flap Motor
- Open it up: Remove the electrical connector. Remove the 4 bolts and lift the top straight up (or the 2 plastic guiding pins will break; no big deal, mine broke, just make sure to remove the broke-off plastic bits from the assembly so it does not jam up the plastic gears).

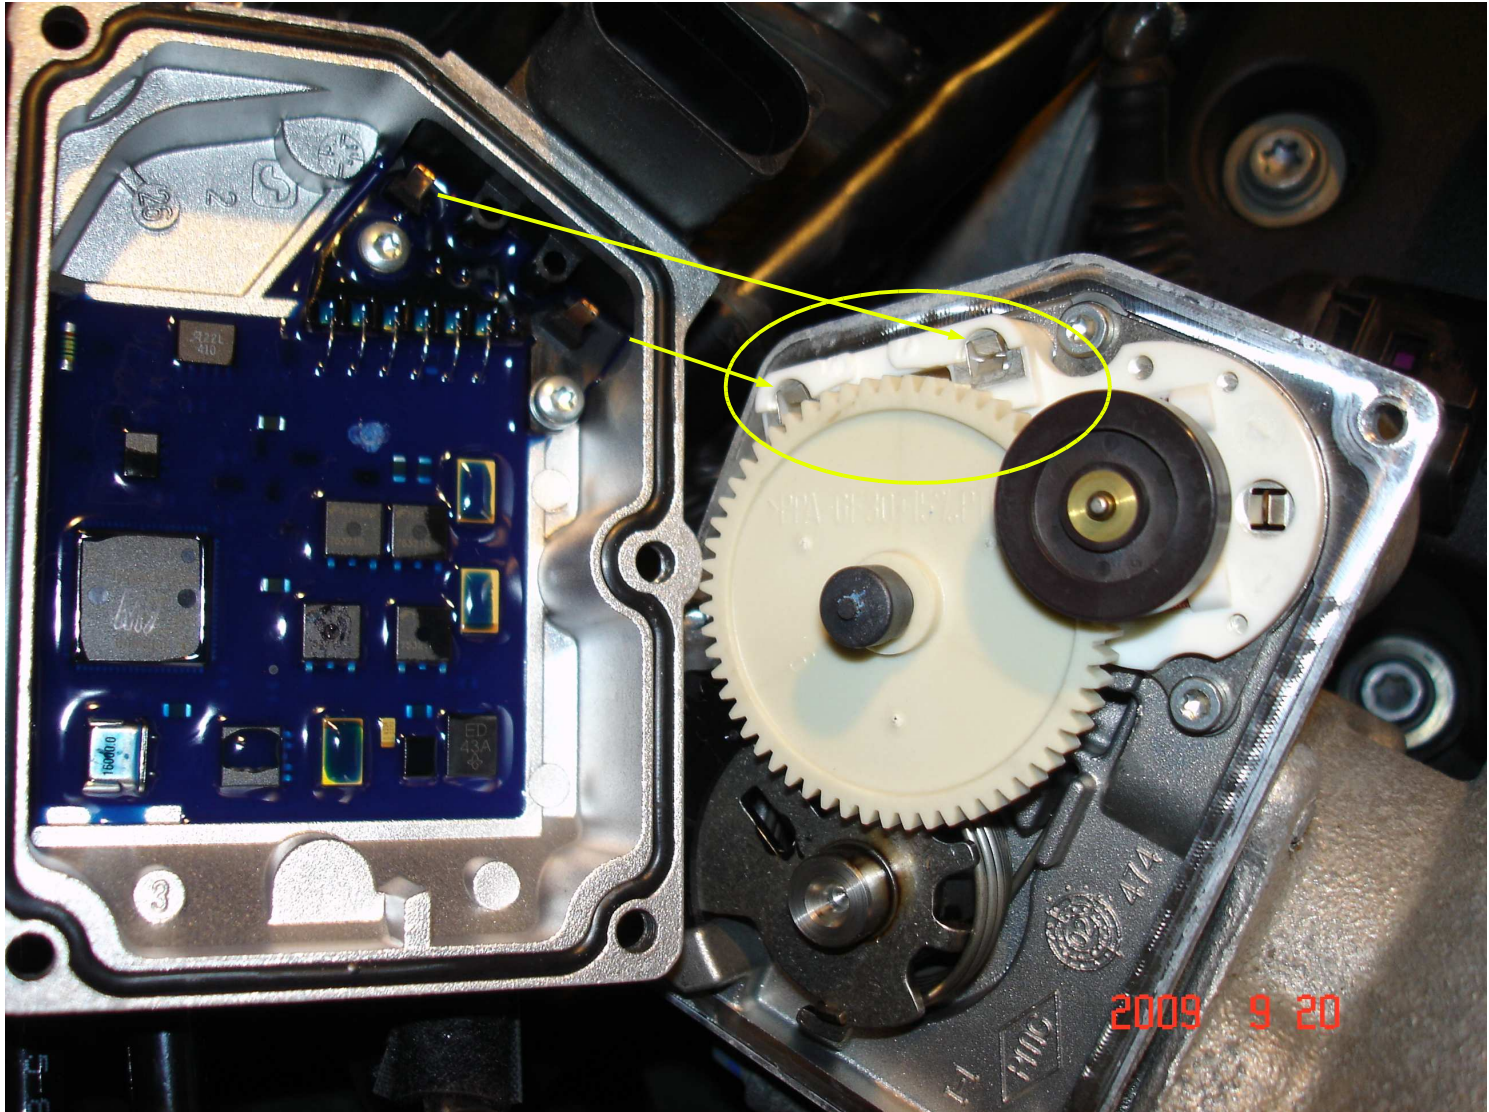
Note the 2 flat pins contacts into the “female sockets”

=> Make both gaps smaller to improve the electrical contacts.
I used a small nail and lift both tabs up on each of the 2
“female sockets”
