# Technical Bulletin

69 08 02 Feb. 11, 2008 2011271, Supersedes Technical Bulletin Group 69 number 07-03, dated Mar. 23, 2007 due to Labor Operation code update.

Igniter, Side Airbag, Diagnostic Trouble Code(s) Stored in DTC Memory

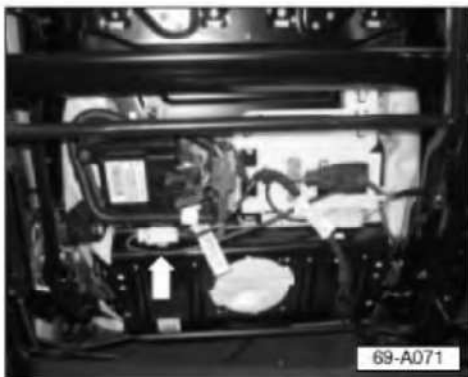
### Rabbit/ new GTI / Eos ONLY:

The pictures are used to illustrate connector location only, seat does not have to be disassembled for repair.

- Remove male and female side connectors T3K (N199-drivers side), T3L (N200 passenger side, as shown) by cutting one wire at a time, discard connectors.

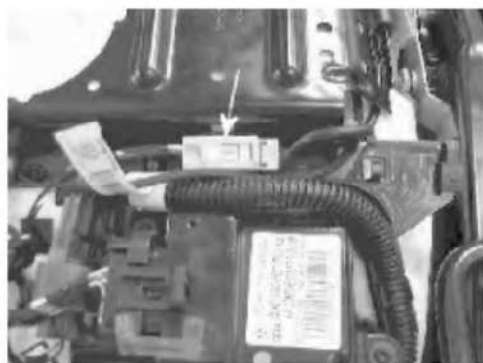
## Passat ONLY:

- Remove male and female side connectors T3 (N199-drivers side), T3a (N200-pass. side, as shown) by cutting one wire at a time, discard connectors.

- Using butt splice crimping tool VAS 1978/24: Splice the harness together using three 4in. sections of Repair wire Part No: 000 979 010 (from VAS 1978AR wiring repair kit) and 6 butt connectors Part No: 111 971 941A harness repair kit 1978.
