Emissions Recall Circular

Code: **M6**

Subject: 2004–2005 MY Golf, Jetta and New Beetle with TDI Engines

Replace EGR Cooler

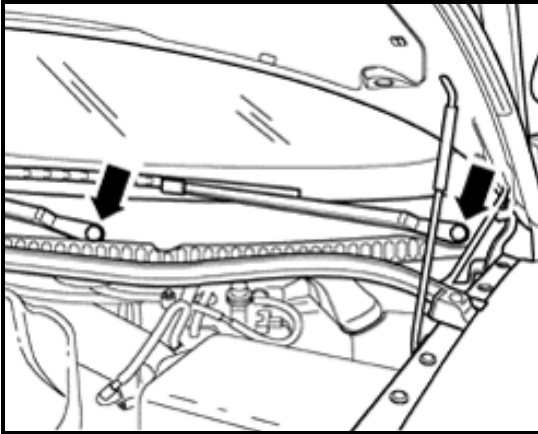
1

- ⇐ Ensure wiper arms are in park position and remove black cover caps -arrows-

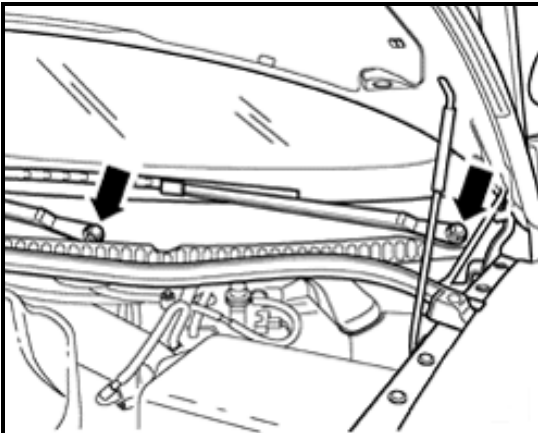
2

- ⇐ Loosen nuts -arrows- but do not completely remove

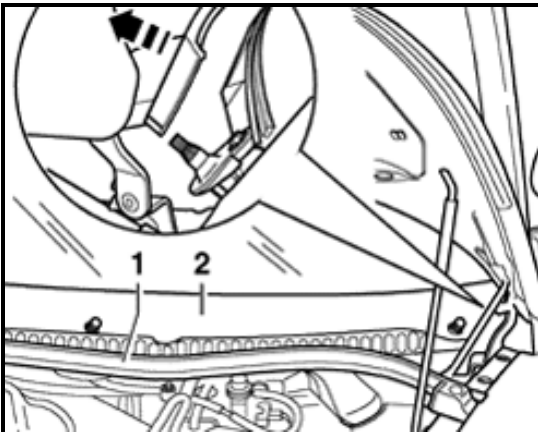
3

- Remove plenum panel seal -1-

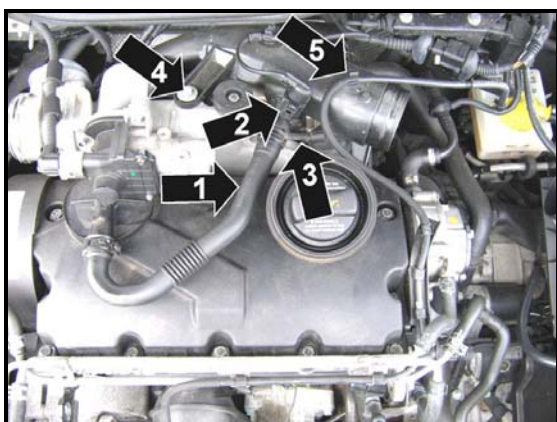
- ⇐ Disconnect connector -2- from crankcase air valve and remove harness from clip on air intake pipe
- ⇐ Disconnect air hose -1- from PCV valve and move aside
- ⇐ Disconnect vacuum hose -3- from EGR cooler, remove from clip on air intake pipe and move aside
- ⇐ Remove bolt -4- securing air intake pipe to intake manifold

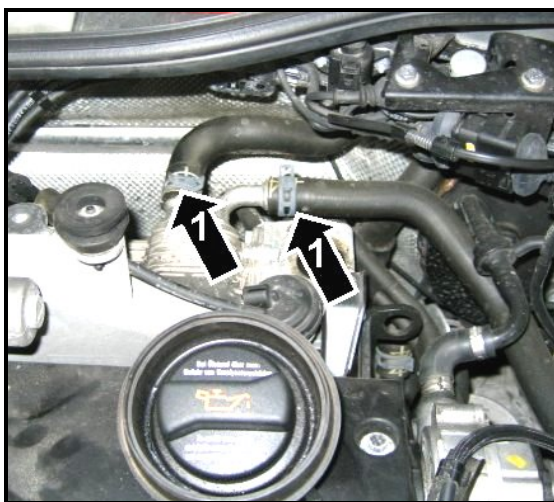
- ⇐ Remove nuts -20- securing lower connecting pipe to exhaust manifold
- ⇐ Remove lower connecting pipe -18- and gaskets -21- and -22-
- Open cap on coolant reservoir bottle to relieve any pressure and close cap
- Place pan (VAS 6208 or equivalent) under vehicle to catch coolant seepage

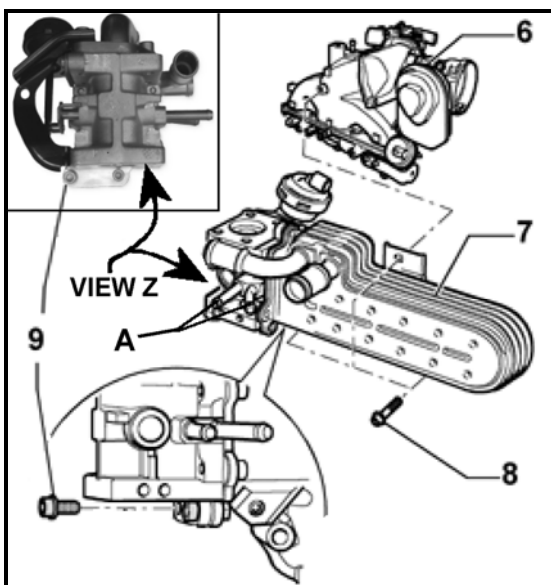
- Use clamps 3093 or equivalent and clamp off coolant hoses to EGR cooler
- ⇐ Remove clamps -1- and disconnect coolant hoses from EGR cooler

Tip: Illustration is for Jetta, however, New Beetle assembly is similar

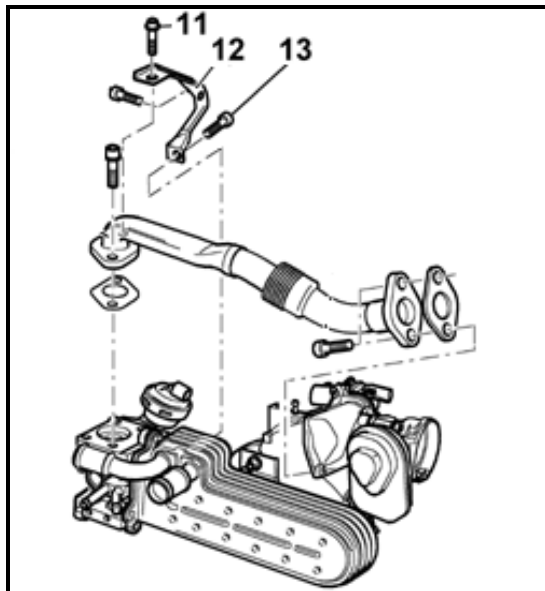
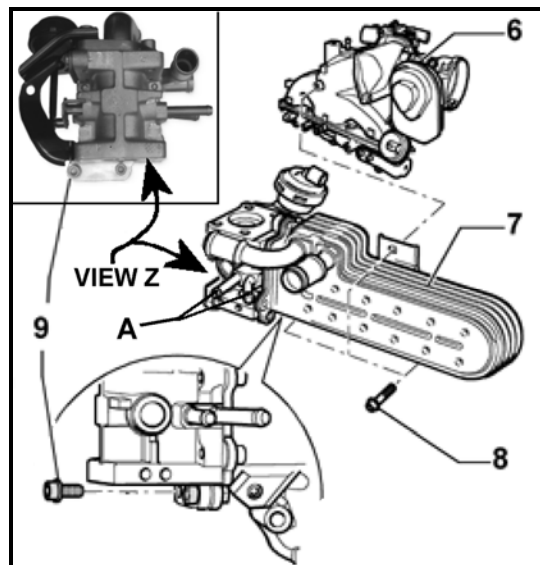
- ⇐ Remove screw -9- securing EGR cooler to intake manifold
- ⇐ Remove screws -8- and remove EGR cooler -7- from intake manifold -6-
- Make note of smaller diameter coolant hose locations connected to EGR cooler pipes -A-
- Use 3094 hose clamps and clamp off coolant hoses
- ⇐ Remove clamps securing coolant hoses to pipes -A- and disconnect coolant hoses

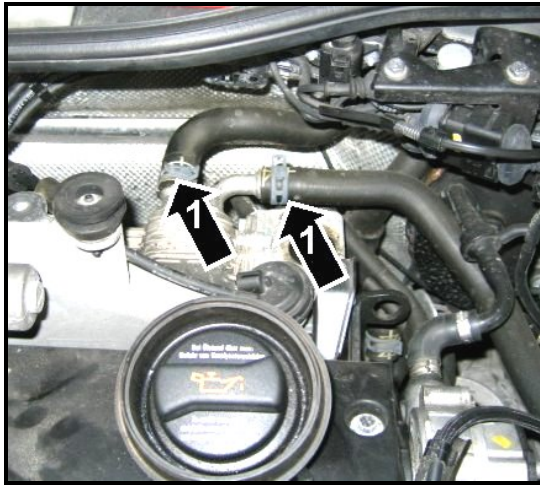
Note: New part installation must be followed according to work step sequence to prevent stress

- ⇐ Remove screw -13- and bracket -12- from removed EGR cooler
- ⇐ Install bracket -12- onto new EGR cooler (038 131 512 J) from the repair kit and secure (hand tighten) with screw -13-
- ⇐ Hand start screw -11- to correctly position bracket -12- on regulating flap
- ⇐ Tighten screw -13- to 5 Nm (45 in. lbs.) and remove screw -11-
- ⇐ Reconnect 2 small diameter coolant hoses to pipes -A- on EGR cooler and secure with clamps
- Remove 3094 hose clamps
- ⇐ Position new EGR cooler -7- onto intake manifold -6- and secure (hand tighten) with (3) screws -8-

Note: EGR cooler must be able to move about screws -8-

- ⇐ Secure EGR cooler to intake manifold with screw -9- and tighten to 10 Nm (89 in. lbs.)
- ⇐ Tighten (3) screws -8- to 10 Nm (89 in. lbs.)

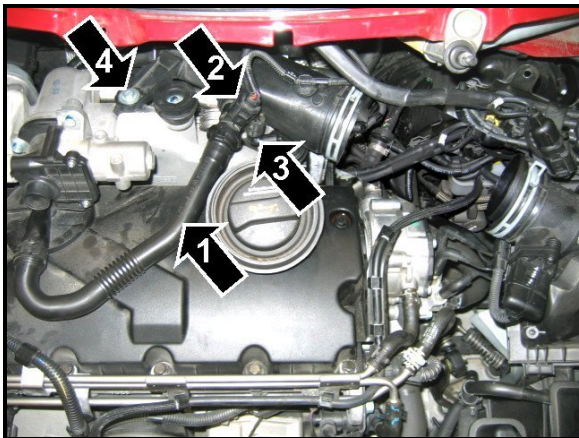
- ⇐ Secure air intake pipe to intake manifold with bolt -4-
- ⇐ Reconnect vacuum hose -3- to EGR cooler
- ⇐ Insert vacuum hose -5- into clip on air intake pipe
- ⇐ Reconnect air hose -1- to PCV valve
- ⇐ Reconnect connector -2- to crankcase air valve and insert harness into clip on air intake pipe

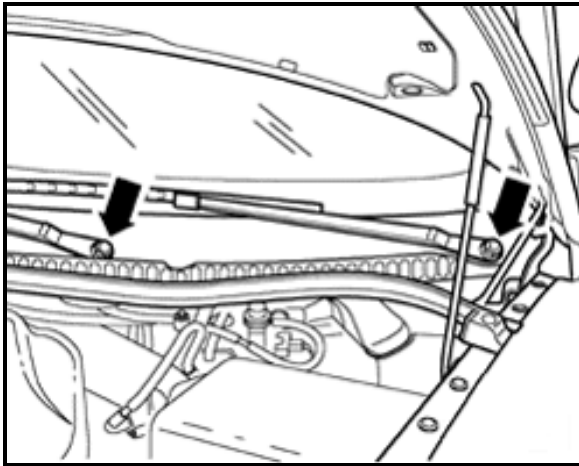
- ⇐ Reinstall plenum panel and secure with bolts -B-
- ⇐ Secure solenoid valves to plenum panel with 2 nuts -A-
- Insert vacuum hoses into retainers on underside of plenum panel
