Preventing Catastrophic Camshaft Lobe Failures in Low Emission Diesel Engines

J. A. Mc Geehan and P. R. Ryason

Chevron Products Company

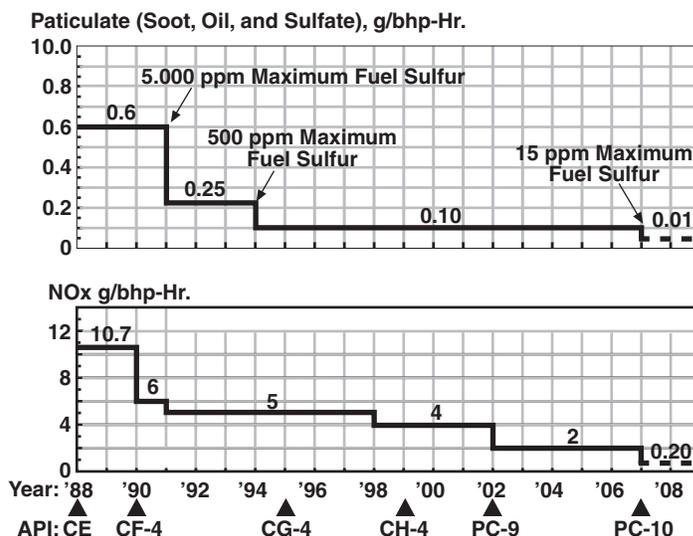
U.S. EPA standards control diesel particulate and NO_x emissions, and both have been reduced stepwise. (See Figure 1.) Since October 1998, these emissions have

Figure 1 – EPA’s reductions in particulate, NO_x and fuel sulfur level for diesel engines. Paradigm shifts in oil quality levels driven by exhaust emission regulations.

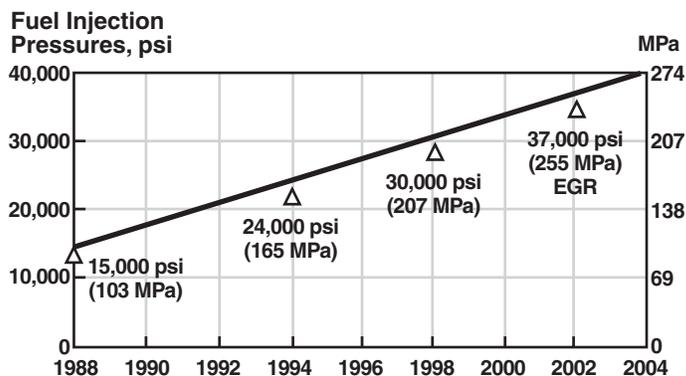
Figure 2 – Trend to high fuel injection pressures with unit injectors with reduced emissions.

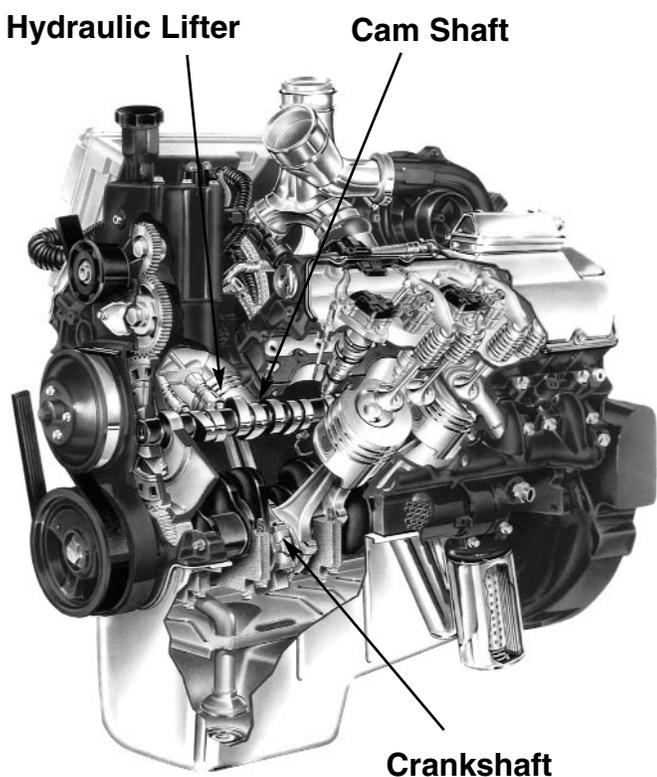
Figure 3 – V-8 configuration provides fast and adequate lubrication. Oil thrown from both crankshaft and down from hydraulic lifters on to cam lobes.

Adequate lubrication is critical, especially in applications of stop-go engines where the oil could quickly drain from the cam system, particularly the roller pin. The optimum clearance between the pin and roller will affect the drainage of oil and its retention. Finally, the volume of oil reaching the cam system is important to insure that these components are fully flooded during operations. These volumes may be 8-12 gallons/min. (30-45 L/min.) in 12-liter overhead cam engines with no field failures.

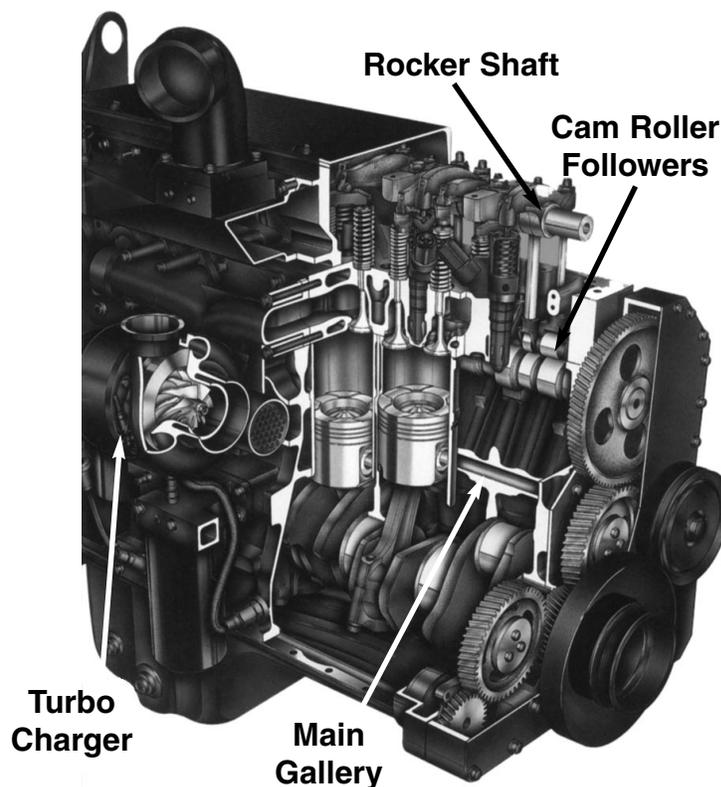
Figure 4 – Cummins M-11 low temperature pumpability test illustrating position of pressure transducers in: main oil gallery, turbocharger cam-roller follower gallery and rocker shaft.

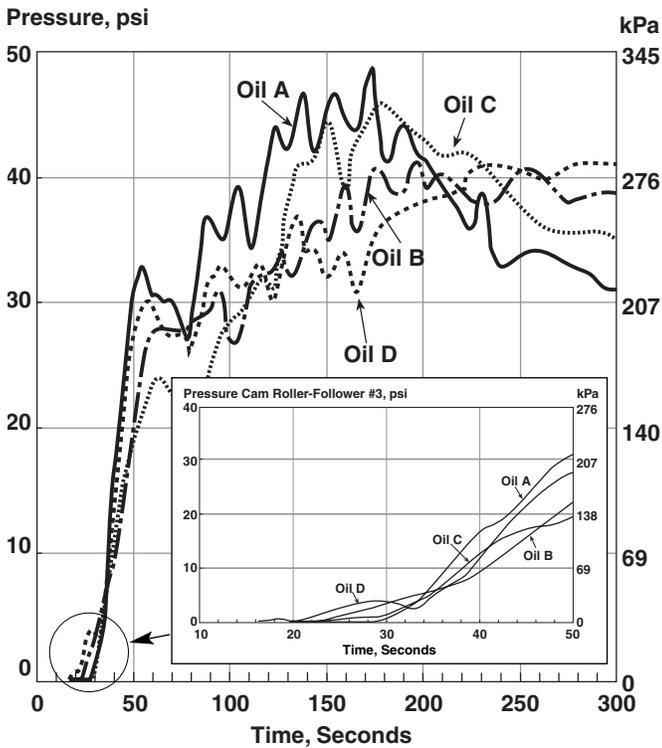
Figure 5 – Cummins M-11 low temperature pumpability at -15°C. Pressure at roller follower #3. Comparison of four commercial API CG-4/SJ – SAE 15W-40 oils.

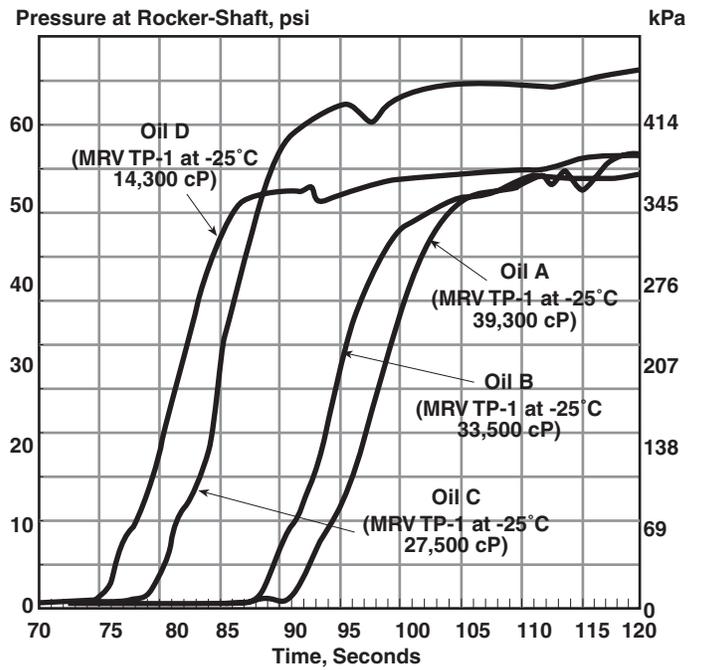
Figure 6 – Cummins M-11 low temperature pumpability at -15°C. Pressure at rocker-shaft. Comparison of four commercial API CG-4/SJ – SAE 15W-40 oils and MRV TP-1 viscosities at -25°C.

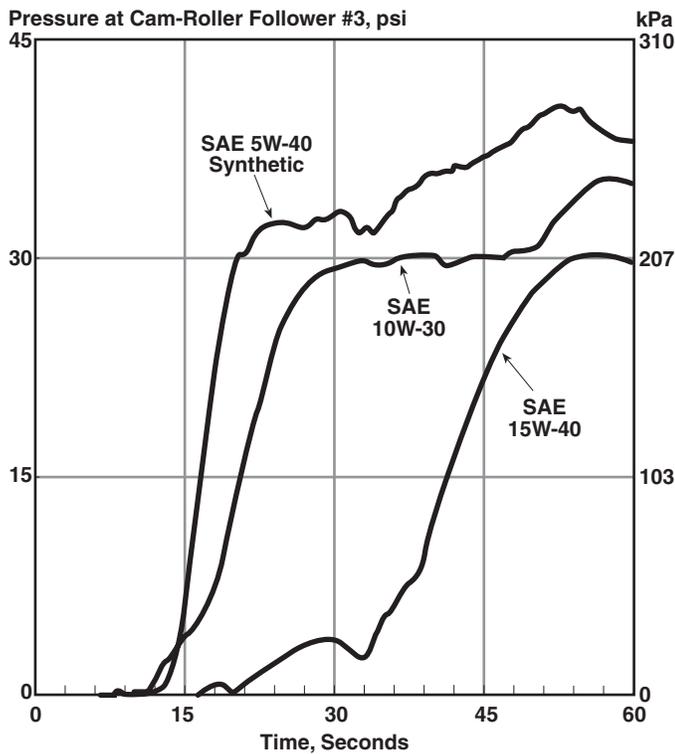
Figure 7 – Cummins M-11 low temperature pumpability at -15°C. Pressure at Roller Follower #3. Comparison of SAE 5W-40 synthetic, 10W-30 and 15W-40 grades.

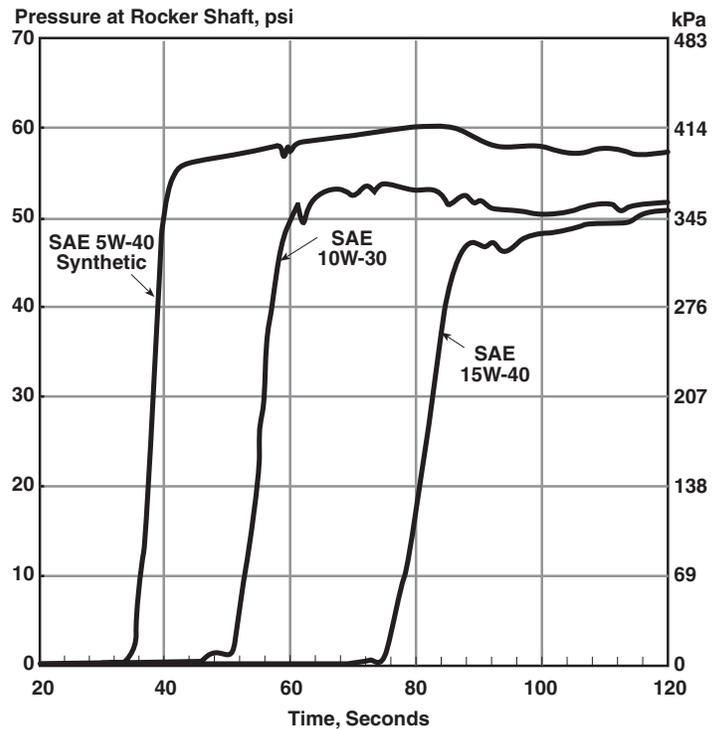
Figure 8 – Cummins M-11 low temperature pumpability at -15°C. Pressure at rocker shaft. Comparison of SAE 5W-40 synthetic, 10W-30 and 15W-40 grades.

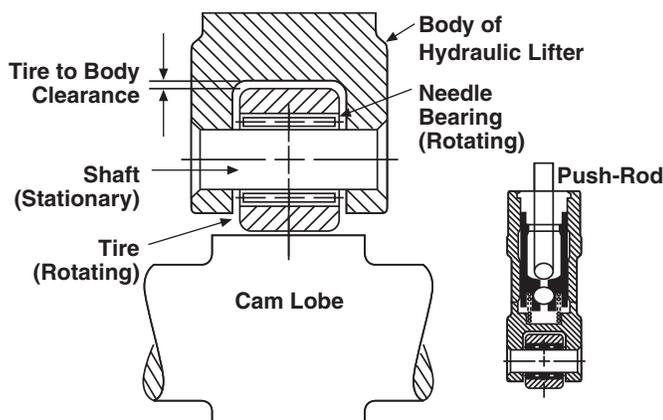
The above engines used steel roller followers with needle bearings in the hydraulic lifter. (See Figure 9.) In order to maximize load capability, the needle bearings are not in a cage, but are "free" within the roller. Without the cage the needle bearing can skid on the shaft due to lack of alignment.

Figure 9 – GM 6.2 liter engine roller follower configuration

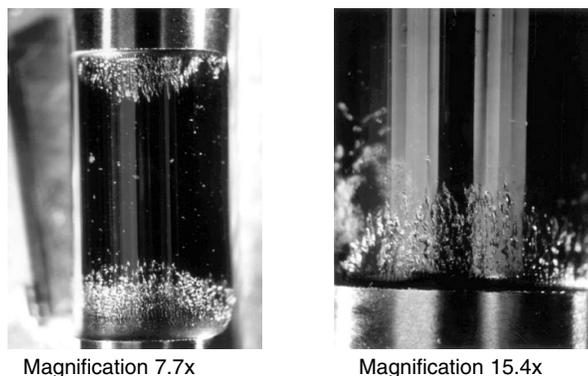
In field failures, polishing of the center stationary shaft, with contact fatigue at the ends where the needle radius was positioned, identified the initial failure [9]. Soot polishing could progress to catastrophic failure of the pin and the cam. Note the misalignment of needles to the center pin in the failed roller. (See Figures 10 and 11.)

Figure 10 – GM 6.2 liter roller follower polishing and surface fatigue to the stationary shaft – field parts from ambulance fleet.

Polishing failures of this roller follower were eliminated by formulating engine oils that provided a protective wear film on the steel roller and needles in spite of 5% soot in the oil. Using low wear oils, we demonstrated that phosphorous, sulfur, and zinc from the zinc dithiophosphate (ZnDTP) had adsorbed and reacted to provide an anti-wear film. (See Figure 15.)

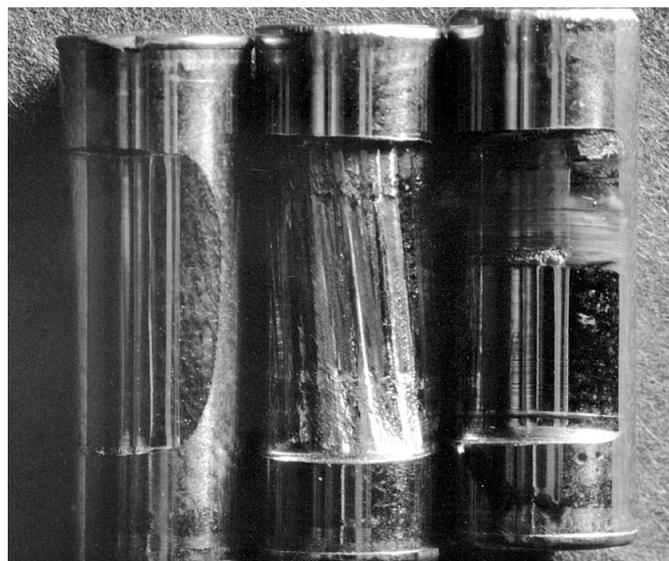
Figure 11 – 6.2 liter engine – catastrophic failure of central stationary shaft from field.

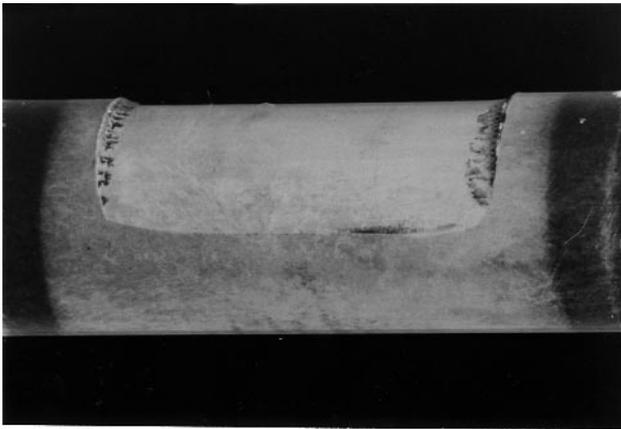
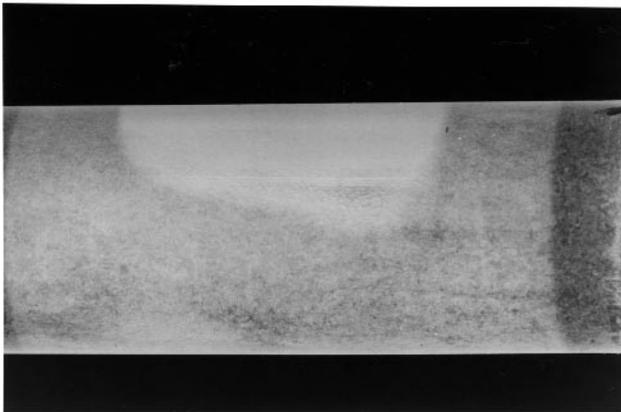
This test simulated the wear problem with high and low wear in oils, as shown on the center pins. (See Figures 12 and 13.) Subsequent field testing demonstrated that oils which qualified as low wear in this test provided low wear in the field, compared to oils which failed the test and produced high wear in the field. (See Figure 14.)

Figure 12 – Stationary shaft from GM 6.2 liter 50-hour engine dynamometer test. Top axle was double length (100 hours) test with TMC1001 (REO 217/91). Bottom axle used REO 203/83.

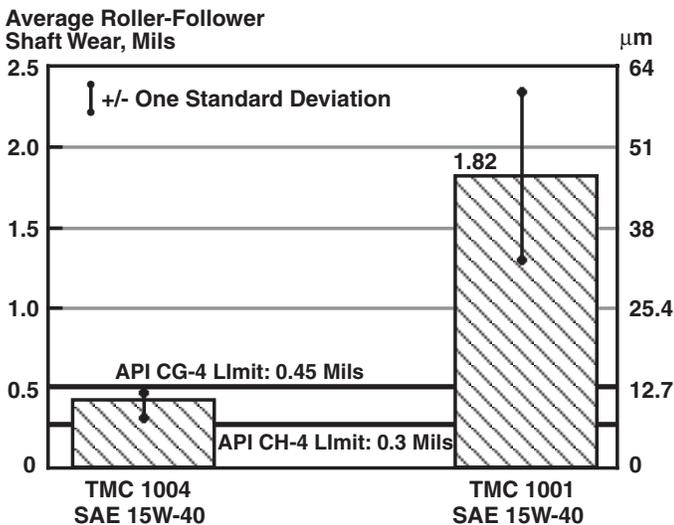
Figure 13 – GM 6.2 liter – 50-hour roller follower wear test with API CH-4 and CG-4 limits compared to low and high wear reference oils.

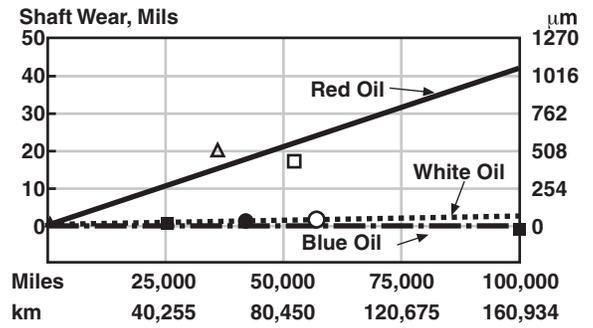
Oil	Red	White	Blue
Truck	△ □	● ○	■
Shaft Wear Mils	1.6	0.7	0.2
Inches	0.0016	0.0007	0.0002
µm	40.6	17.8	5.1

Figure 14 – Correlation of data between GM 6.2 liter field tests and GM 6.2 liter 50-hour dynamometer test results. Blue oil demonstrated zero wear at 100,000 miles (160,934 km) and lowest wear in 50-hour dynamometer test.

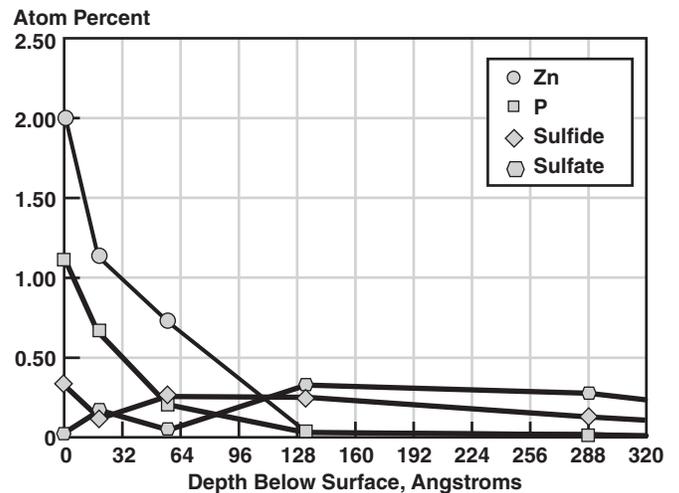
Figure 15 – Electron spectroscopy for chemical analysis (ESCA) depth profiles for low wear 6.2 liter stationary axle from 50-hour test. Phosphorous, zinc and sulfur adsorbed on low-wear axle, providing a protective wear film.

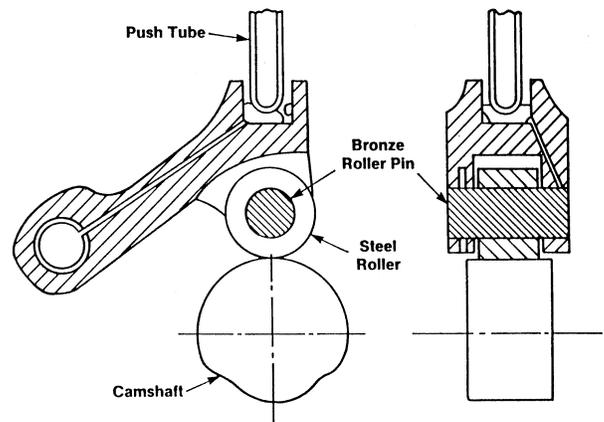
The majority of engines in the U.S. with over 10 liters displacement use a steel roller with a bronze pin. To ensure adequate engine durability, it is necessary for a combination of critical parameters to be correct, as any one may cause a failure. (See Figure 16.)

Figure 16 – Camshaft and roller follower assembly with bronze pin and steel roller.

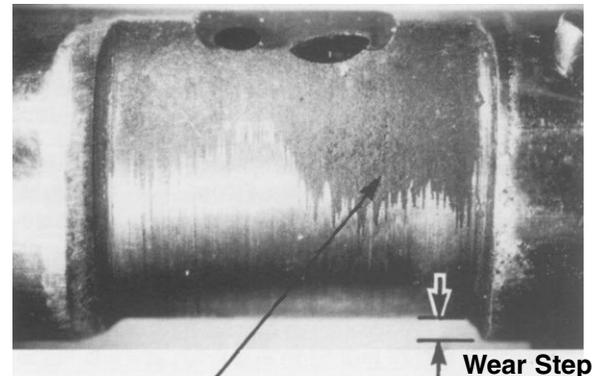
In the early 1980s, prior to diesel engine emission regulations, bronze pin corrosion occurred which resulted in catastrophic camshaft failures [15]. This was a result of an additive -- molybdenum dithiophosphate -- being added to fully qualified API CD-SF-SAE 15W-40 oils, with the claim of fuel economy improvement. The addition of 1% of molybdenum dithiophosphate resulted in corrosive wear of both the bronze pins and the bronze wrist pin bushings. (See Figure 17.)

Figure 17 – Corrosion of roller follower bronze pin from the field.

X-ray powder diffraction of the deposit on the bronze pin identified $Cu_{1.8}S$, and Electron Spectroscopy for Chemical Analysis (ESCA) found over 40% cuprous sulfide. This analysis and bench test definitively identified corrosion of the pin [16]. To guard against such failures, supplementary additives should never be added to fully formulated API qualified oils, unless the full battery of sequence tests is run to confirm that no harm is caused by the modified formulation.

API CG-4/SH and CH-4/SJ oil categories now require three tests to exclude oils that might cause corrosion. They are the L-38 gasoline test for bearing corrosion of copper-lead bearings; Mack T-9 test for bearing corrosion of copper-lead bearings; and Cummins bench test, which uses strips of copper, lead, phosphor-bronze and tin immersed for 168 hours at 121°C [17].

This sequence of tests has eliminated this corrosion problem in the field. But extra components should not be added to fully qualified API products as unknown complex reactions can take place within additive systems and can cause catastrophic failures, as discussed above.

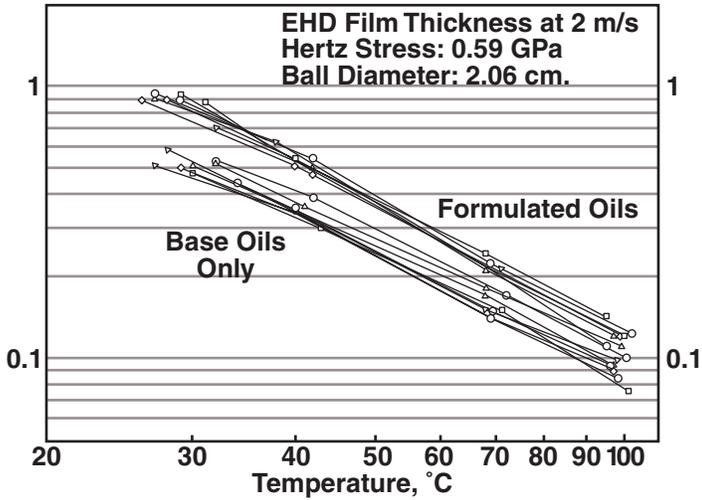
Figure 18 – EHD film forming capabilities versus temperature. Two different DI/VI formulations of API CG-4/SJ quality, using six different base stocks, ranging from API Group I to Group II.

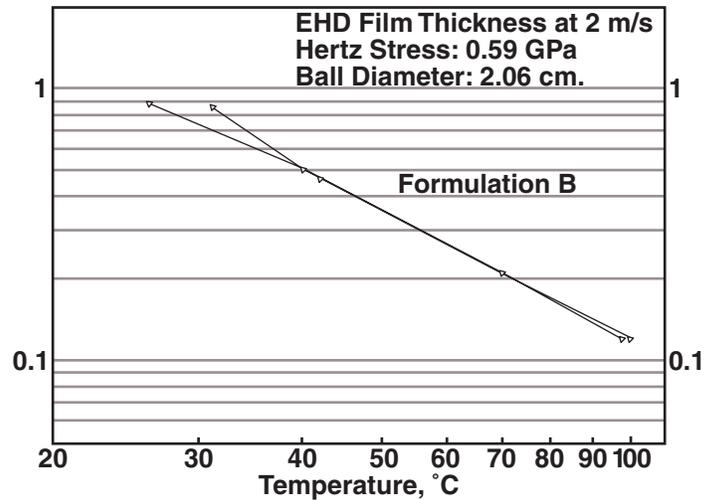
Figure 20 – EHD film forming capabilities versus temperature. One API CG-4/SJ oil using Group I (66% saturates) and Group II (99% saturates).

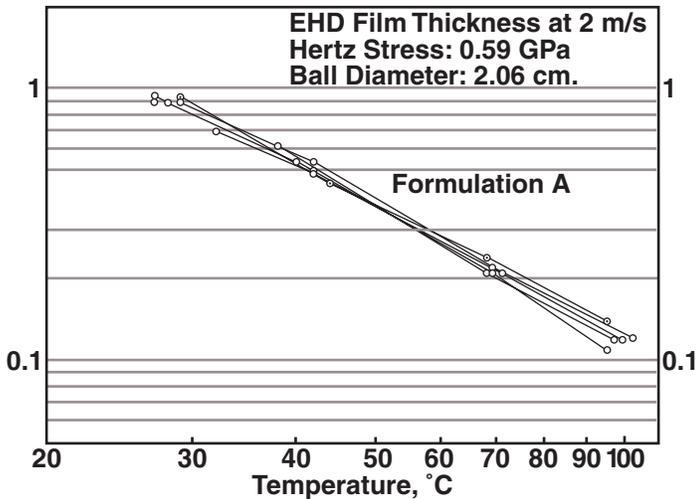
Figure 19 – EHD film forming capabilities versus temperature. One API CG-4/SJ oil using six different base stocks, ranging from API Group I to API Group II.

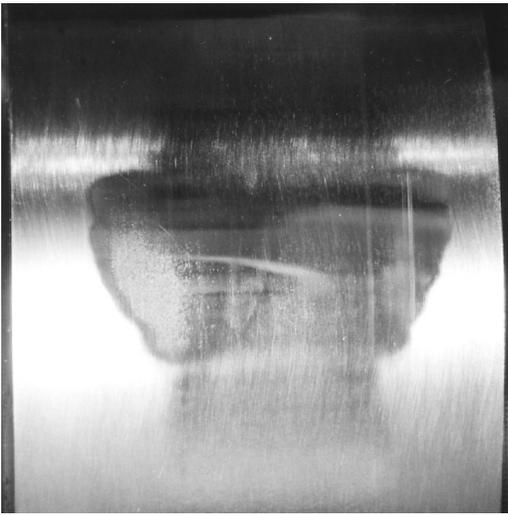
Magnification 2.6x

Elastic deformation of a roller is illustrated in Figure 21, showing the wear track of a roller on a cam lobe surface. Wear, in this case, is the result of asperity-asperity contact (i.e., metal-to-metal contact) that has produced “glazing” and contact fatigue micropitting.

Figure 21– Injector lobe showing glazing and micropitting, initiating steps (up-ramp)

Our experience indicates that “Thielenhaus” stone polishing provides a very consistent and smooth surface finish. A number of manufacturers have used this approach and significantly improved cam durability by reducing

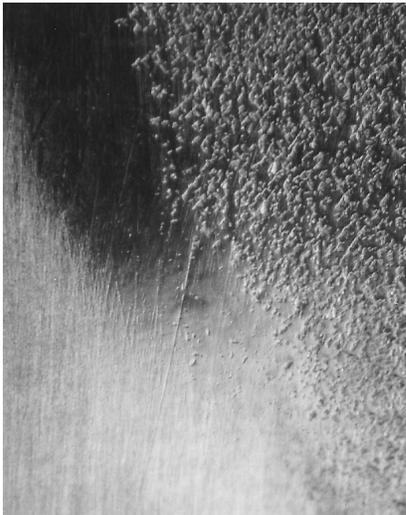
Figure 22– Injector lobe showing glazing and micropitting, initiating steps (up-ramp)

Evidently, the roller was crowned. On traversing the cam nose it elastically deformed, producing an image of the broader contact area of roller and cam lobe in the higher pressure cam nose area. Figure 22 shows a higher magnification view of an area exhibiting surface distress (glazing, followed by micropitting). Asperity-asperity contact (see Figure 23) at high pressures plastically deforms (i.e., flattens) the asperities. Areas of flattened asperities appear polished, but not smooth, hence the term “glazing.” Metal-to-metal contact implies the absence of lubricant. In concentrated contacts, metal-to-metal contact can be inferred from the lambda ratio:

Magnification 31x

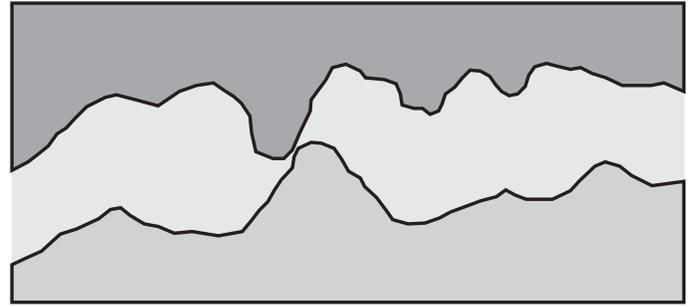
Figure 23 – Asperity-to-asperity contact.

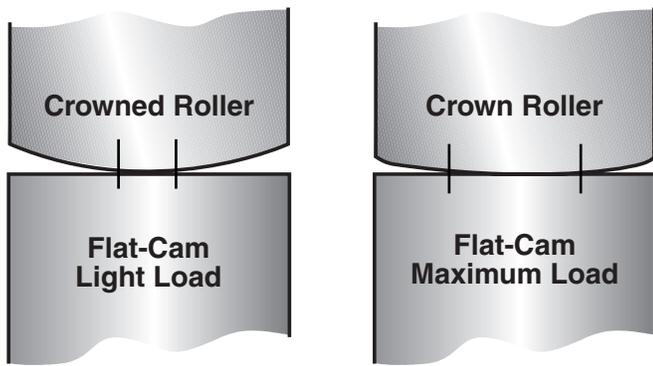
Figure 24 – Illustration of barrelled roller elastic deformation under load.

In addition, the roller must be crowned. If the roller is flat it will cause edge-loading on the cam lobe at high loads and contact fatigue can occur.

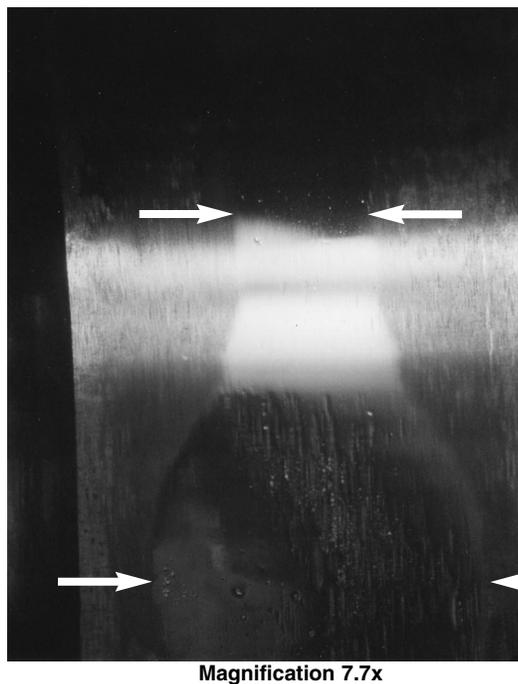
Figure 25 – Example of elastic deformation of roller shown on cam surface. Light load to maximum load.

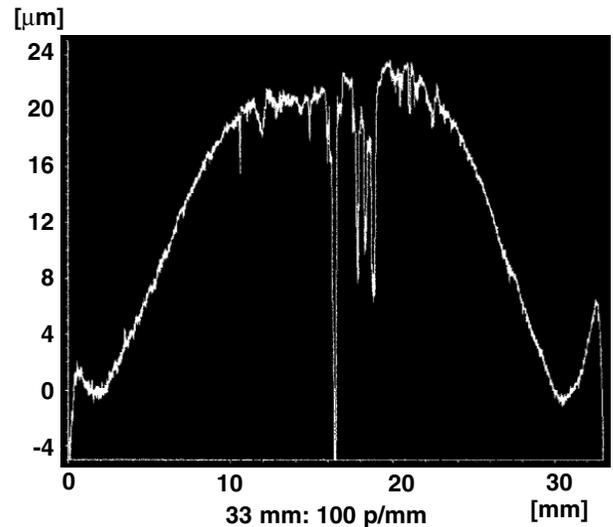
If the cam face is bowed due to the hardening process, the end result is a point contact between the roller and the cam in which the Hertzian stress will exceed the capabilities of the cam.

Figure 26 – Bowed cam lobe profile. Failed cam with contact fatigue from the field.

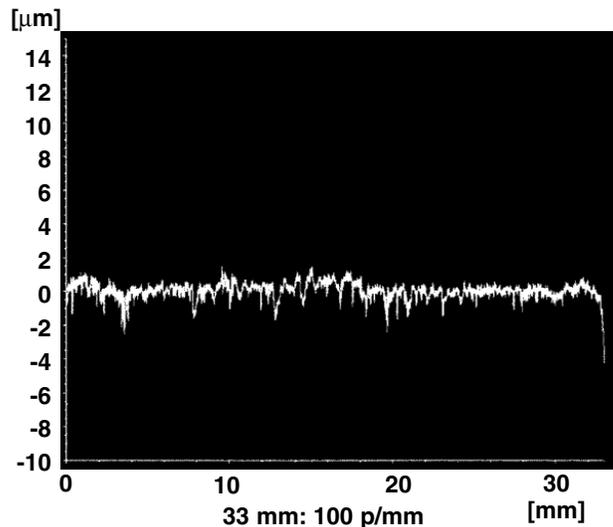
Figure 27 – Flat cam lobe profile. No failures at 500,000 miles (800,000 km).

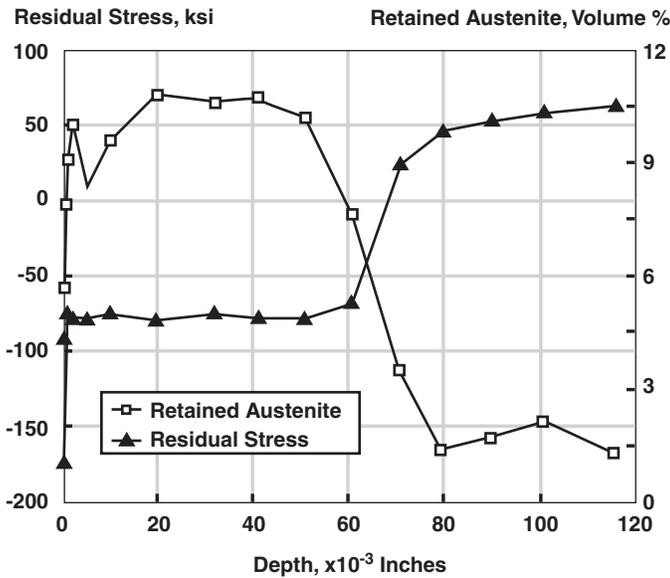
In the case of the GM LT-1 cam that we benchmarked, we had conducted X-ray diffraction of the lobe, which indi-

Figure 28 – GM-LT-1 cam lobe – x-ray diffraction analysis of compressive stress and retained austenite. Residual compressive stress – 175 ksi (–175,000 psi) at surface and 95% martensite structure.

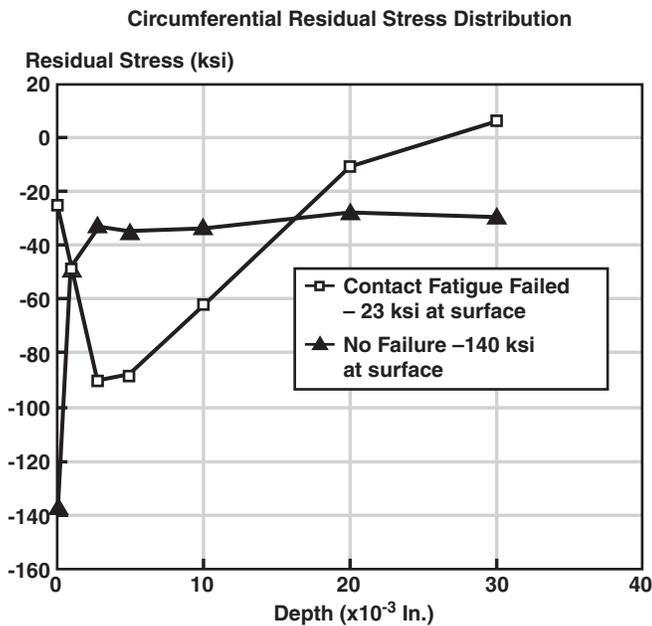
Figure 29 – X-ray diffraction analysis of one cam lobe with contact fatigue with compressive residue stress of – 23 ksi (– 23,000 psi) and second lobe with no failure with compressive stress at

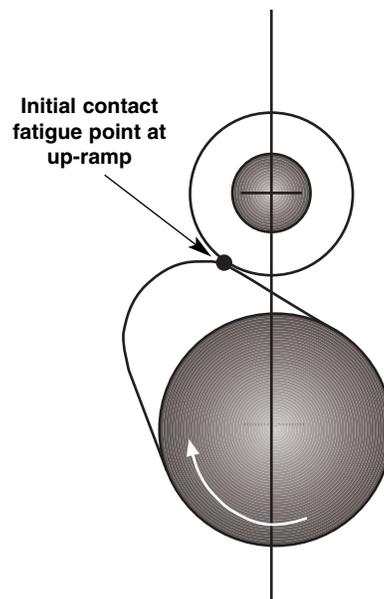
In our experience with one engine with 80,000 miles (129,000 km) of service, cam contact fatigue failure of the injector lobe first occurred at the cam roller interface, approximately 10-15 degrees before the nose of the cam. (See Figure 30.) All the bronze pins in this application were in perfect condition. This initial failing point progressed to cause damage to the cam nose and down the ramp. (See Figures 31 and 32.) It is important to

Figure 30 – Contact fatigue first before cam nose – then damage occurs on down-side of cam.

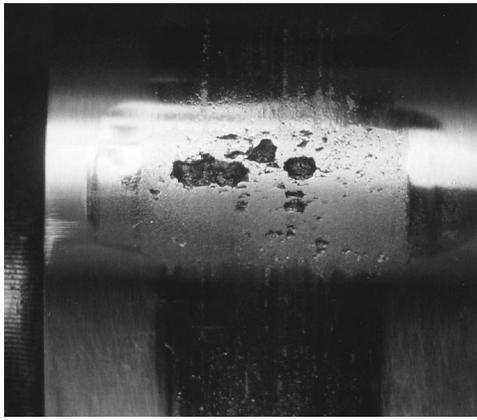
Magnification 2.6x

Figure 31 – Injector lobe – fatigue pitting in advanced stage (up-ramp)

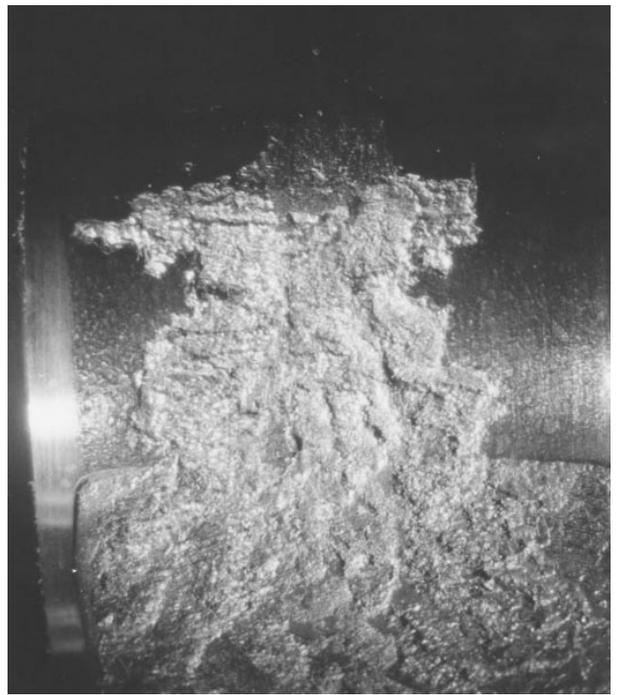
Magnification 2.6x

Figure 34 – Injector lobe, showing pitting, denting, and spalling.

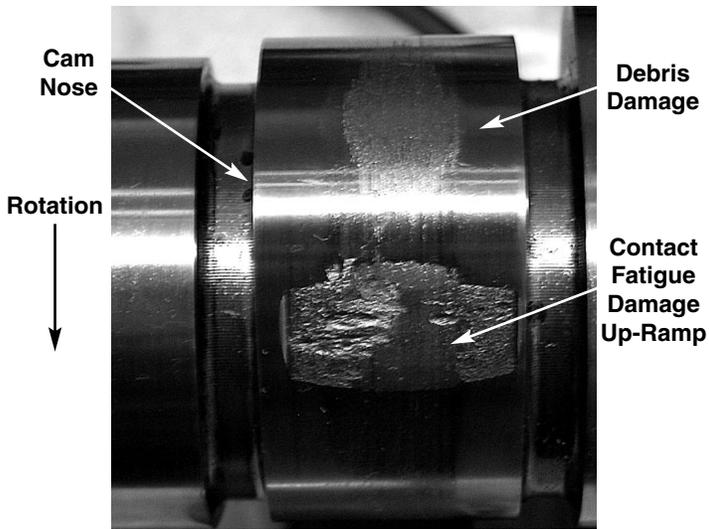
Figure 32 – Contact fatigue on up-ramp with subsequent damage on nose and down ramp.

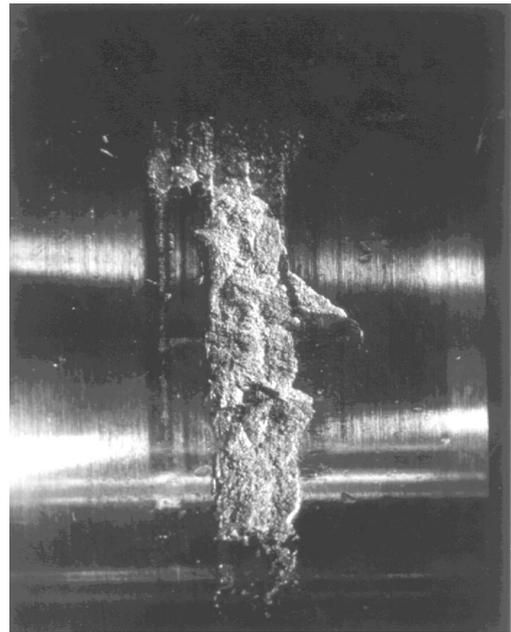
Magnification 2.6x

Figure 36 – Injector lobe showing spalling, cracking and denting.

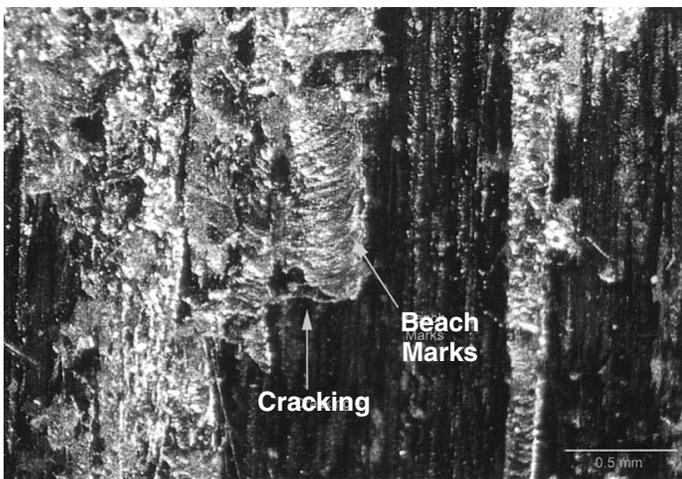
Magnification 25x

Figure 33 – Injector lobe at nose of cam (500,000 miles, 800,000 km) contact fatigue.

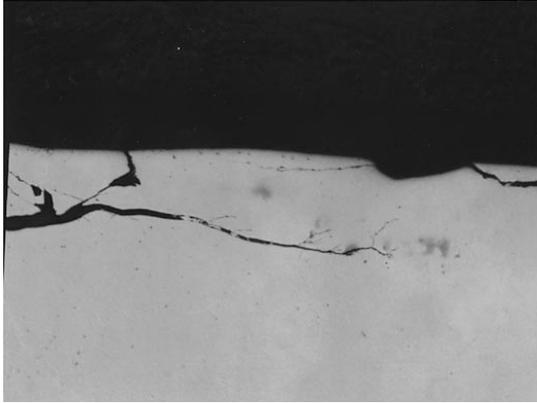
Magnification 250x

Figure 35 – Cross-section of metallographic section of failed cam lobe.

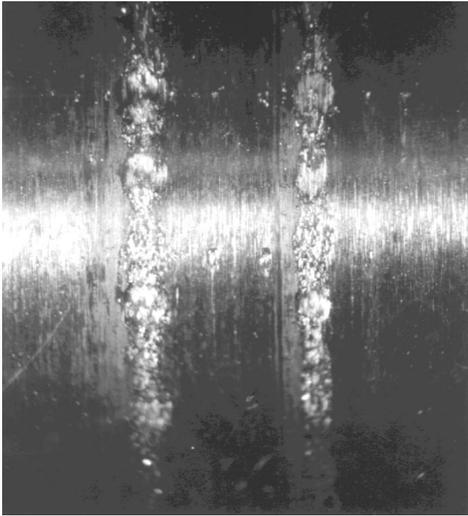
Magnification 2.6x

Figure 37 – Injector lobe showing pitting, “skidding”, adhesive wear and denting.

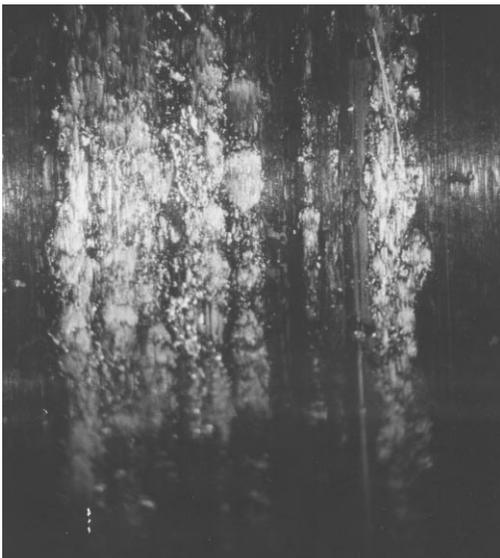
Figure 38 – Injector roller – pitting, sliding wear, and denting.

Magnification 10x

These injector lobe failures were initiated by contact fatigue, leading to cracking and subsequent benchmarks as shown in Figure 33. In more advanced stages, the contact fatigue is clear, as shown in Figure 34-36. The subsurface cracking is apparent in some cases. (See Figure 35.) In other cases, skidding, or adhesive and denting damage due to passage of wear debris from other failing cams are evident. (See Figure 37 and 38.)

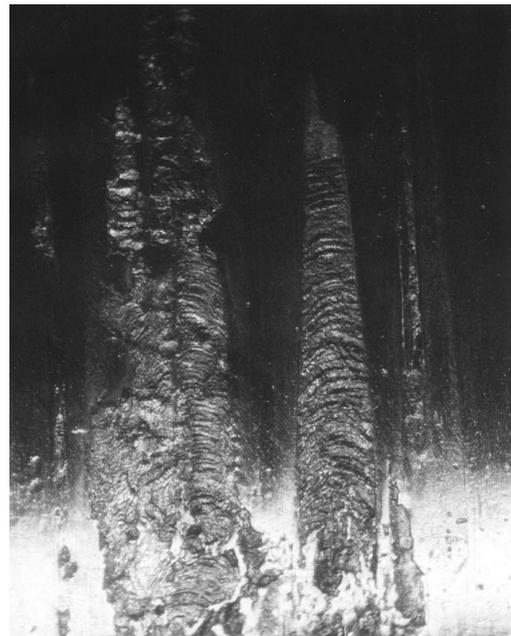
Magnification 23x

Examples of intake lobe failures due to contact fatigue and roller skidding are shown in Figure 39 and 40.

Figure 39 – Intake lobe failure showing bench marks, contact fatigue and leading edge of damage area.

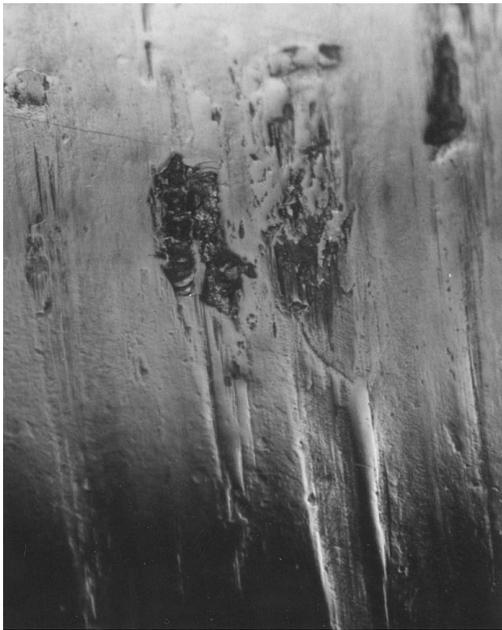
Magnification 31x

Figure 40 – Intake rollers having sliding damage with plastic flow and contact fatigue pitting.

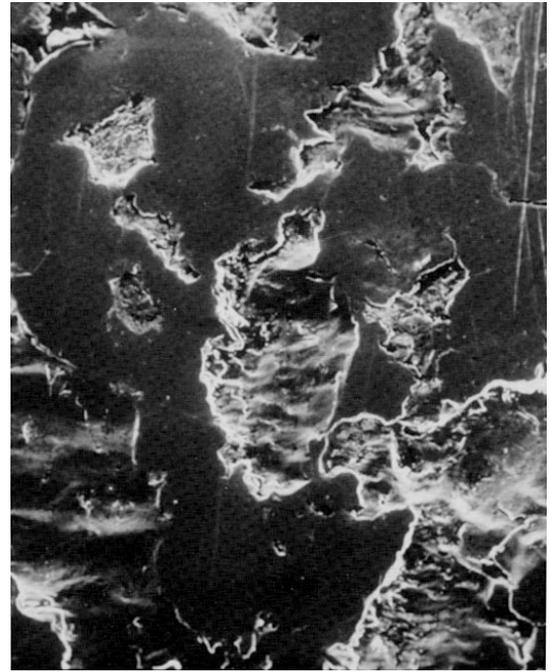
Magnification 300x

Figure 42 – Exhaust valve cam lobe surface showing contact fatigue.

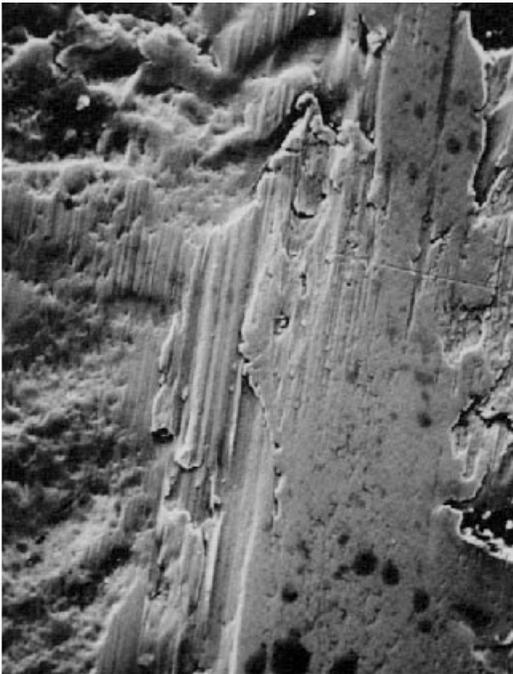
Magnification 300x

Figure 41 – Exhaust valve cam lobe surface showing abrasion, adhesion and contact fatigue.

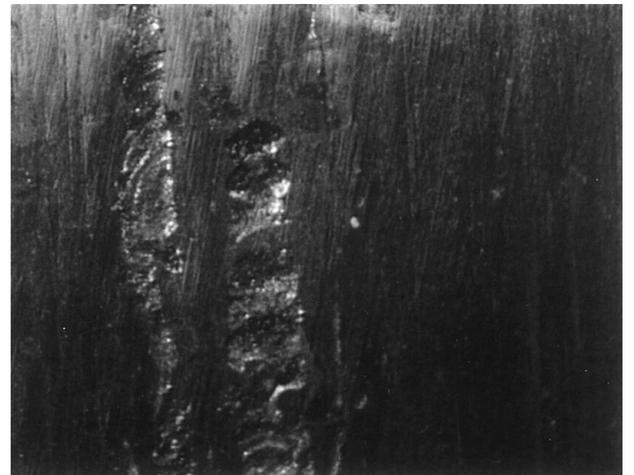
Magnification 40x

Figure 43 – Exhaust lobe – contact fatigue.

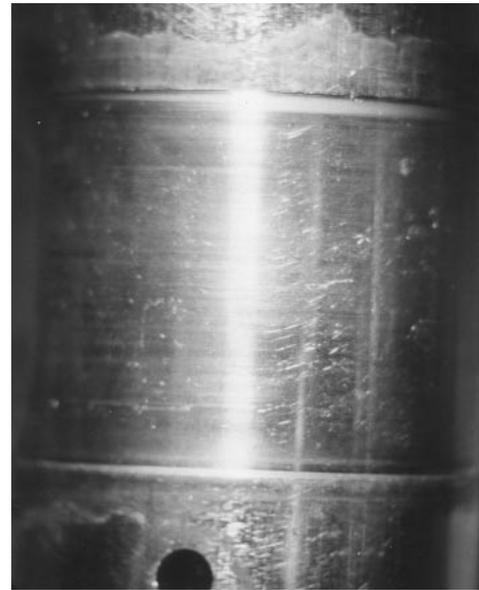
Figure 45 – Exhaust roller bronze pin showing wearstep.

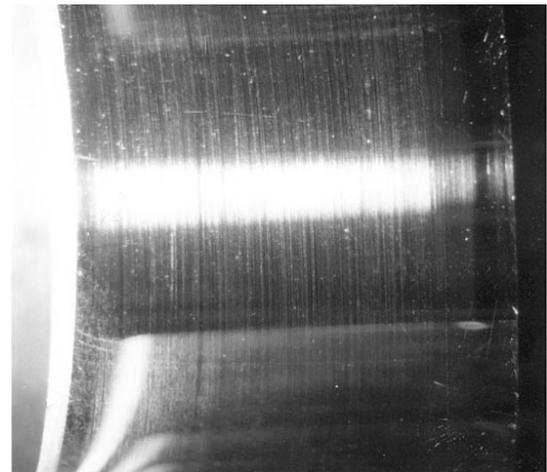
Magnification 5x

Figure 46 – Inside surface of steel using bronze pin roller,

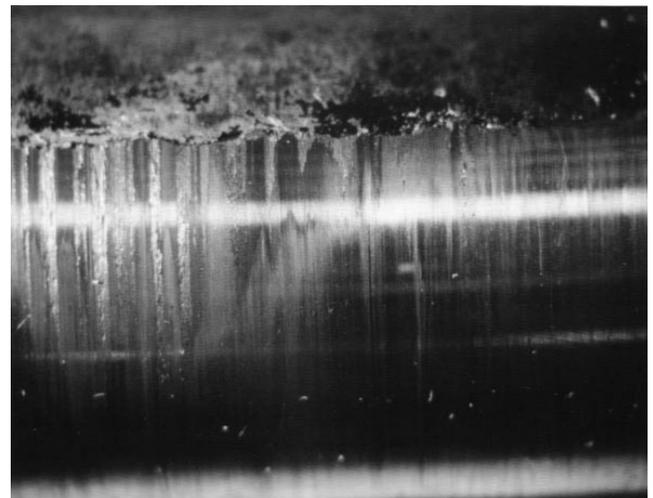
Magnification 5.1x

Low friction between the central pin and the roller is essential for minimizing wear, and skidding of the roller. However, contact fatigue debris from the lobes may cause secondary damage to the pin-roller interface, resulting in bronze pin wear and sliding of the roller on the cam surface. Alternatively, inadequate lubrication during frequent starts will result in bronze pin wear. A disadvantage of the bronze pin is its relative softness, which makes it readily abraded. Examples of this damage show abrasive wear of the pin and the inside of the roller. (See Figures 45-46.) Alternatively, due to high friction, the oil to the pin has become extremely hot and pyrolyzed. In some cases due to the high friction, the pin had rotated from its fixed position and cut off its oil supply hole. (See Figures 47 and 48.)

Figure 47 – Injector bronze pin showing abrasive, erosive and adhesive wear.

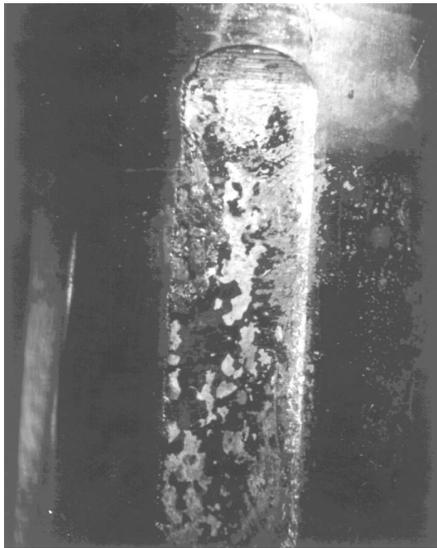
Magnification 2.6x

Figure 48 – Injector bronze pin – deposit on the flat due to pyrolyzed lubricating oil due to excessive heating.

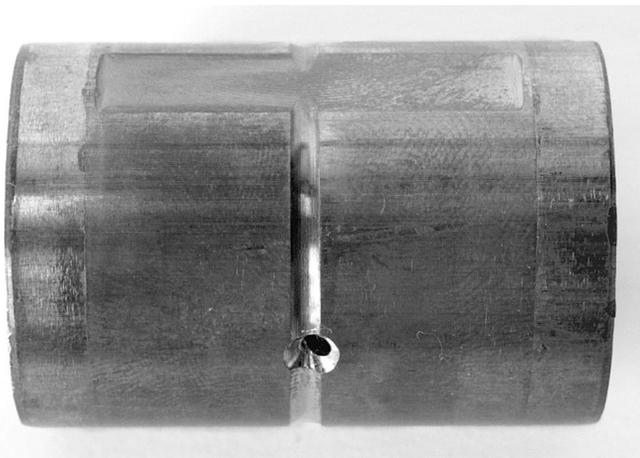
Figure 49 – Improved lubrication of a large diameter bronze pin through the use of an oil distribution groove around the periphery of the pin.

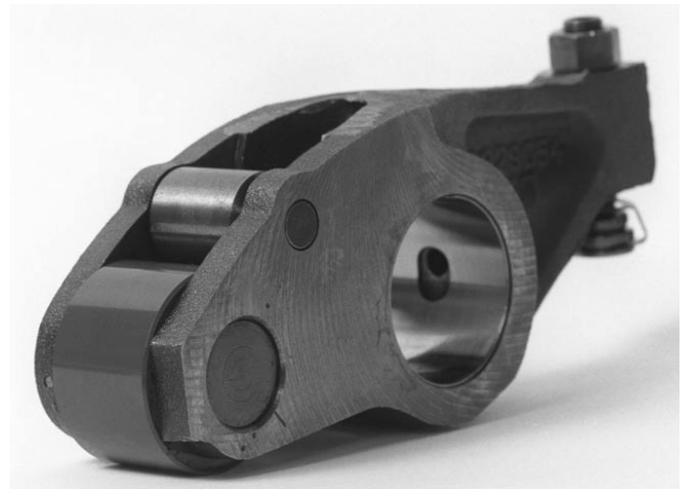
In stop-go vehicles or vehicles that have frequent shut downs to save fuel, the low friction between the center pin and roller is critical. We have found numerous failures of bronze pin-roller combinations, yet we have found none with the use of the silicon nitride roller and steel pin, provided the Hertzian stress is within the capability of the ceramic roller, and the ceramic porosity is correct and controlled. (See Figures 50 and 51.)

Figure 50 – Rocker arm configuration – injector silicon nitride roller and steel pin.

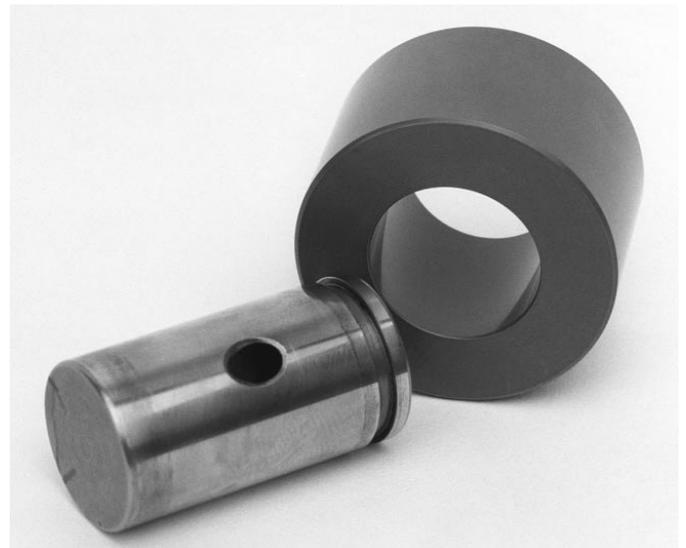
Figure 51 – Silicon nitride roller and steel pin after 4,000 hours durability testing.

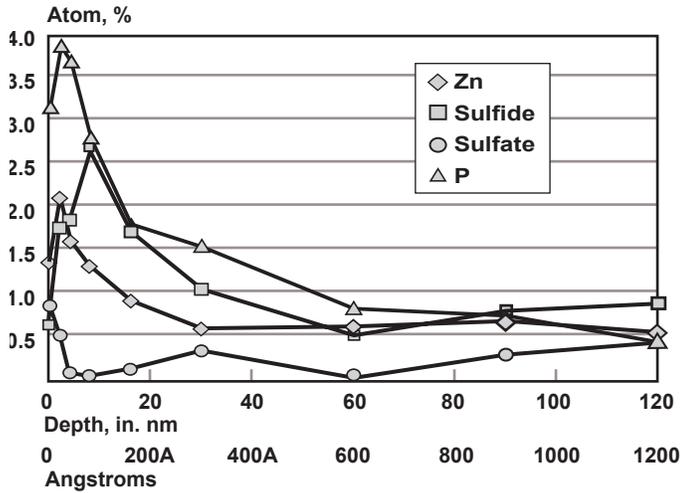
Figure 52 – ESCA depth profile on steel axle used in ceramic roller follower. Zinc, phosphorus and sulfur adsorber on to axle, providing a protective wear film.

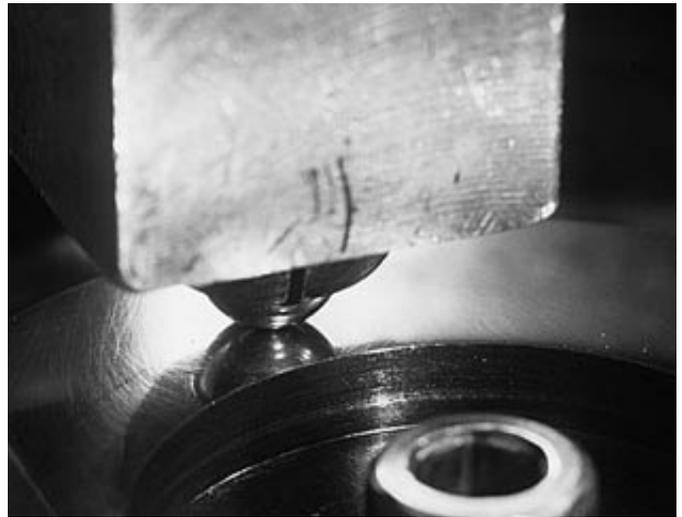
Figure 53 – Ball on flat tribometer contact.

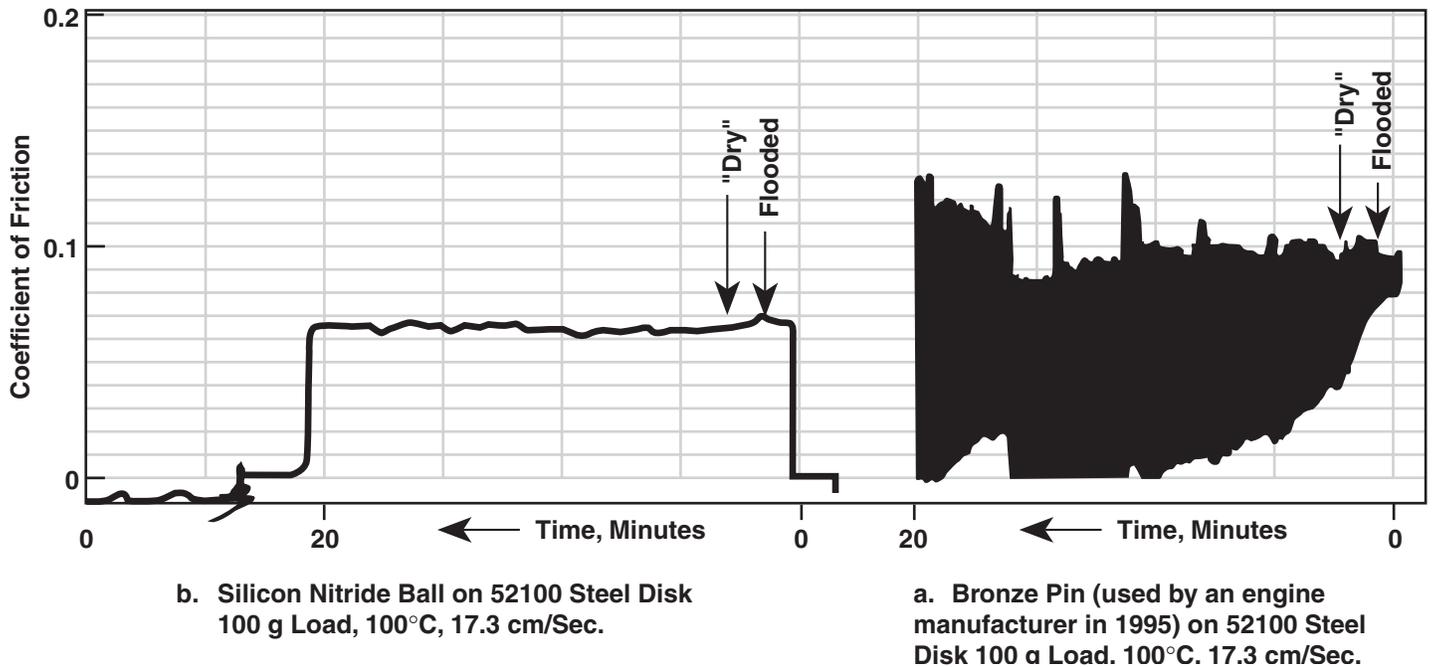
Figure 54 – Friction versus time alternately flooded with API CG-4/SJ – SAE 15W-40 oil (~2 min.) and “dry” (~1 min.).
 a. Range of motion of the recorder pen in measuring friction. The silicon nitride ball had low and constant friction under flooded and starved conditions. In contrast, the bronze pin had severe stick-slip with very high friction under starved conditions; and high friction with stick-slip under flooded conditions that would cause roller skidding on the cam.

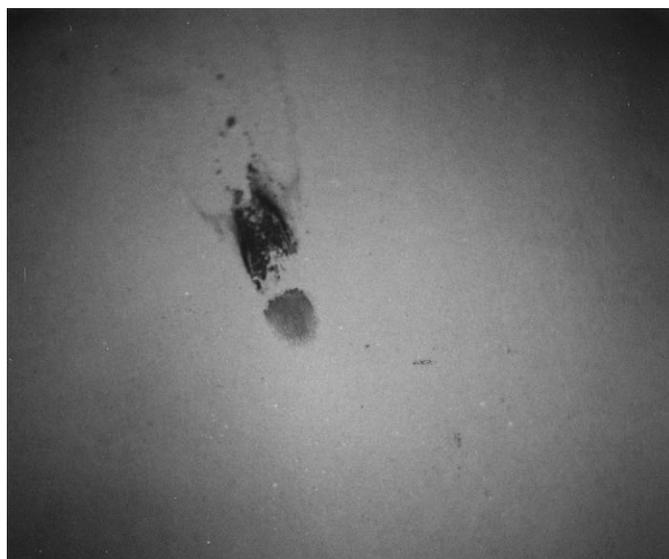
Magnification 103x

Figure 55 – Silicon nitride ball (Norton), wear scar from the tribometer wear test.
