Preventing Catastrophic Camshaft Lobe Failures in Low Emission Diesel Engines

J. A. Mc Geehan and P. R. Ryason

Chevron Products Company

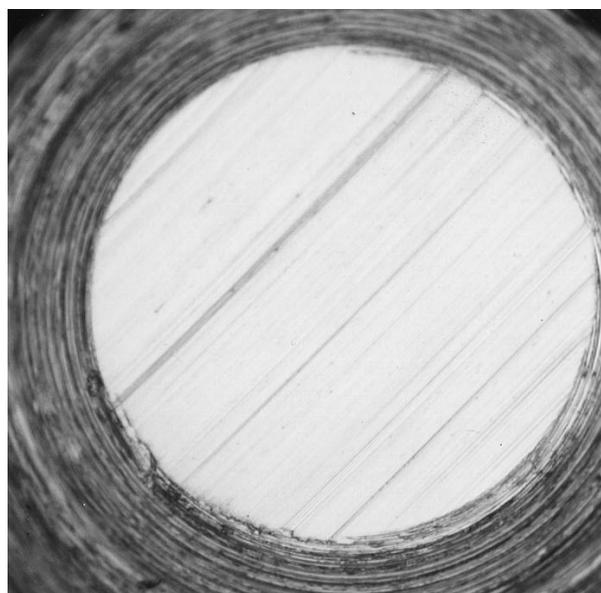
Magnification 103x

Figure 56 – Bronze pin wear scar from the tribometer wear test. Bronze pin cut from engine roller follower pin.

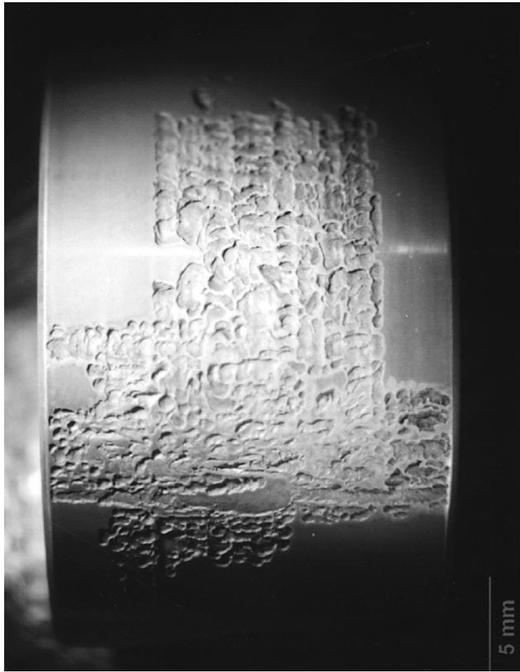
Nevertheless, Hertzian stress and the porosity of the ceramic must be closely controlled. In one instance where it exceeded these requirements, failures did occur until the stress was reduced. (See Figure 57.)

Figure 57 – Experimental ceramic roller operating at too high an Hertzian stress.

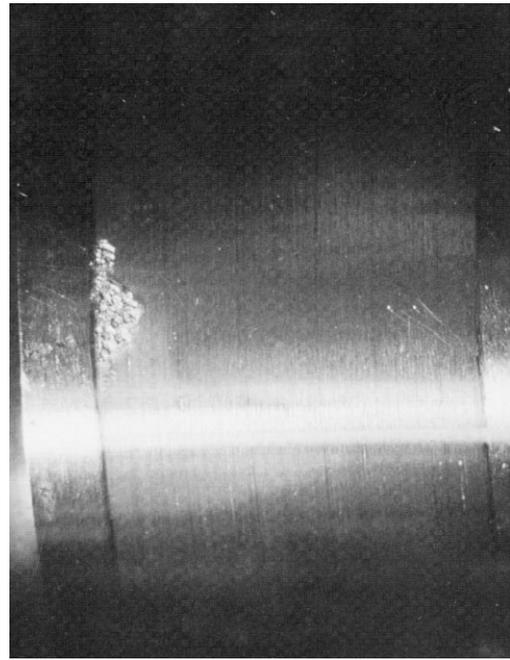
Figure 58 – Intake cam lobe showing contact fatigue pitting due to misalignment.

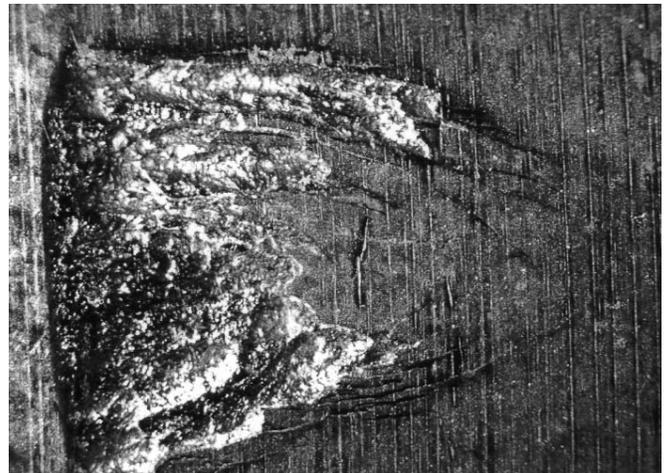
Figure 59 – Side of cam lobe showing contact fatigue near nose due to misalignment.

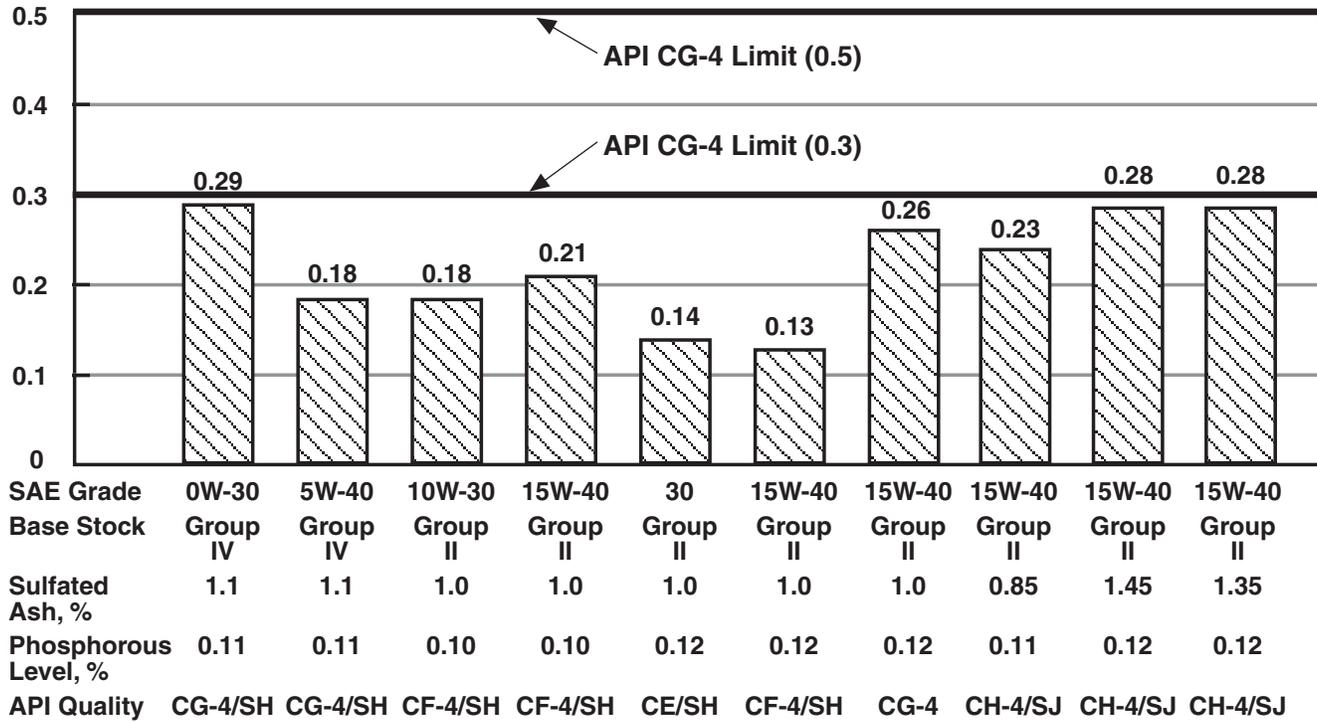
Figure A-1 – GM 6.2 liter roller follower wear test (5% soot)

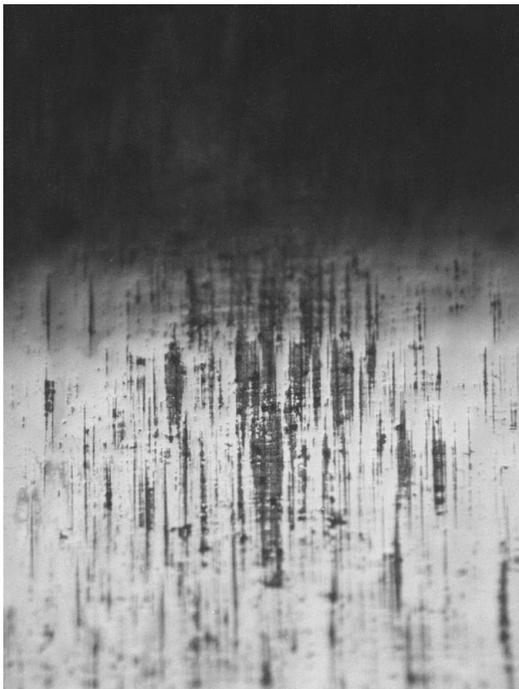
This cam must be flooded with oil from both the crankshaft and the hydraulic lifters, due to its location in the V block. Consequently, the finish after running is glazed but without failures, as shown in Figures A-2 through A-3.

Figure A-2 – Engine cam showing surface glazing in V-8 engine surface fully flooded in oil.

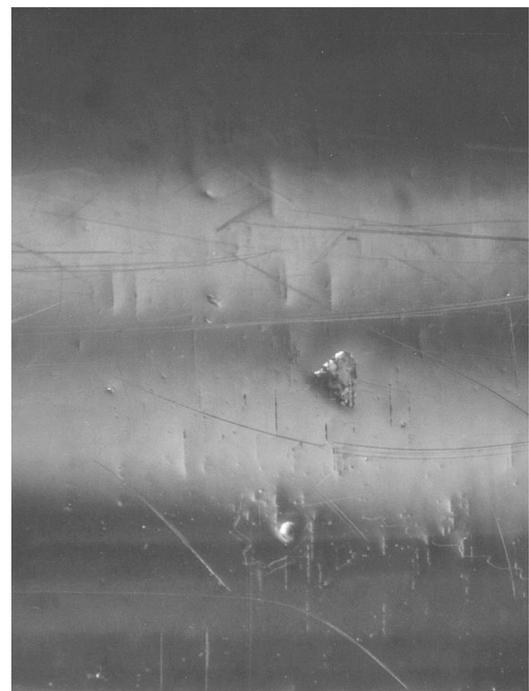
Figure A-3 – Engine cam showing surface glazing in V-8 engine. Surface is fully flooded with oil.
