Oil change: Mark's 2015 Jetta. Changed oil and 10k service on 11 October 2015.

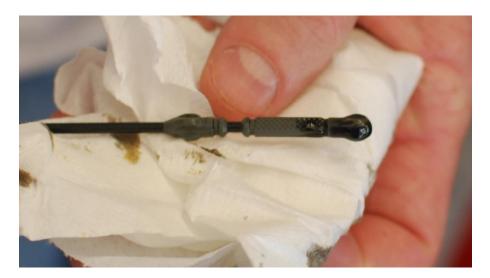
Oil level before the change at 9,997 miles.

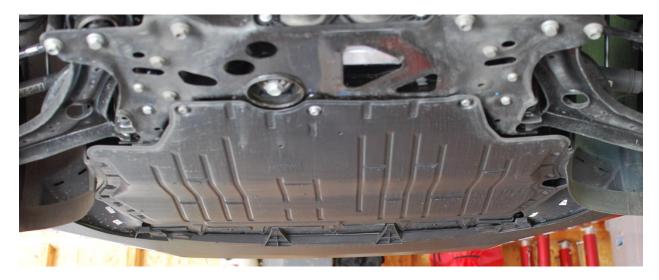
This plastic cover has to come off.

T-25 for one screw in the front and four on each side.

Three screws into the steel sub-frame that holds the rear of this plastic cover take T-45.

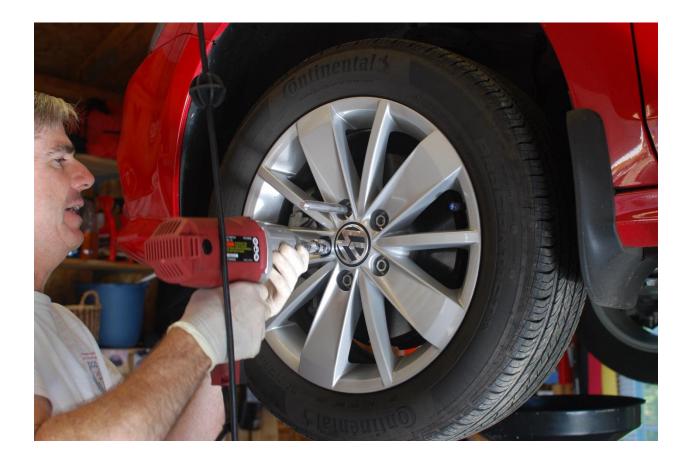
Rotate the tires while the oil drains. We swapped front to rear as called for by the owner's manual.

While the wheels are off, check the brake pads for wear, and give the parking brake a look-see.

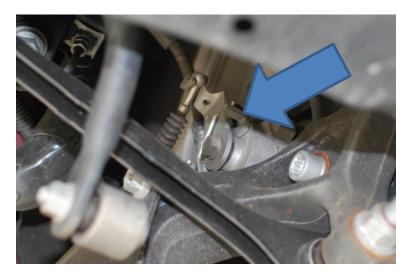
Inside the rear wheel, with the brake released, there should be a gap where shown. As a side note, use the parking brake once in a while. It adjusts brakes to keep the piston where it goes and helps avoid sticking pistons, which cause premature pad wear.

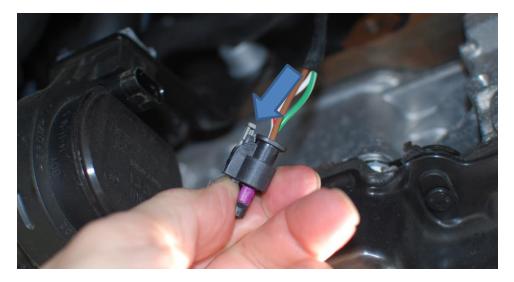
Wire to one of the coolant pumps is in the way. The gray clip pulls straight back (against the arrow) with a slight click, then the connector pulls straight out of the pump.

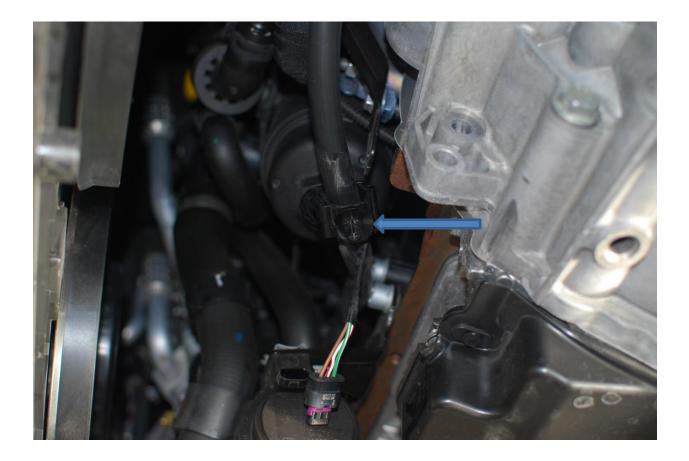
The wiring harness passes through a clip that attaches to a metal bracket. There presumably is a way to remove the wiring harness from the clip, but we found it easier to just pull the clip out of the metal bracket with the wiring harness still passing through the clip.

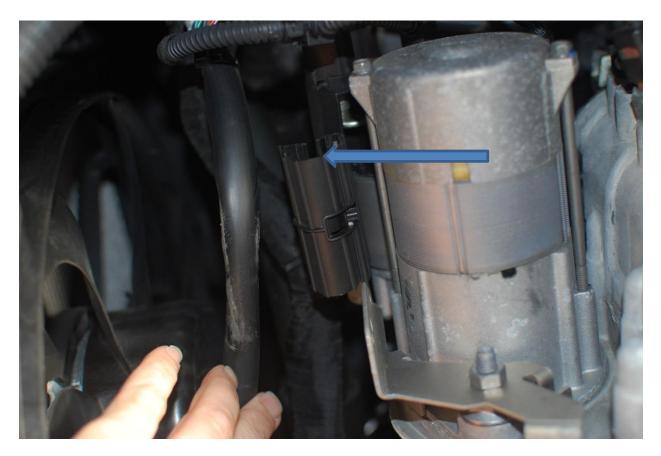
The wiring harness also passes through this clip, closer to the drivers' side of the car. The harness lifts right out of this clip.

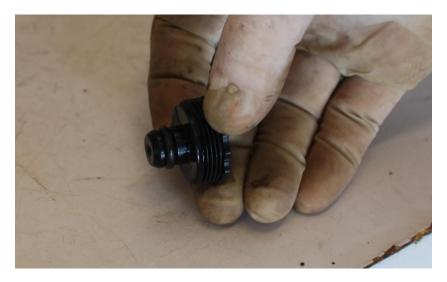
Note the O-ring on the oil filter cap drain plug. You also can see the fingers in the cap that engage and click while turning this drain plug to install.

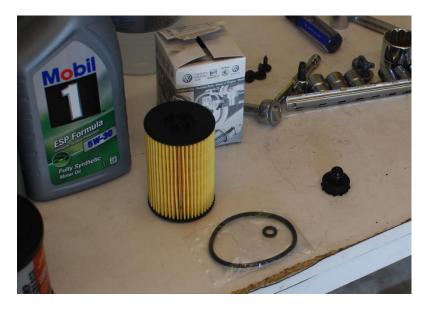
Filter came with two O-rings. One for the cap plug, and one for the cap itself.

Above, the oil filter is upside down from the way it fits in the car. Bottom of the filter is closed, and has 4 raised parts that hold it to the cap.

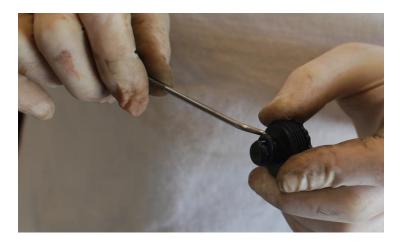
A pick is useful for removing the O-ring from the cap plug.

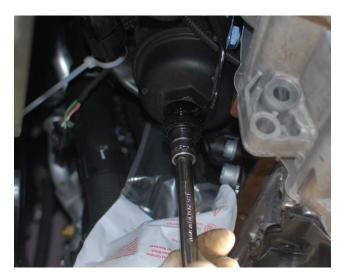
With a drop of fresh oil on the new O-ring, the plug goes back into the cap.

It clicks going in. The detents should keep it from backing out. No need for too much torque.

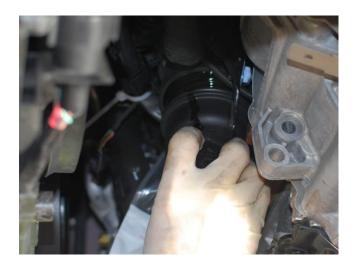
With the plug back in, the filter and cap come out with a 32mm socket.

While most of the oil has drained out, there is some left inside. So don't be surprised if a little wants to drip. Note where the o ring sits in the cap.

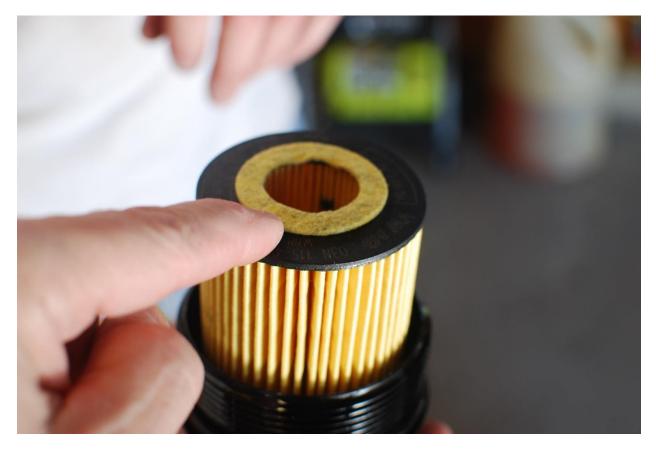
The filter clicks into the cap. The top is a felt-like substance. Seals clean (inside) from dirty (outside).

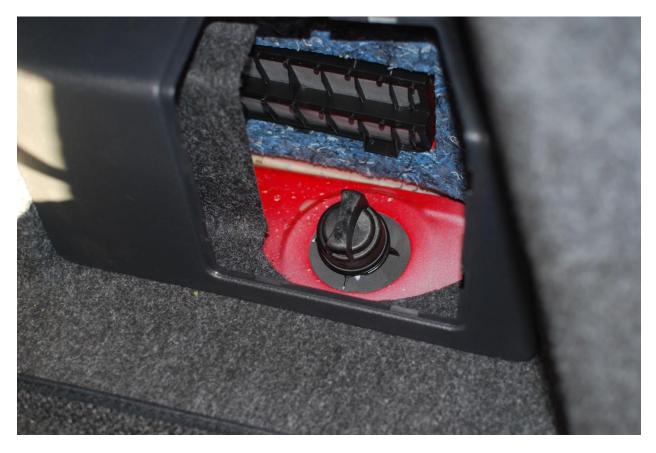
Diesel exhaust fluid in this car is filled inside the trunk.

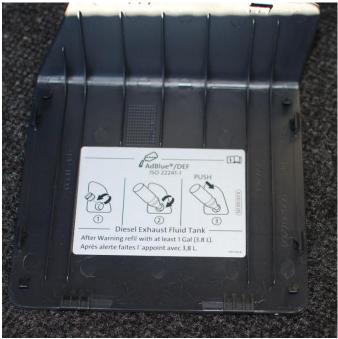
Helpful instructions are included on the part you pull off to get to the fill port.

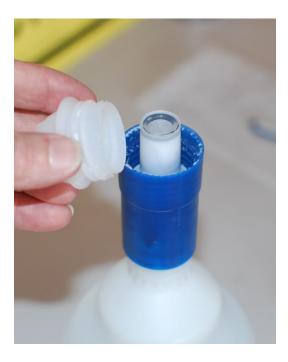
The cap comes off the container, and the blue part screws on where the cap is removed on the car.

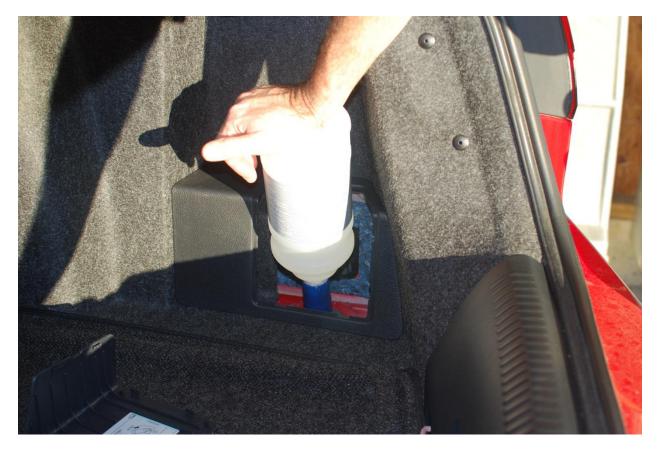
Fluid will not exit the bottle 'till you press down.

Mark put two half-gallon bottles in and we could watch some values change during the fill on VCDS (17:3x:xx is time of day)

Field 702 went from 9350 ml to 13028 ml or 3678 ml, which converts to 0.971 gallons.

The DEF tank level sensor only has a couple levels, so do not expect the levels or distance estimates to be too precise. It is not like the fuel tank level sensor.
