I have recently disassembled 5 failed fans from A4's and A5's - ALL of the failures have been brush tension failures, and 4 of the 5 fans were repairable with about 30 to 45 minutes work each.

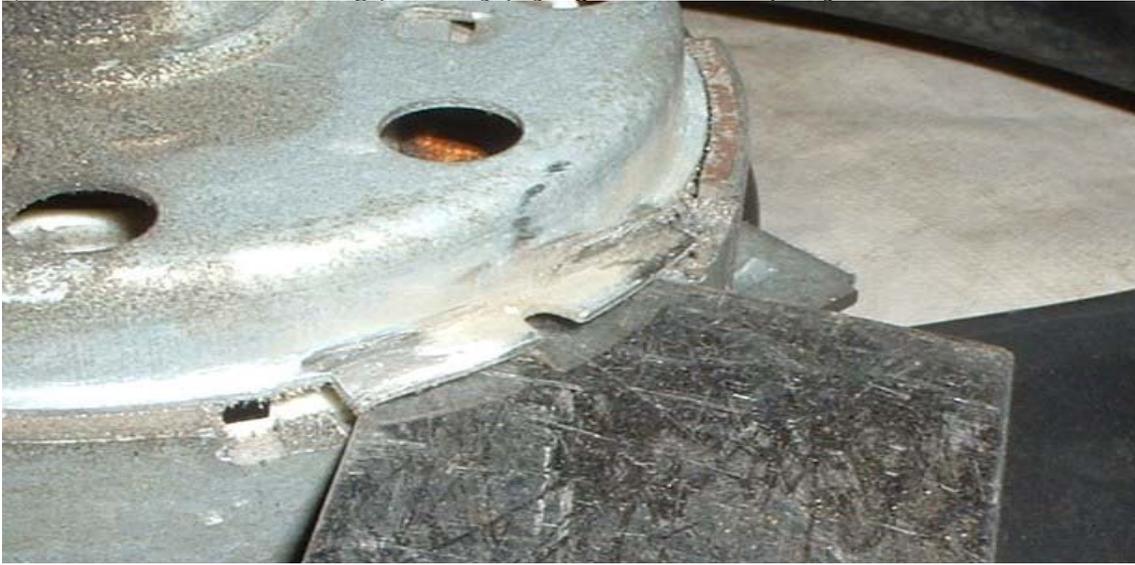
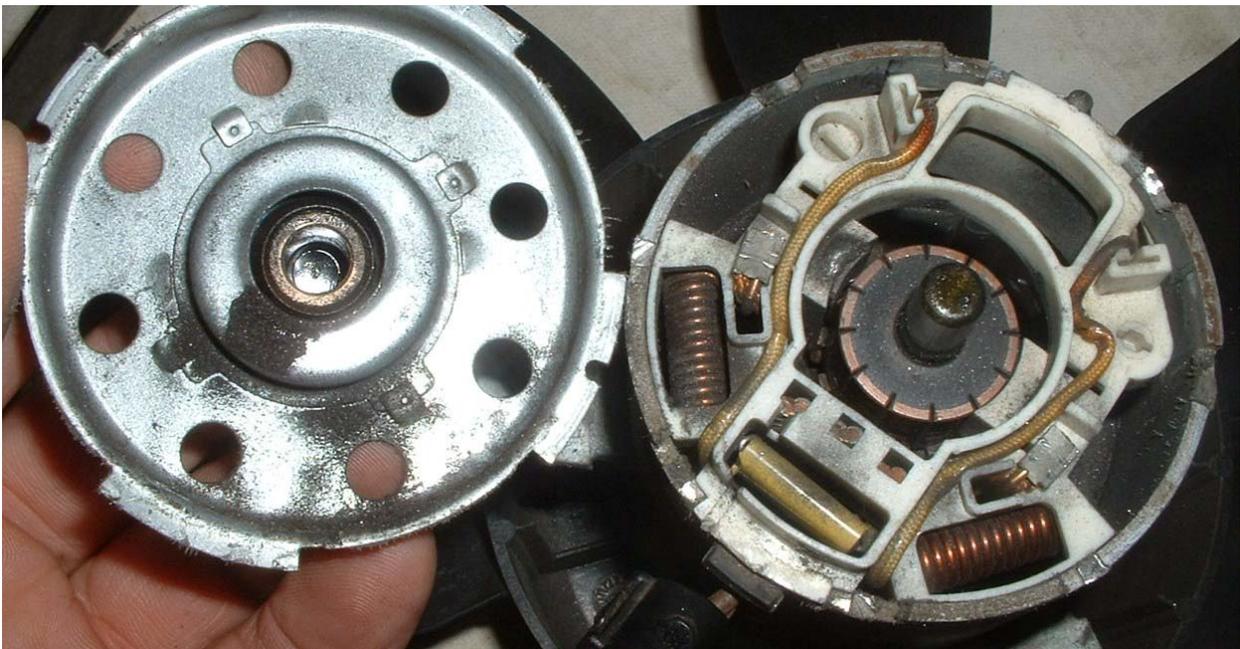
3) Remove the rear bearing plate, by prying it out with a putty knife.

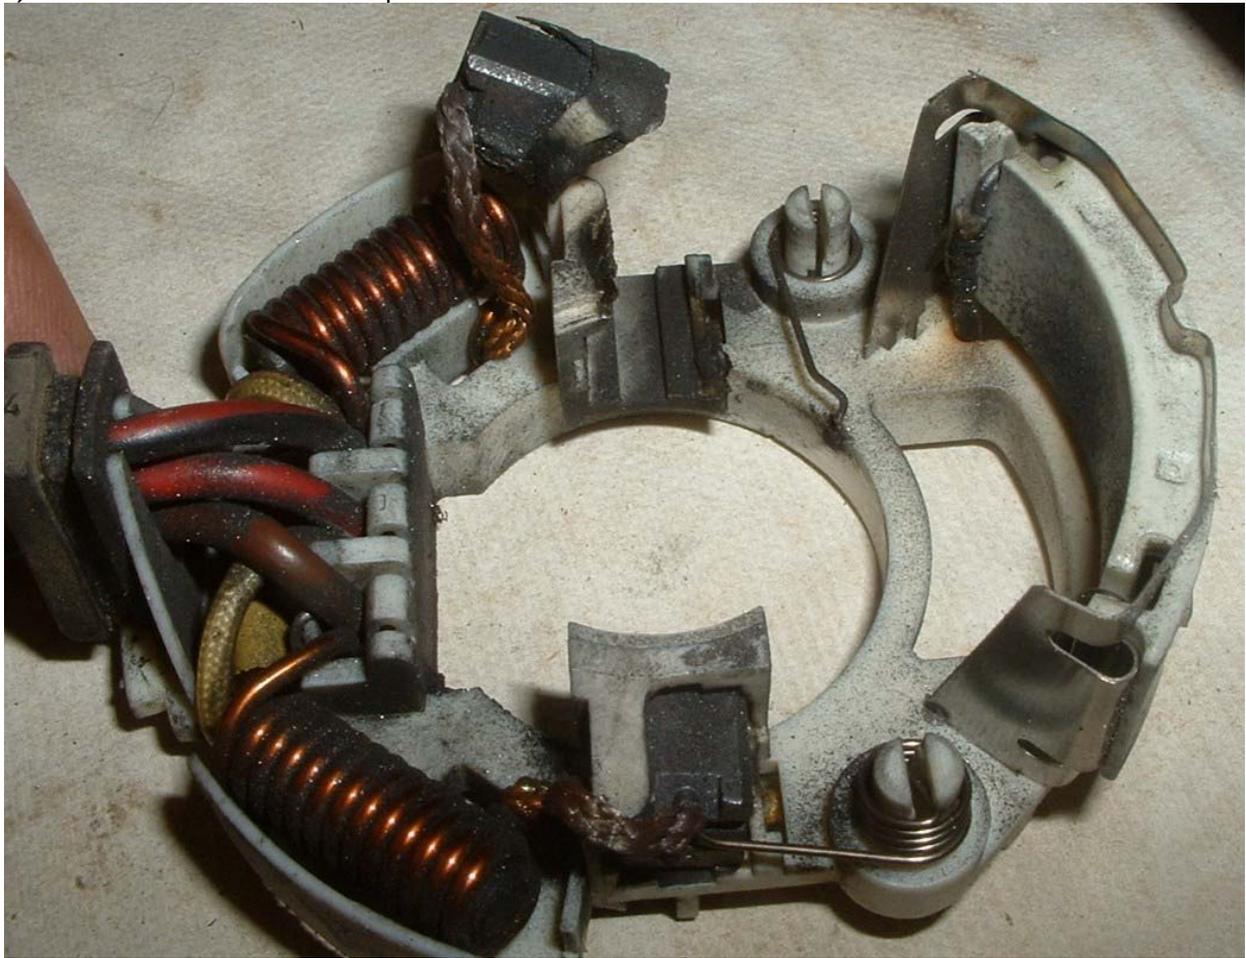
4) Remove the brush holder plate.

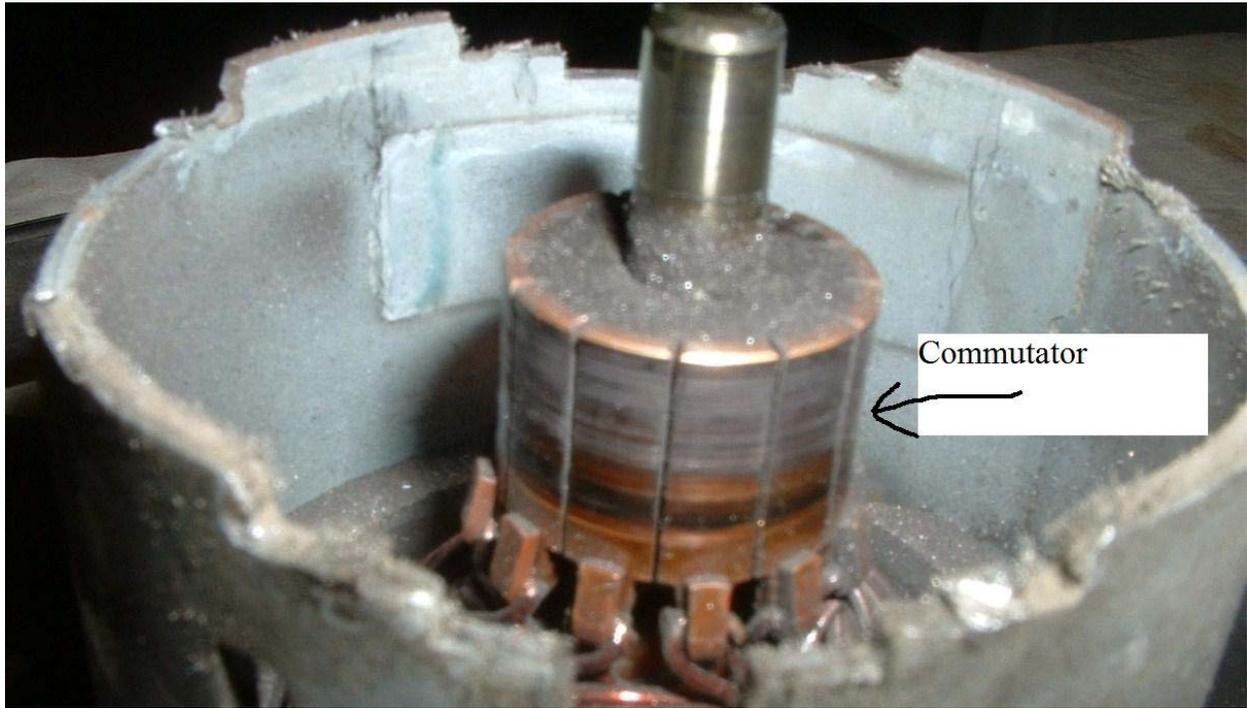
5) Examine the commutator; if it has a step of less than 1/16" ground into it, it is probably functional. Clean the fan internals – all you can reach.

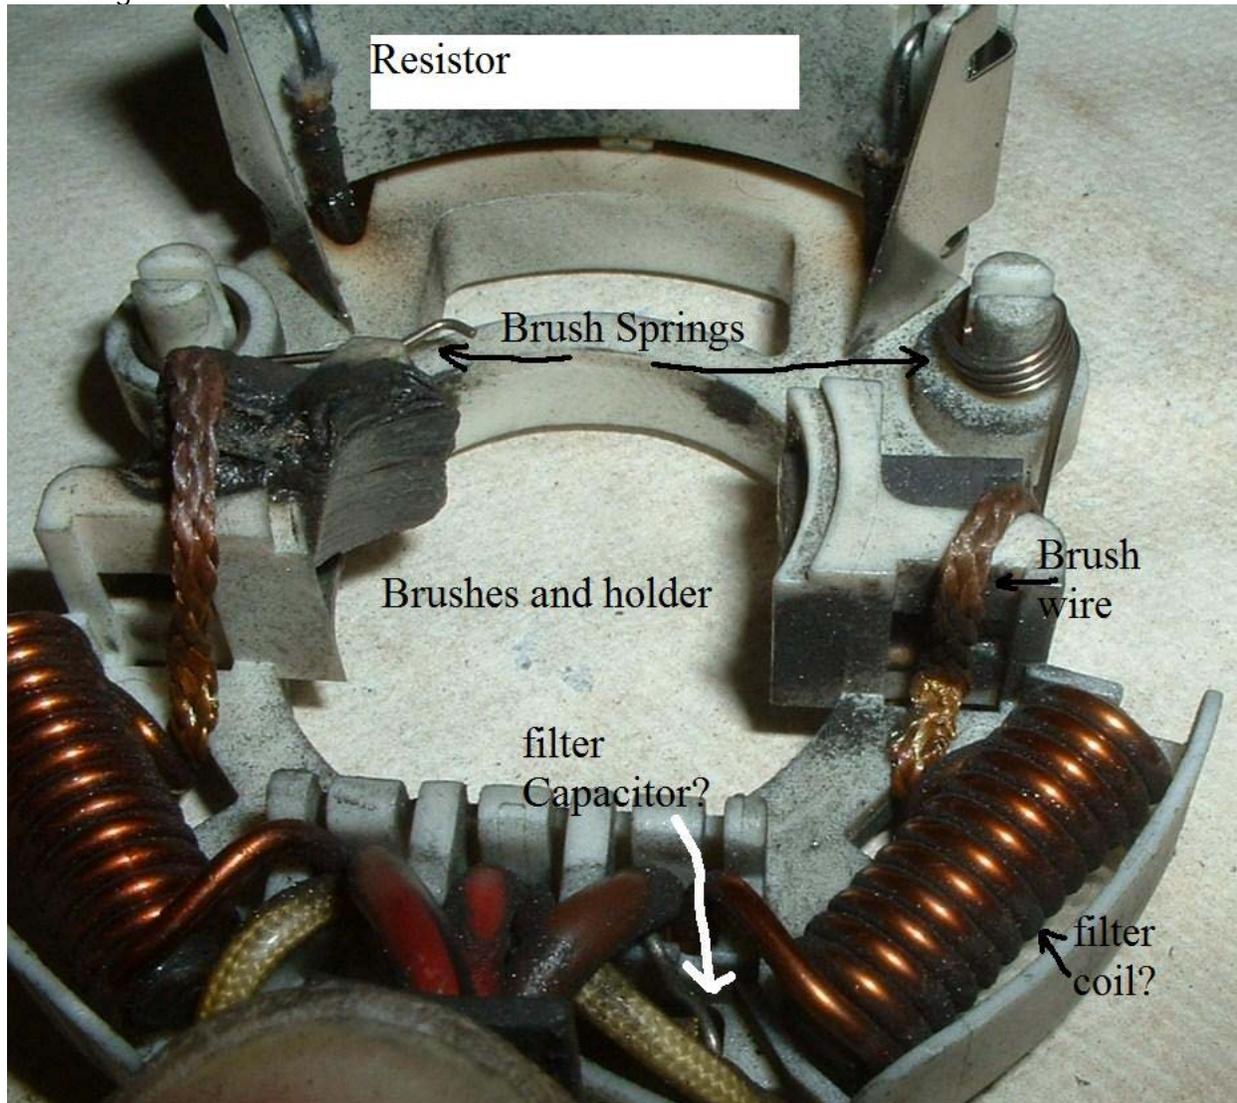
6) Examine the brushes, do they move freely in their holders? Note the brush length for later use. They will need to have about 3 times as much in the holder as out, to prevent becoming cocked. These have cocked and stuck and ruined the brush holders.

The brush holders are getting some debris in them (sand?) that is causing them to stick, and not feed into the commutator. In 4 cases simply cleaning the brush holder out with contact cleaner and exercising the brush through its range of motion allowed normal operation to be restored.

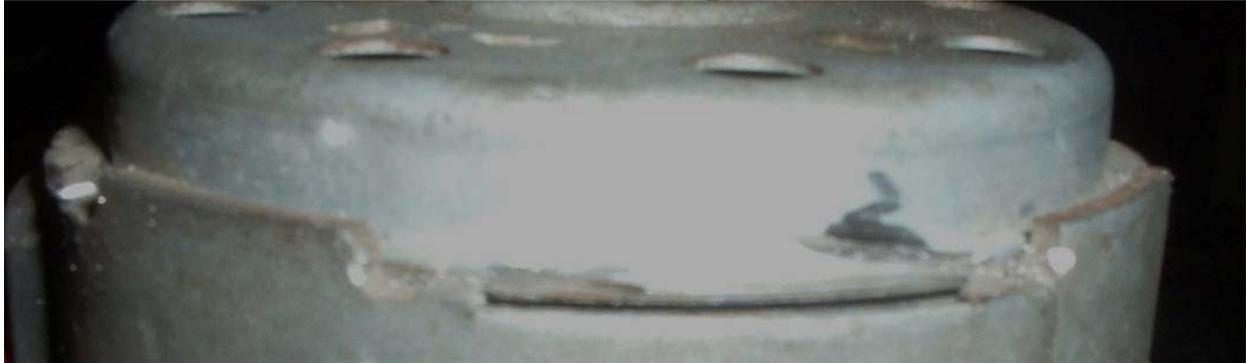
9) Put a rag and tape inside to cover the rotor and internals. Take the Dremel tool and remove any remaining burrs, so that the rear bearing plate will fit flush again. Be careful to direct the debris out of the fan. This one is not fitting flush.

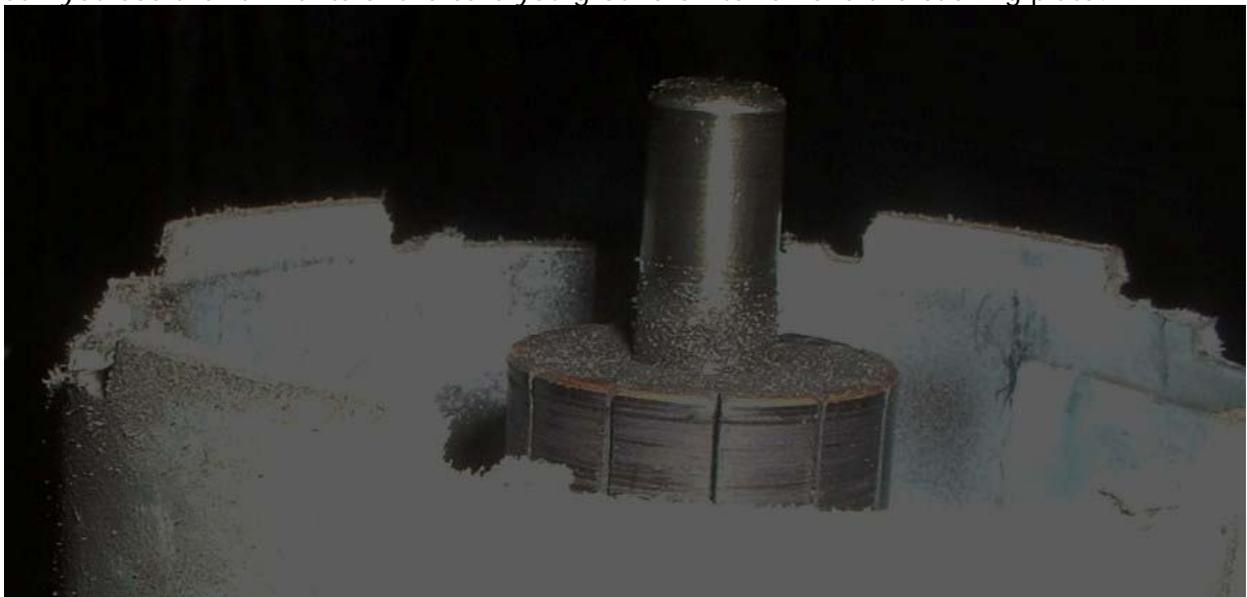
Can you see the remnants of the ears you ground off to remove the backing plate?

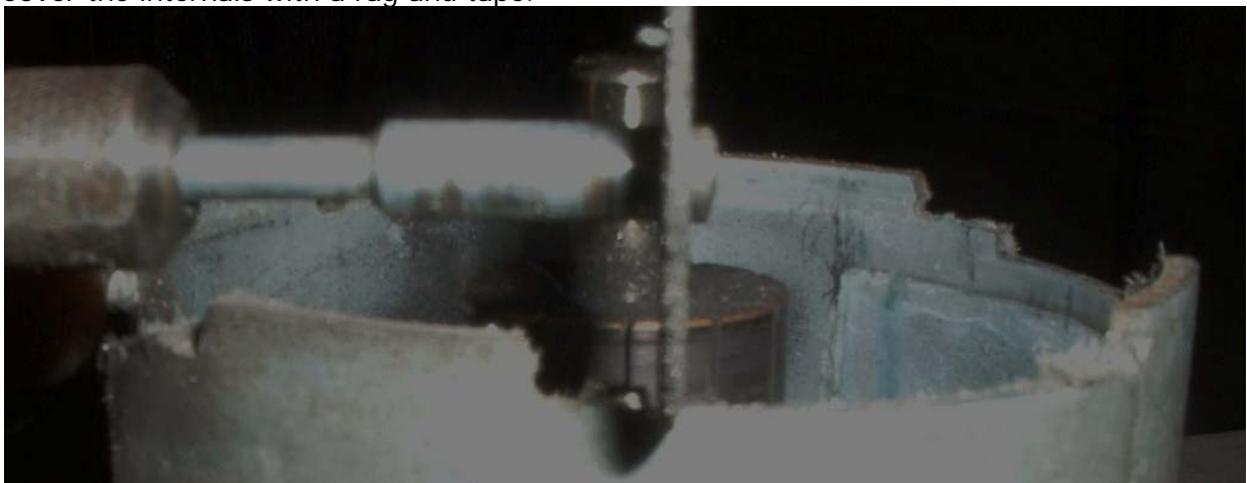
Use a Dremel to remove the remnants of the clamping ears. Direct debris out of the fan. Cover the internals with a rag and tape.

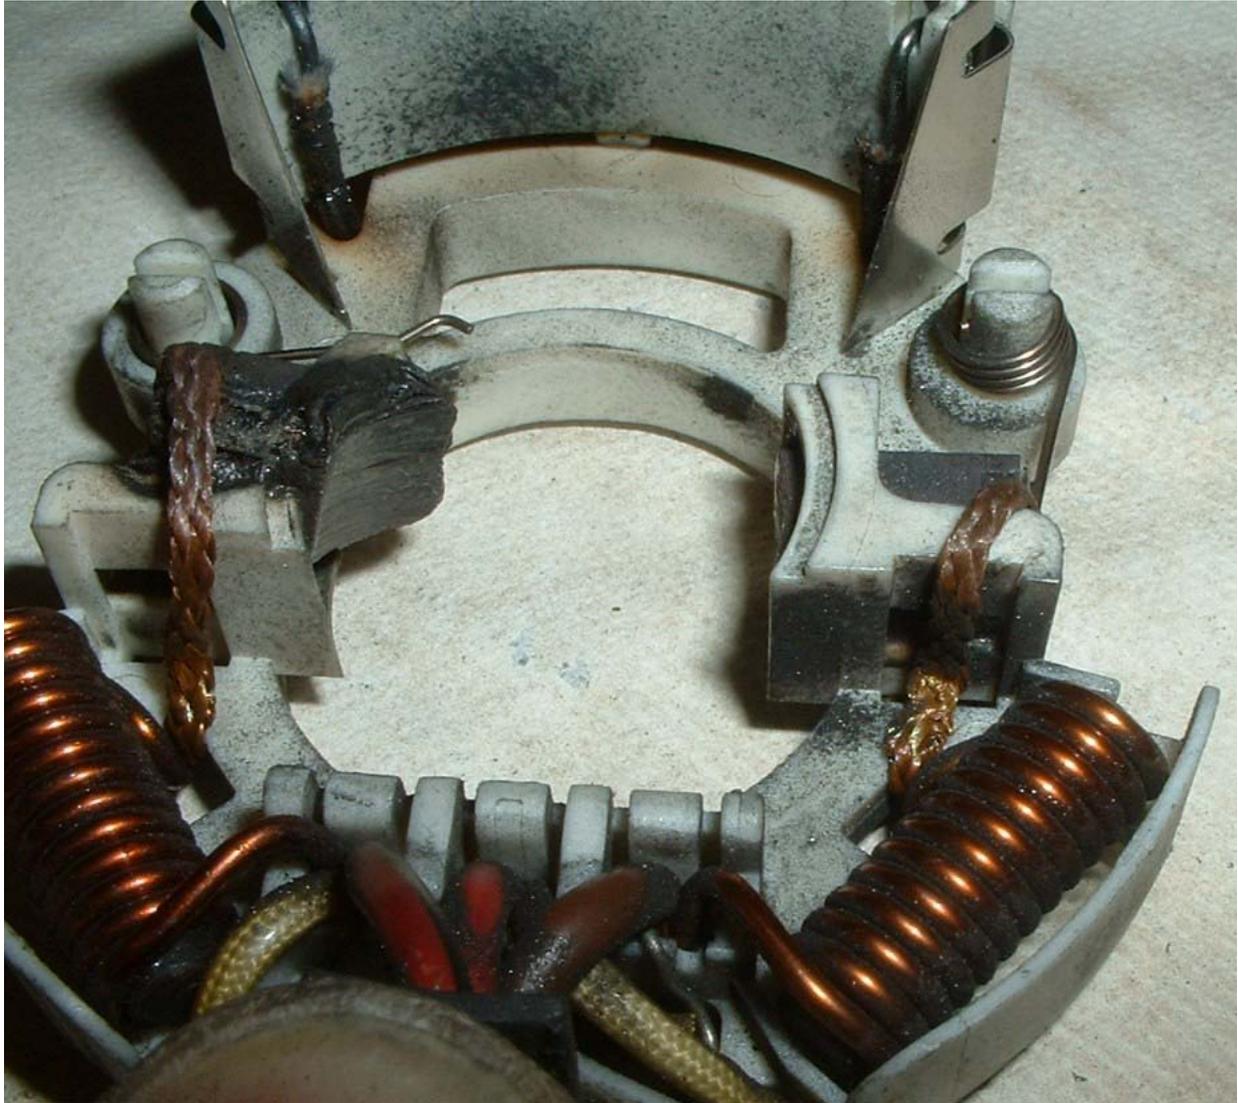
10) Reinstall the brushes, hold them back with your fingers (may be easier with two people, if there are 4 brushes.) Inspect the wiring attachment to the brushes to ensure it has freedom to move in its slot.

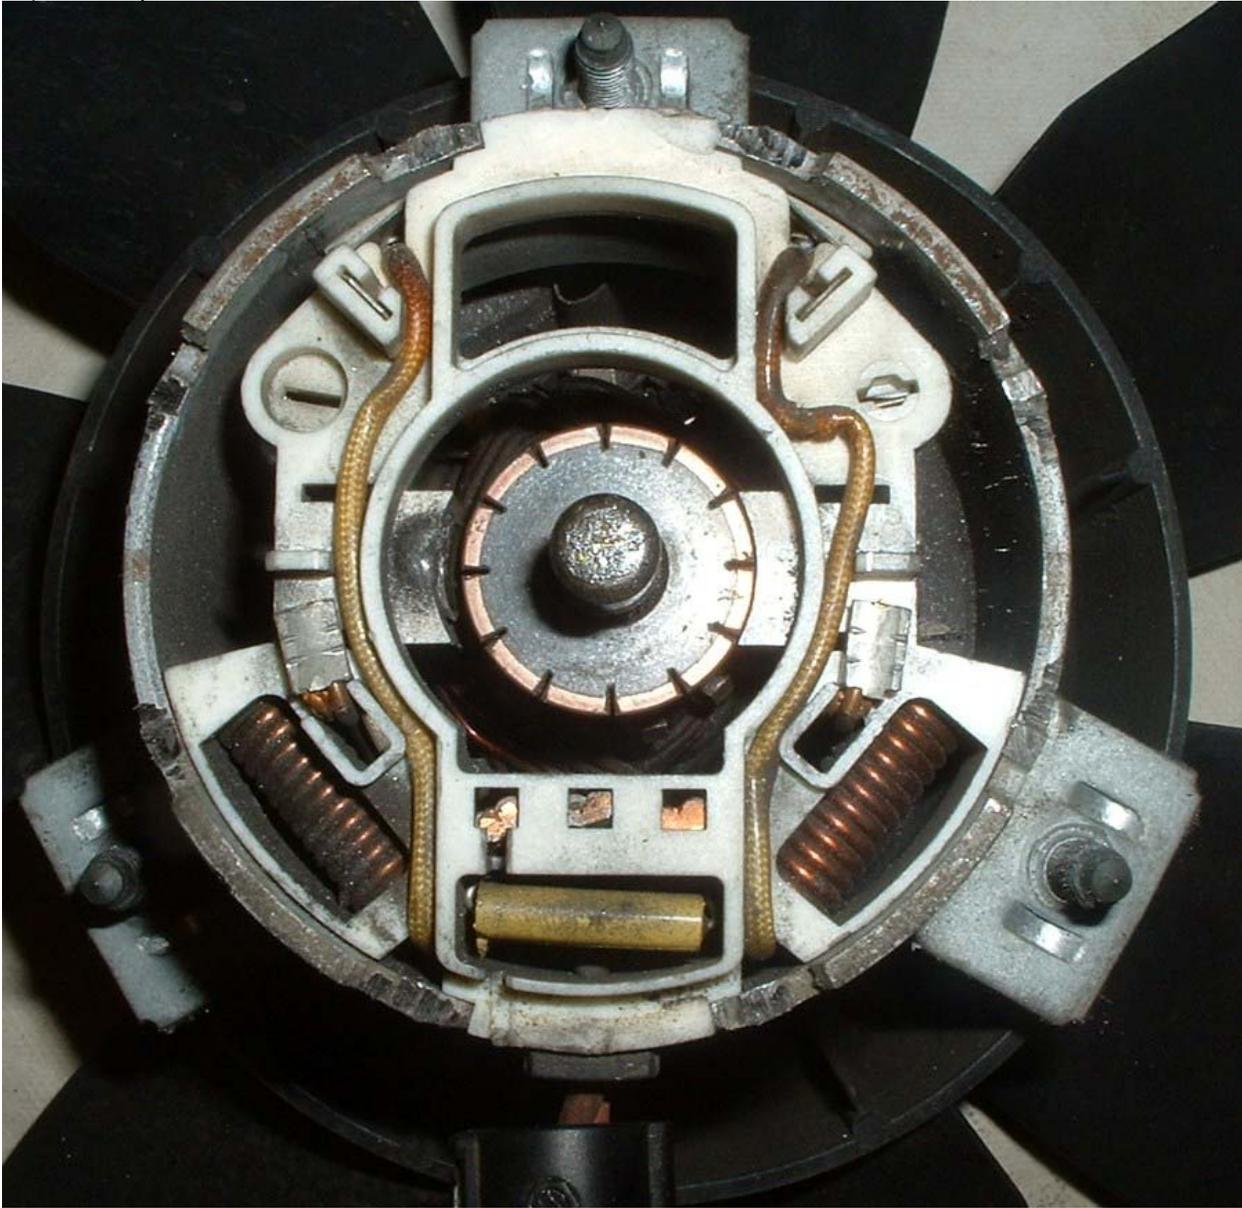
11) Brush plate reinstalled.

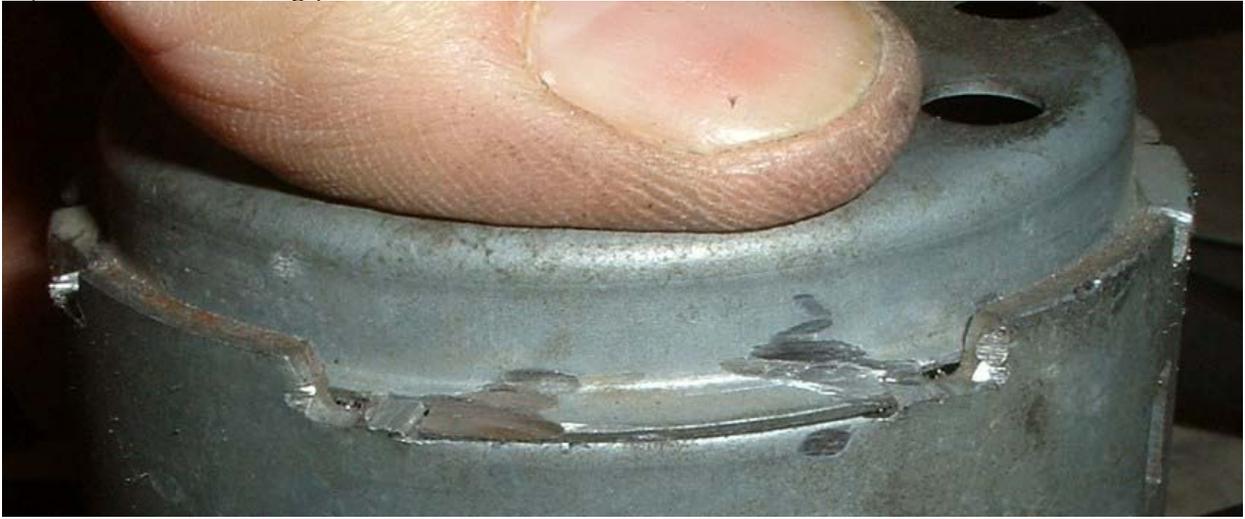
12) Ensure the bearing plate sits flush.

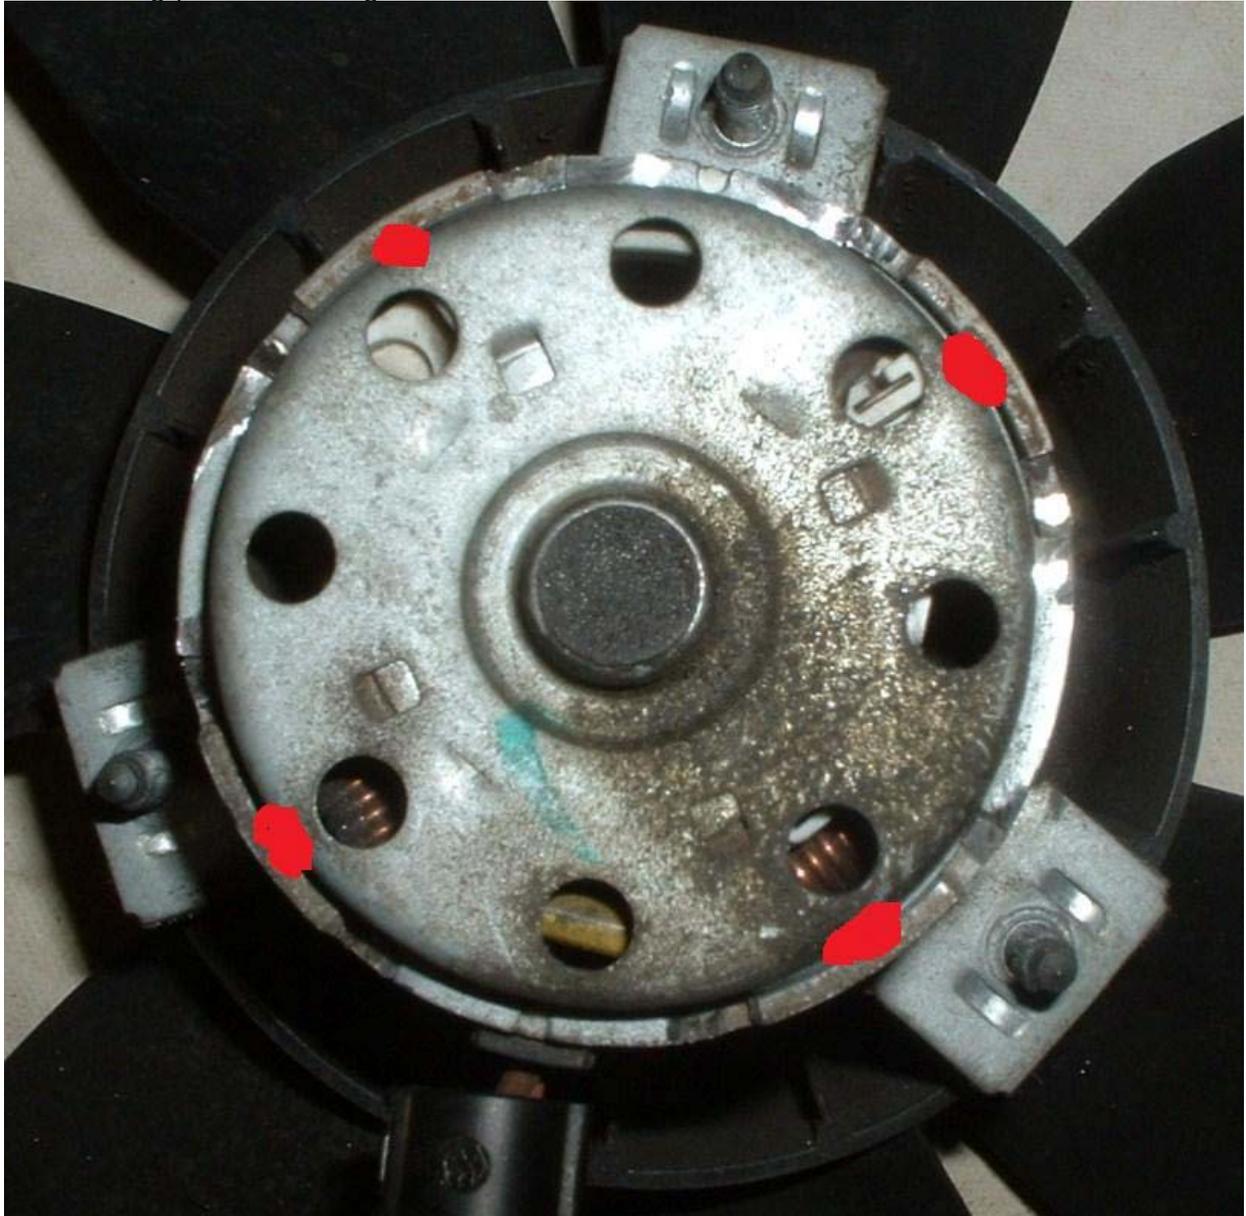
14) Mix up some DEVCON or JB WELD and put 3 or 4 dabs spaced evenly around the rear plate, to form a bond between the side walls and the plate.

This backing plate has 4 segments, so I would use 4 dabs of JB Weld, instead of 3.

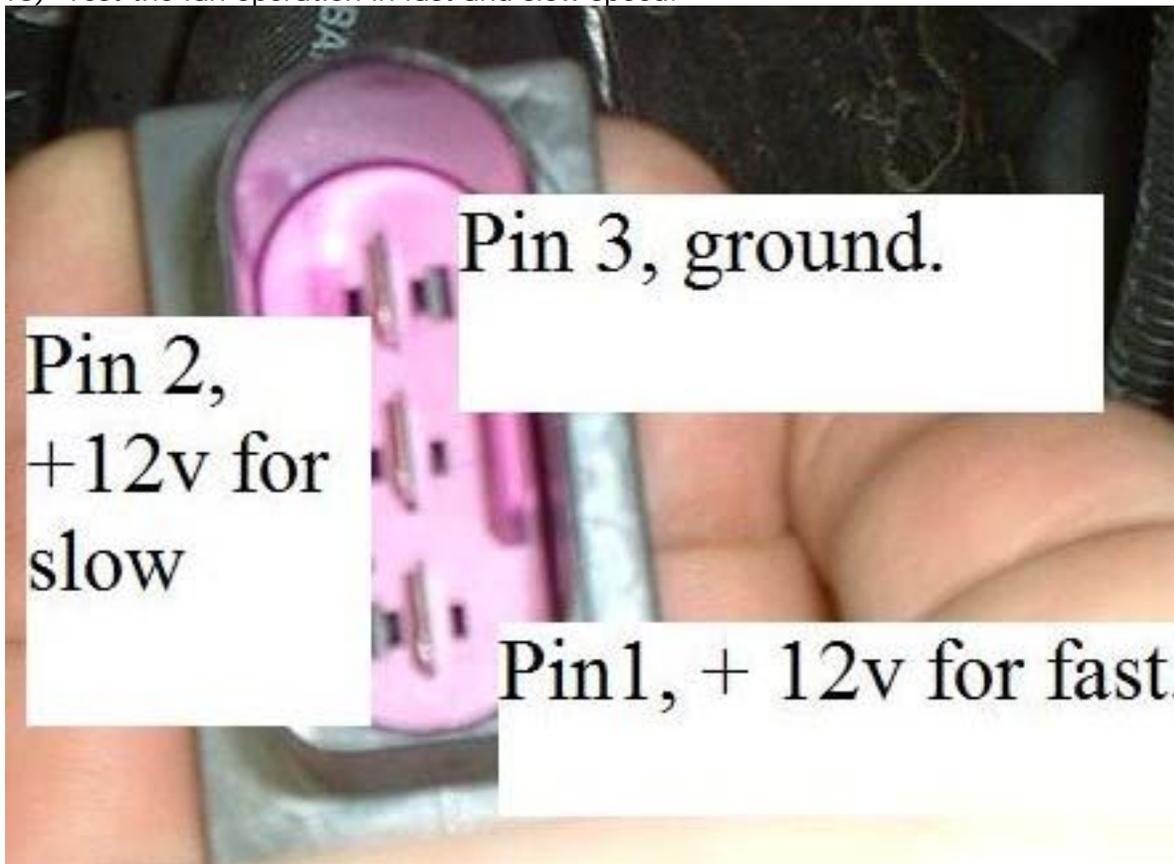
16) Test the fan operation in fast and slow speed.
