N75 valve investigation/ Tdi engine

I have drawn a schematic of the operation of the N75 valve, and there are photographs of the inside. The valve is working perfectly, now.

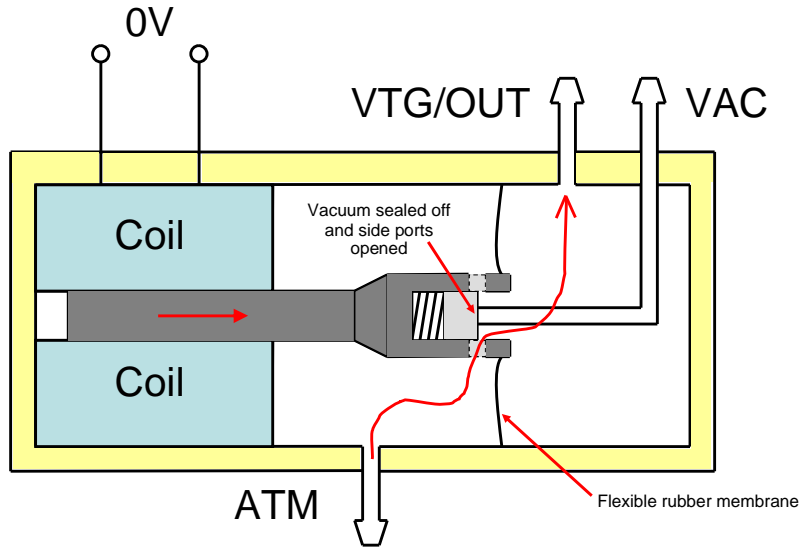
N75: De-energised state

Note: if vacuum seal is leaking, then vacuum (VAC) can suck from atmosphere (ATM)

Note that there is no spring return on the valve spool. The vacuum itself is used to close the valve. If you test it at the workbench, you will need to temporarily block the control port (which is normally connected to the VGT actuator), while applying vacuum to set the valve into the right position.

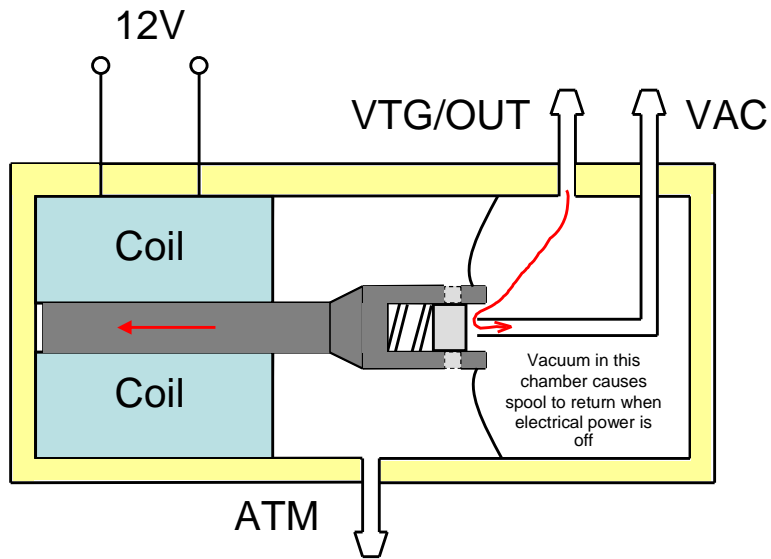
N75: Energised state

In my Passat, I found that the N75 design is OK, but the application of it is not. The ATM connection draws air continuously from the 'clean' side of the air filter, and it is exhausted to the vacuum line, during the operation of the valve and the VGT actuator. Pierburg (manufacturer) have an option for an integrated air filter, but this option is not taken by VW. Unfortunately, the air from the clean side of the air filter is not clean enough, and the very fine dust builds up inside the N75 valve. This finally causes sticking or bad sealing. Perhaps an inline pneumatic filter should be inserted into the ATM take off at the main air filter?

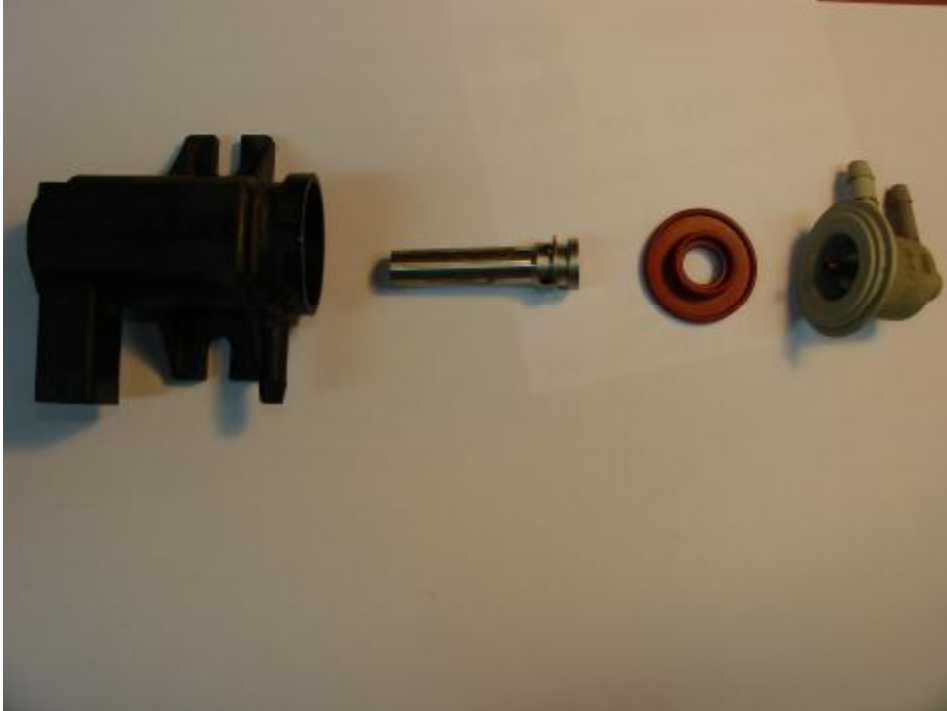
This photo shows the solenoid on the left, the spool (shiny rod), the rubber diaphragm or membrane, which fits over the spool, and the head. The steel clamping band is not shown. Remember which way round the diaphragm is. The top shown here should face right.

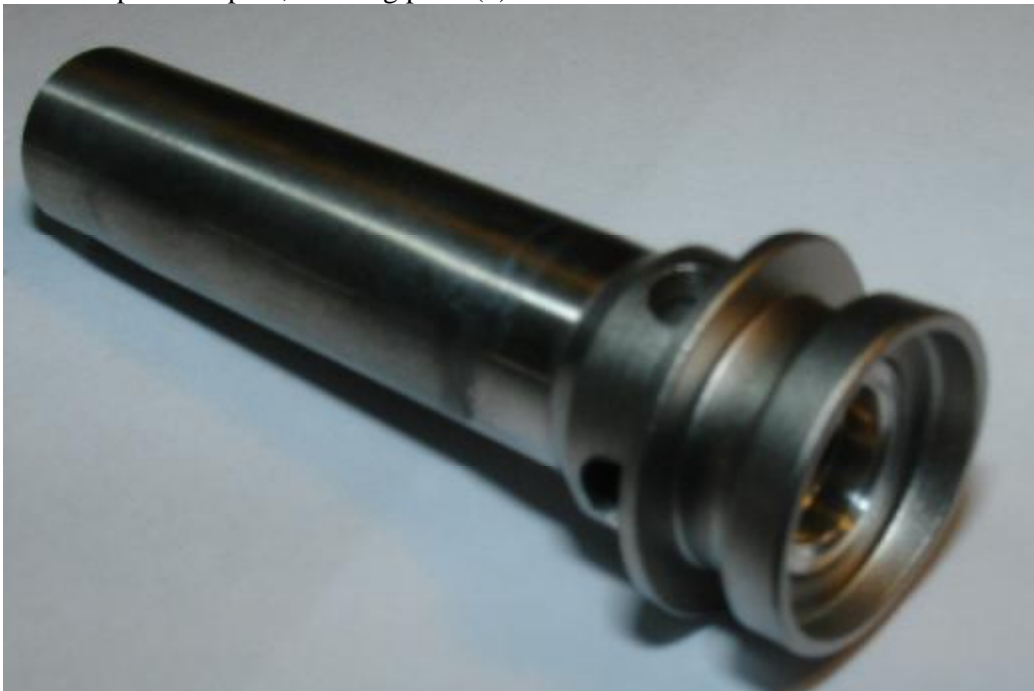
A close up of the spool, showing ports (4) in the side.

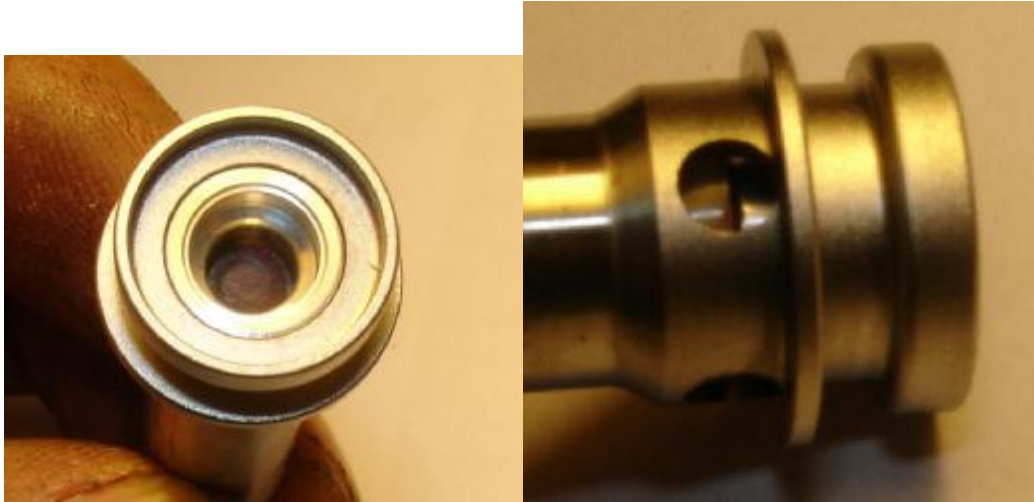
The part of the spool which gets dirty is inside here. The bottom of the hole is a seal which can move further inside. The area inside the 4 ports also gets dirty. The photo shows after I cleaned it. Sorry, I didn't think to take photos when it was dirty.

Once inside, use electrical contact cleaner (but be careful of solvents) and clean tissue. Light Lithium grease must be re-applied to the valve spool which slides inside the solenoid. Check that the small seal inside the valve spool can move up and down (it is set inside the 4 holes, and can be seen down the centre of the spool).

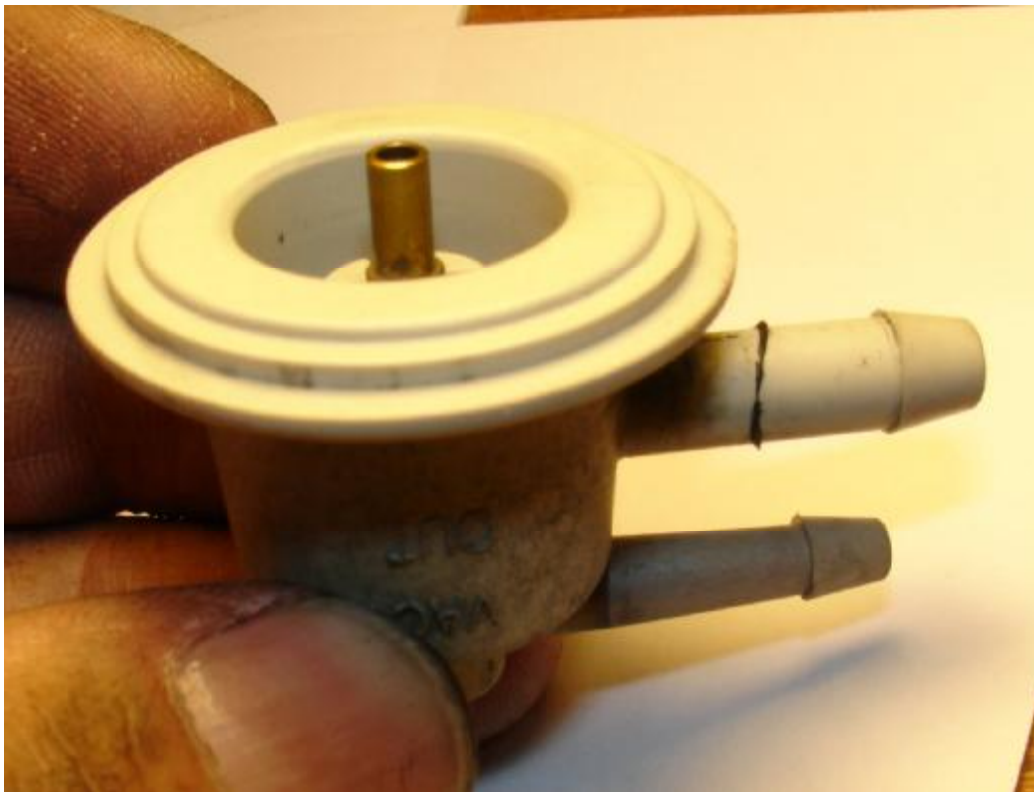
The valve head is shown next. The centre pipe is the vacuum line, which is connected to the bottom pipe connector (VAC). The other connection is OUT, connected to the VGT actuator. The end of the pipe normally seals against the seal shown at the bottom of the hole in the spool, in the de-energised state.
