Service Action Circular

Code: P9/66C8

Subject: 2001-2005 Model Year Passat and Passat Wagon
Service Air Plenum Area to Improve Drainage and
Install Improved Pollen Filter Seal

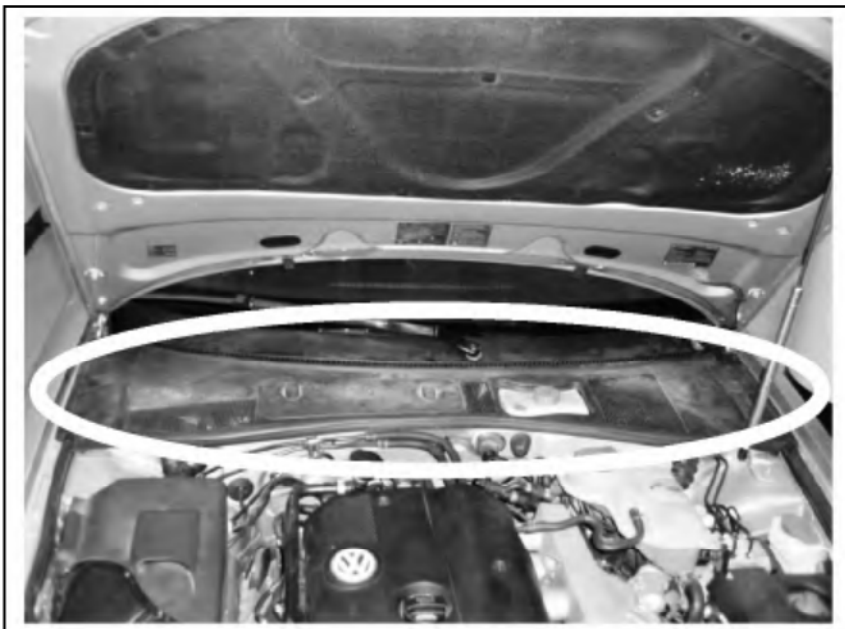
On some vehicles, moist debris might clog the air plenum drain area and water could leak into the passenger compartment. In order to prevent this condition, we will inspect, clean and modify the air plenum drain. We will also modify the sunroof drain (if equipped) and install an improved seal for the pollen filter on your vehicle.

Additionally, this condition can be prevented by ensuring that the air plenum area is maintained regularly to keep it clear of dirt and debris. This helps to avoid the water drain holes from becoming blocked, and it prevents water from entering the vehicle through the heating and ventilation ducts. Please refer to your owner's manual for additional information, including important warnings about working in and around the engine compartment and air plenum area.

To help ensure that the air plenum area remains clear in the future, we recommend regular inspection and, when necessary, cleaning of the air plenum area shown in the picture below. Please be sure to keep this letter with your owner's manual so it will be available for future reference.

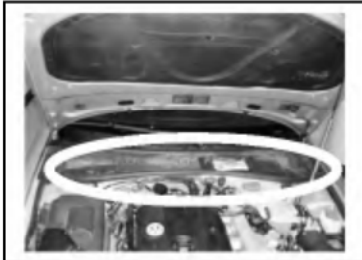
In some 2002 model year Passat and Passat Wagons moist debris might clog the air plenum drain area and water could leak into the passenger compartment and into the brake booster. In rare cases, during cold weather, frozen water may impede proper performance of the brake vacuum assist.

These conditions can be prevented by ensuring that the air plenum area is maintained regularly to keep it clear of dirt and debris. This helps to avoid the water drain holes from becoming blocked, and it prevents water from entering the vehicle through the heating and ventilation ducts. Please refer to your owner's manual for additional information, including important warnings about working in and around the engine compartment and air plenum area.

Additionally, to help ensure that the air plenum area remains clear in the future, we recommend regular inspection and, when necessary, cleaning of the air plenum area shown in the picture below. Please be sure to keep this letter with your owner's manual so it will be available for future reference.
