Technical Bulletin

Update Programming To Eliminate the Possibility of a Slight Hesitation

01 06 09 August 1, 2006, 2012686

Model(s)	Year	Eng. Code	Trans. Code	VIN Range From	VIN Range To
Passat – Passat Wagon	2004 - 2005	BHW	All	All	All

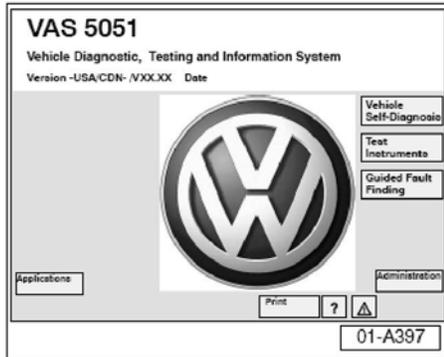
Update - Programming (Flashing) procedure, checking for update match

- Switch ignition ON.
- Switch VAS 5051/5052 ON and insert flash CD into CD drive as soon as start screen appears.

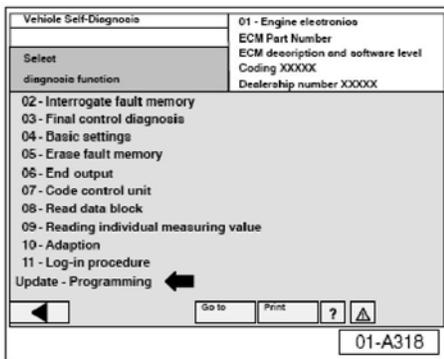
- Select vehicle system "01-Engine electronics" .
- Program checks software level.

If software level of ECM MATCHES level indicated by Flashing CD:

"Update-Programming" (arrow) will appear.

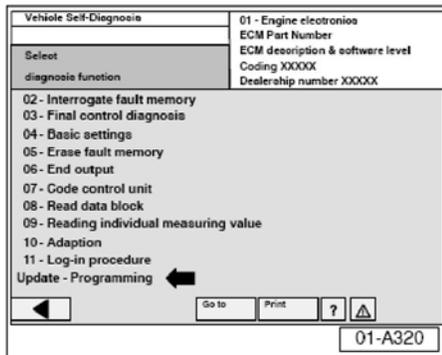
- Select vehicle system “01-Engine electronics” .

- Select “ Update - Programming” option at bottom of screen (arrow).

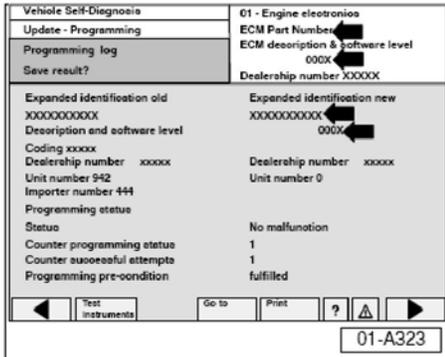
Once “Update - Programming” (flashing) is complete:

Similar screen appears.

ECM Part Number and old software level is still displayed at (arrows).

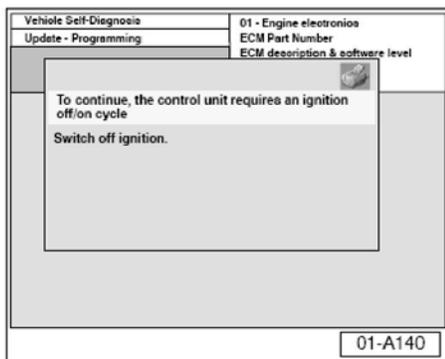
Once “Update - Programming” (flashing) is complete, the control module must be re-initialized.

- Select the forward arrow button.

The tester requests you to switch the ignition OFF.

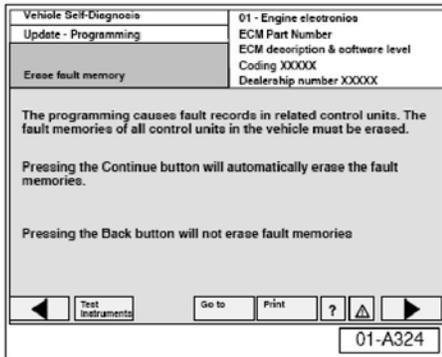
Fault memories, erasing after “Update - Programming” (flashing)

Due to the CAN bus system, fault messages will be stored in various Control Modules during programming.

To erase ALL fault memories:

- Confirm by selecting the forward arrow button.

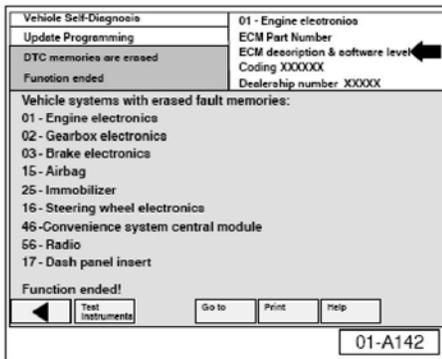
Once fault memories have been erased:

Similar screen appears.

Old ECM Part No. and software level still appear at (arrow).

Function ended appears at bottom of screen.

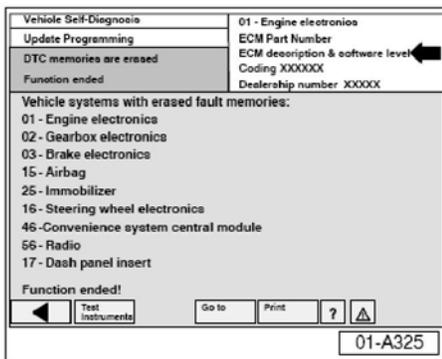
Similar screen appears.

Updated software level will appear at arrow.
