B4 Passat TDI MFA Conversion (Revised)

Introduction

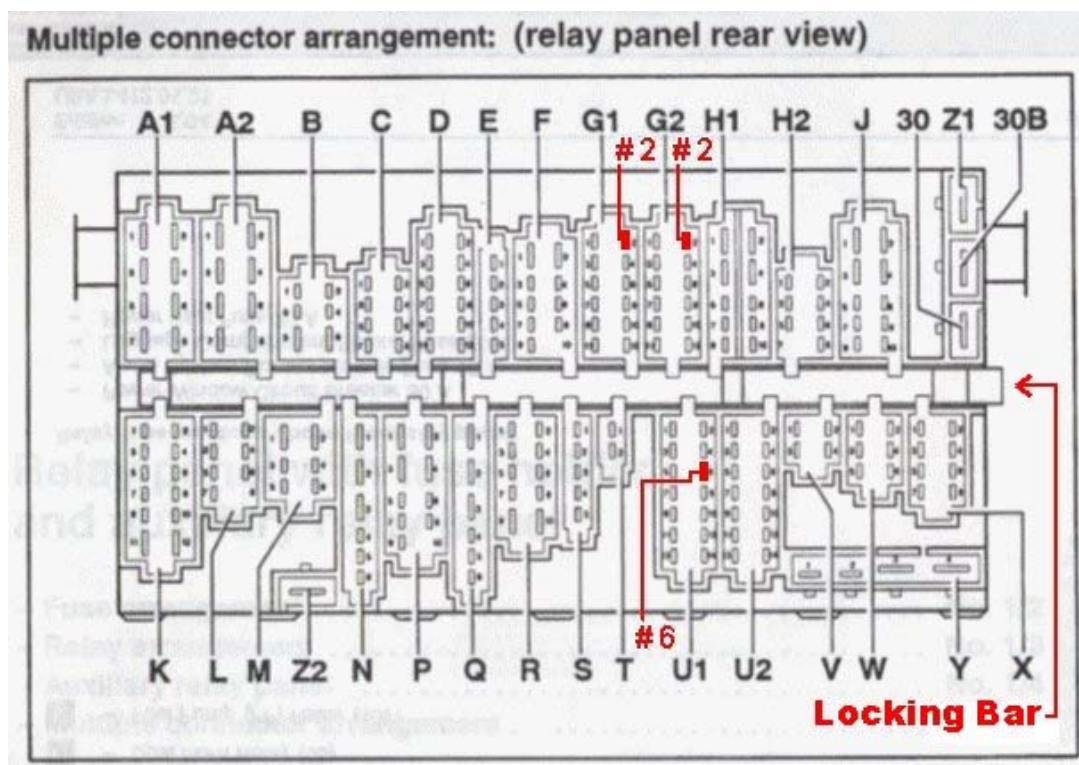
Figure 1

7. Fabricate a 4-wire harness (approximately 32" long) for the MFA controller/wiper switch. Use P/Ns 1HO-953-634, 357-907-968 and (4) 000-979-133 as the connector plugs and terminals/wire. Unsnap, then unhook and rotate the fuse/relay panel down so that the backside is exposed. The panel should now be upside down, oriented as shown in Figure 1.

8. Install MFA controller/wiper and turn signal switches and new harness. The relay panel end of the harness connects to the "V" socket in Figure 1. In the middle of the passenger's side end of the relay/fuse panel there is a rectangular bar, flush with the panel side end (see Figure 1). This bar extends throughout the width of the relay panel and locks all of the connector plugs to the panel at their inner ends. Before installing the "V" plug, pull this bar out (toward the passenger's side) to unlock all connector plugs. Push it back in after installing the "V" plug. The MFA controller's 4-pin connector slides onto the 2 slots under the steering column right next to the turn signal switch connector you slid off previously.

- 2. Wire the tach drive signal.** Locate the white tach signal wire. It runs from the #6 pin of the U1 harness connector on the back of the fuse/relay panel (see Figure 1) to pin #10 of the instrument cluster harness connector. Splice into this wire and run it to the "Sig. In" terminal of the SGI-8 and return it to the splice via the "OUT1" terminal.

1. Locate the sensor input wires. On the back of the fuse/relay panel, locate the brown/white and white/red wires that originate from pins G1/2 and G2/2, respectively (see Figure 1). These wires may either be taped together, bare-ended and unconnected at their other ends or they may have a 2-pin connector plug.

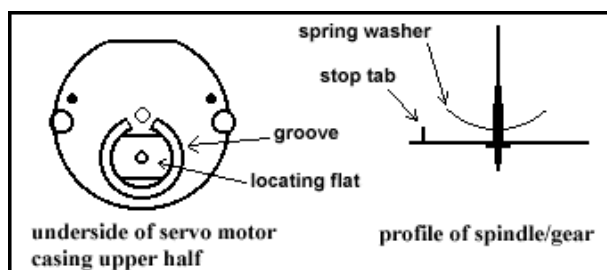
Figure 3

If the needles **didn't** come off, you now must remove them by pulling straight up without rotating. The first time you do this (you will be doing it at least twice) you may pull apart the 2-piece servo motor casings beneath the face plates rather than pull the needles off their spindles. Don't worry, its not uncommon, but it will feel like you have broken them. Usually the casings at first become only 1/2 separated and the spindle/needle will be floating around at an angle. Just continue to pull straight up (not at the angles at which they're leaning) until they feel like they are free (Note: the needles have probably still not separated from their spindles...but the casing halves have separated). Since the face plate for the 2 gauges and speedo is one unit, you will have to finesse this a bit, trying to pull each of the 3 needles a like amount in stages. Once all casings are separated (or needles pulled from spindles...or a combination of the two), remove the 2 face plates. Pull needles off of any spindles/casings that came off as a unit with the face plates. Don't lose the rectangular spring washer installed between the spindle and the upper casing half. Reassemble any separated servo motor casings. Make sure that the dark grey plastic reduction gear is installed on its shaft in the center of the lower servo motor casing. If not installed, it got pulled off when the casings were separated. Find it and reinstall it, making sure that the small pinion gear in the center faces up (the other side has a boss that is about the same size as the pinion gear, so look carefully). Now install the spindle (with integral reduction gear) into its bore. Rotate the spindle/gear so that the stop tab on the gear will fall into the free rotation (1:00 to 11:00) section of the circumferential groove located in the underside of the upper casing (rather than the 11:00 to 1:00 "stop" area) when the upper casing half is reinstalled (see Figure 3). Now install the rectangular spring washer on the spindle/gear, convex side toward the gear, oriented so that it will be located and kept from turning by the rectangular depression in the underside of the upper casing half (see Figure 3). Now install the upper casing half carefully over the spindle to reintegrate the servo motor casing.

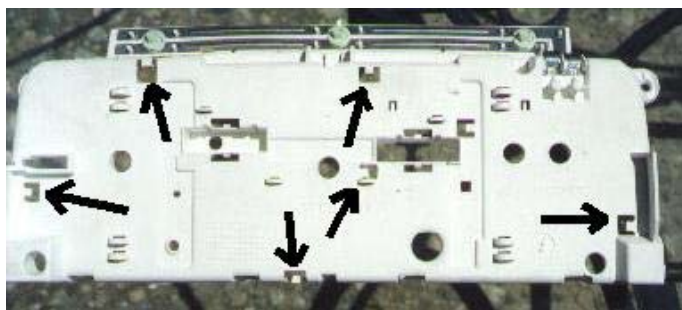
Figure 4

3. Remove the cluster PC board from its housing. Remove the 2 torx screws in the upper left corner of the board. Locate the 6 board retaining tabs. See Figure 4.

From the front, release one tab at a time, lifting the board slightly to rest it atop that tab, and continue around the periphery to the next tab, until all are tabs are free (the 6th tab in the middle, accessible from the back of the housing, is probably not actually retaining the board, but check to make sure). Remove the board.

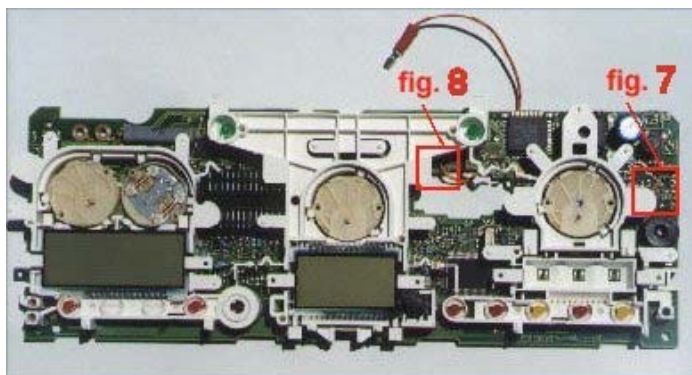
Figure 5

1. Solder in yellow MIL LED bulb in the unused far right location. *NOTE: If you don't have board soldering experience or a 'solder sucker' device, I recommend farming this job out to an electronics technician.* If not using a new LED, desolder/remove original TDI MIL LED bulb. Observe proper LED orientation as shown on the molded graphic located between the 3rd & 4th LED on the right hand LED holder bank.

2. Solder in the 2 resistors as shown in fig. 7 (inset from Fig. 5). These enable the MIL LED. Skip this step if using a '96 GLS cluster.

3. Solder in an MIL signal wire as shown in fig. 8 (inset from Fig. 5). Install from the front side. Install a male pull-apart connector on the other end. This will connect to what is now the only wire on the second 28-pin connector on the cluster wiring harness.
