### Information on Water, Corrosion and Microbial Issues with Diesel Fuel Management in Storage Tanks

## Bottom Sampling Procedure For Retail Underground Storage Tanks

Owner: Product Quality Group for Shell Oil Products US and Motiva Enterprises LLC

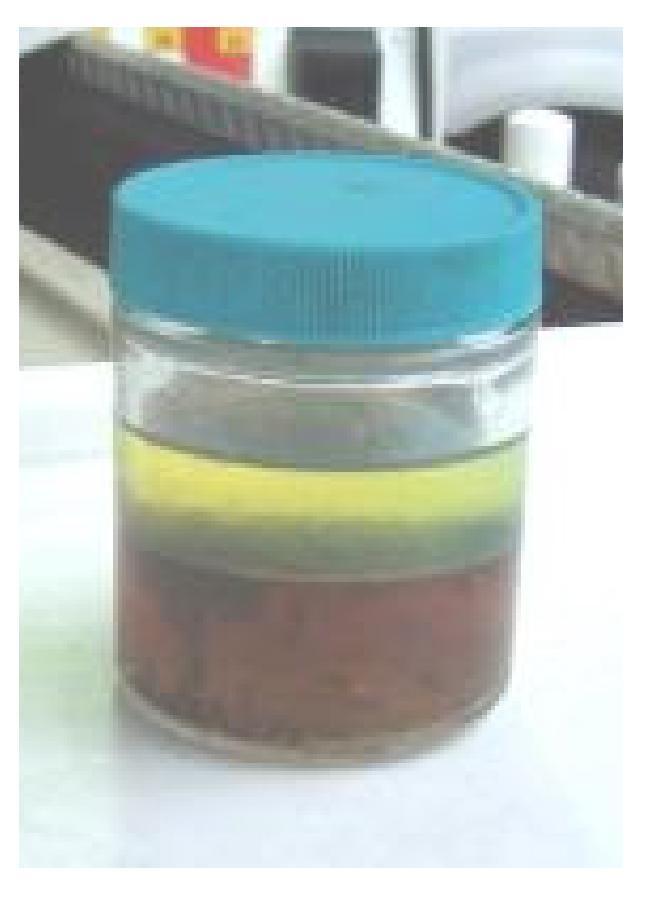
**EXAMPLE 1:** Diesel, large water layer with corrosion products; Slight rag layer.

- V. Water is heavier than either gasoline or diesel. If present, a water layer will be on the bottom and a product layer on the top. It may be necessary to let the sample settle for a few minutes to see the two layers or see any solid material settle to the bottom. If rust, corrosion material or other material is seen, run a magnet across the bottom to see if the particles are magnetic.

- VI. If there are two layers, see if there is any evidence of some material at the interface of the two layers. This is called a "rag layer". If a rag layer or a multiphase layer sample is not observed, a sample should be obtained on the turbine end of the tank. This ensures that if the tank is sloped, a sample will be obtained from the low end where the water will accumulate.

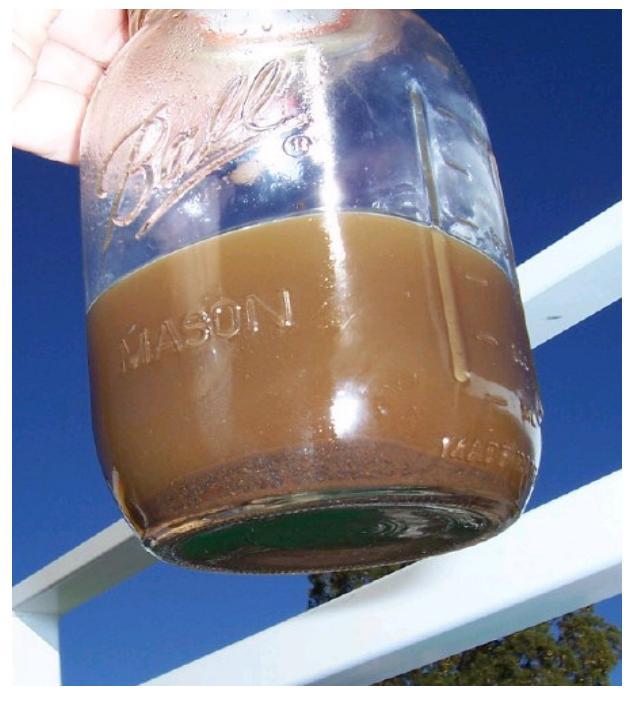
**EXAMPLE 2:** Diesel, small water layer, significant corrosion products. If this sample was allowed to settle, product could become clear
