# Repair Manual EuroVan 1992 ≻

Brake System On Board Diagnostic

Edition 07.2002

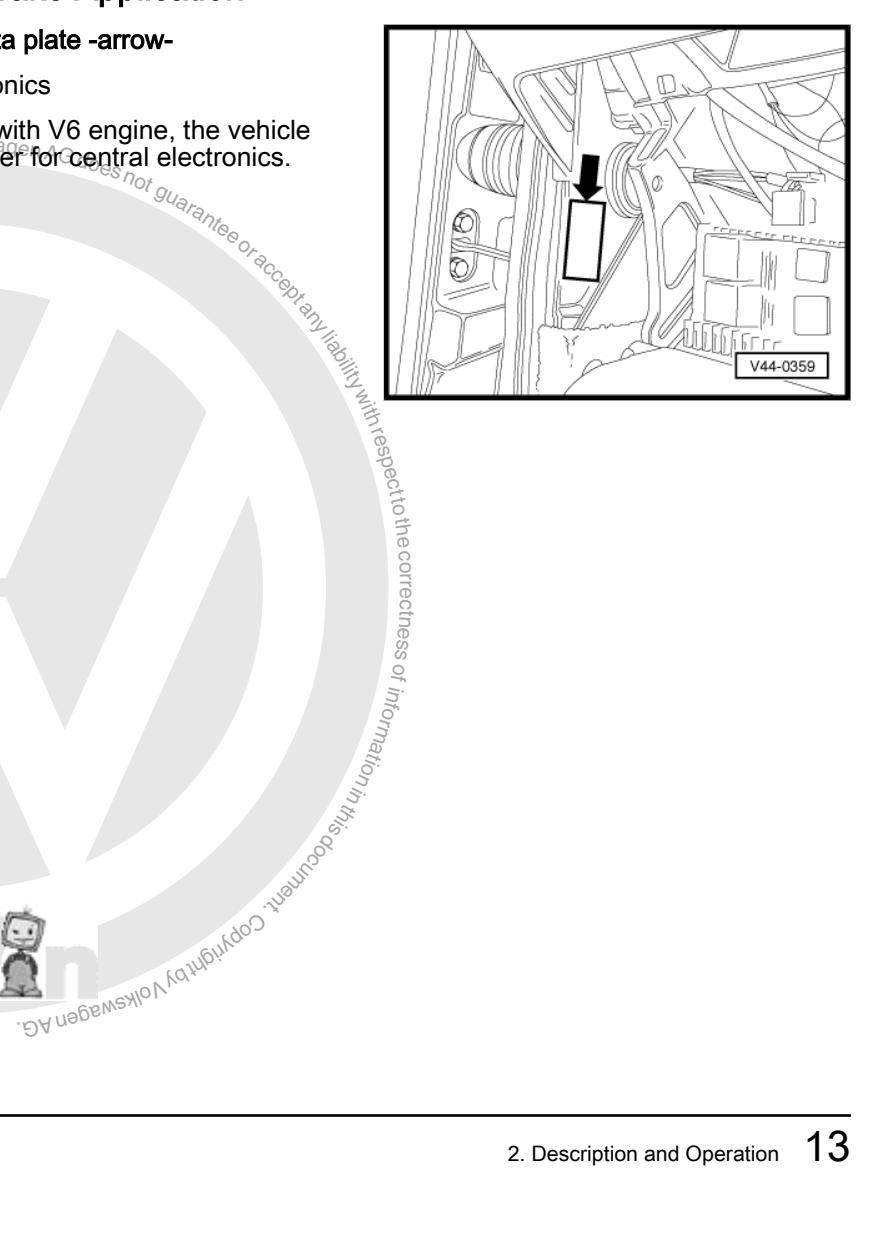
#### Location of PR no. on vehicle data plate -arrow-

For vehicles with knee bar (USA) or with V6 engine, the vehicle data plate is located beneath the cover for central electronics. Lee 94arante

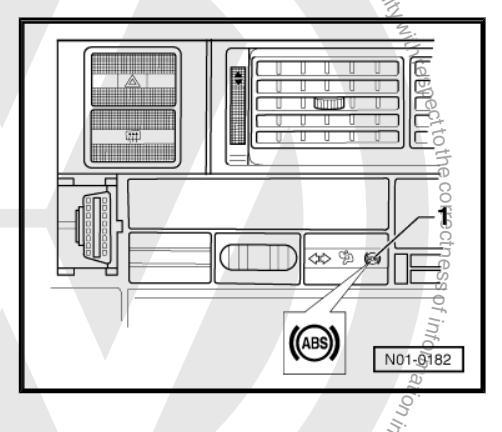
N01-0182

Item no.	Description	_	
1	Brake pad wear indicator light -K32-	/	-
2	ABS Warning Light -K47-	1	Can and the second
3	Warning light for brake system -K118-		
4	ESP Control Lamp -K155-		EN DEN

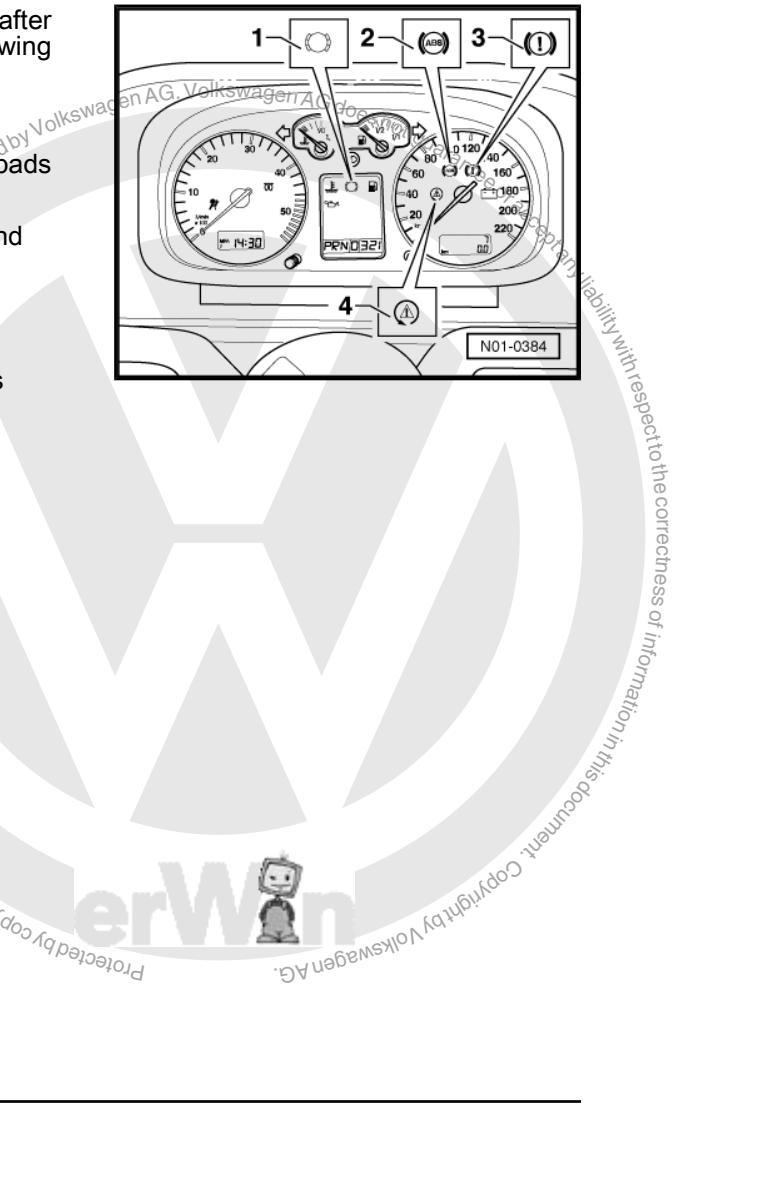
### ABS Warning Light -K47-

- If the ABS Warning Light -K47- ( <u>⇒ page 16</u> ) does not go out after the ignition is switched on and the test sequence is complete, it could be caused by the following errors:
- -a- voltage supply is under 10 volts.

- If the ABS Warning Light -K47- ( $\Rightarrow$  page 16) goes out, but the warning light for brake system -K118- remains lit, the malfunction causes could include:
- -a- brake fluid level is too low

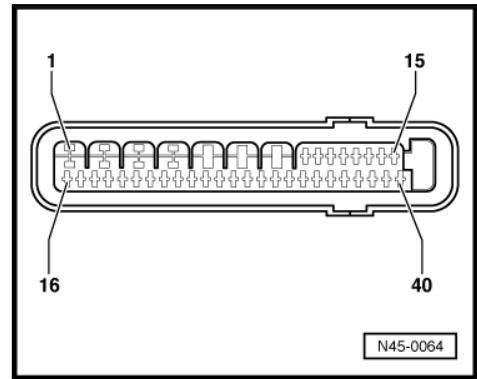
Terminal	Wi	re connection to component	
1	⇒ Ground (GND) point at left in engine compartment		
2	$\Rightarrow$ V $\Rightarrow$ oltage supply from battery +		
3	$\Rightarrow$ Voltage supply from battery +		
4	$\Rightarrow$ Voltage supply, terminal X		
5	⇒ Not assigned	Lokswagen AG. Volkswa	agen AG does n
6	⇒ Not assigned	ised by VO.	HOT GUARA.
7	⇒ Not assigned	authon	Alter Of
8	⇒ Not assigned	11855	Store Dr.
9	⇒ Not assigned	in the second se	PAT A
10	⇒ Not assigned	30 <sup>11</sup>	18011
11	$\Rightarrow$ Not assigned	Loc	Y Nit
12	⇒ Not assigned	)(e, is	A res
13	⇒ Not assigned	nhhc	pec
14	$\Rightarrow$ Not assigned	or ir	toth
		i, in part	e corre
Terminal	Wi	re connection to component	ctne
15	⇒ Not assigned	burk	S Of
16	$\Rightarrow$ Left front ABS wheel speed sensor -G47-	rcial	infor
17	$\Rightarrow$ Left front ABS wheel speed sensor -G47-	amm	mat
18	$\Rightarrow$ Left rear ABS wheel speed sensor -G46-	o, co	nin

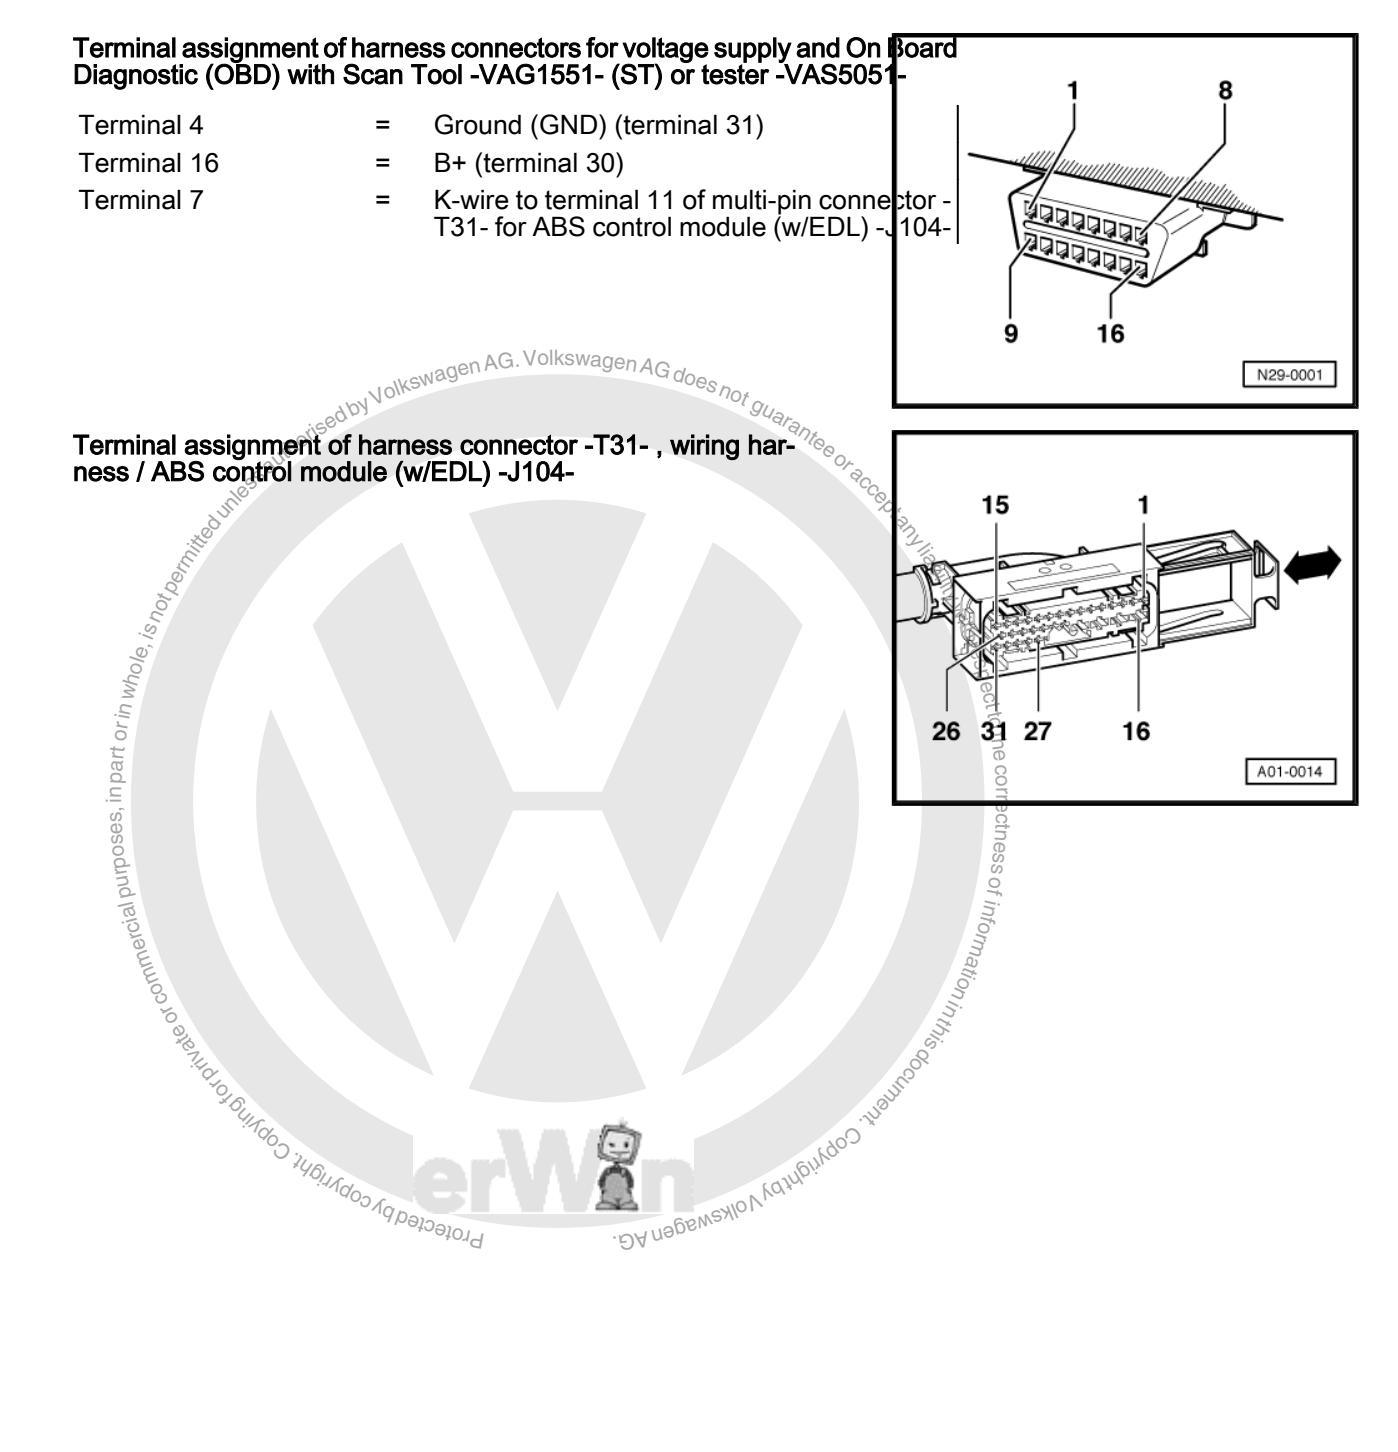
and a contract of the second s				
Terminal		Wire connection to component	uby Volkswag	does not on		
1	⇒ Right rear ABS wheel speed sensor -G44-		thoriseout	andrante <sub>e</sub>		
2	⇒ Not assigned		300	COT RCC.		
3	⇒ Right rear ABS wheel speed sensor -G44-	Supr		Cortan		
4	⇒ Right front ABS wheel speed sensor -G45-	Imit		2		
5	⇒ Right front ABS wheel speed sensor -G45-	oto				
6	⇒ Left front ABS wheel speed sensor -G47-	is is				
7	⇒ Left front ABS wheel speed sensor -G47-	hok				
8	⇒ Left rear ABS wheel speed sensor -G46-	rinv				
9	⇒ Left rear ABS wheel speed sensor -G46-	art c				
10	⇒ Not assigned	du				
11	⇒ Harness connector -T16/7- , K - wire	Ses				
12	⇒ Not assigned	nıpo				
13	⇒ Not assigned	sial P				
14	⇒ Brake light switch -F-	merd				
15	$\Rightarrow$ Voltage supply, terminal X	Loo				
		o areas		11.55 B		
Terminal		Wire connection to component?		THOUSE .		
16	$\Rightarrow$ (GND) from battery -	·~~	<sup>20</sup> 5.	Coby

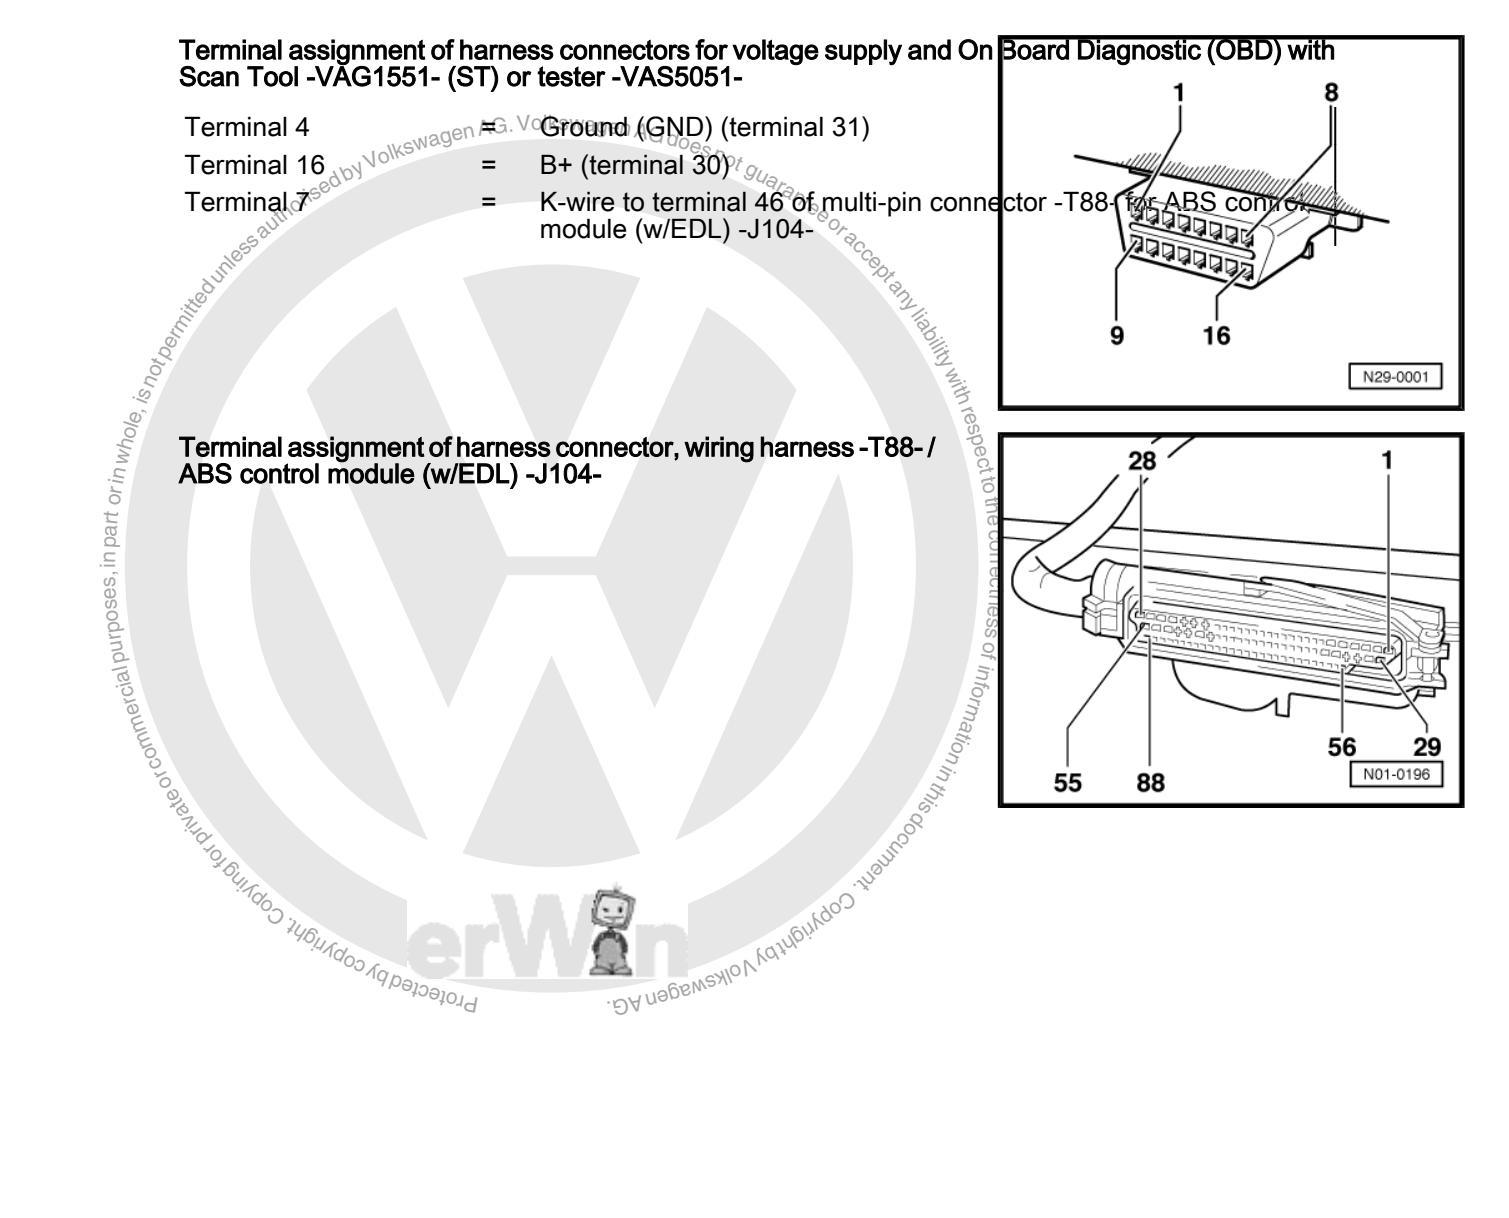
· · · · · · · · · · · · · · · · · · ·	a <sup>th</sup> <sup>n</sup>	· ° ° 0 ~
Terminal	Wire connection to component	1 acces
1	⇒ Voltage supply, terminal 15	Dr. Bay
2	<ul> <li>⇒ Plus-activation of ABS return flow pump relay 3105-</li> <li>⇒ Plus-activation of ABS solenoid valve relay -3106-</li> <li>⇒ Voltage supply of Steering Angle Sensor -G85-</li> </ul>	A lability with
3	⇒ Activation of left front ABS outlet valve -N102-	est la service de la service d
4	⇒ Activation of right rear ABS outlet valve -N135-	pect
5	⇒ Activation of left front ABS inlet valve -N101-	to th
6	⇒ Activation of right rear ABS inlet valve -N133-	8 00
7	⇒ Ground (GND)-activation of ABS return flow pump relay -J105-	rect
8	⇒ Not assigned	nesg
9	⇒ Left front ABS wheel speed sensor -G47	of jj
10	⇒ Left front ABS wheel speed sensor -G47-8	nfort
11	⇒ Right rear ABS wheel speed sensor -G44- (only in vehicles with 16" suspension)	natio
