### RADIATOR REPLACEMENT ON A BKDB 2.0 TDi VW TOURAN 2008.

## THE PROBLEM:

**REMOVAL PROCESS:**

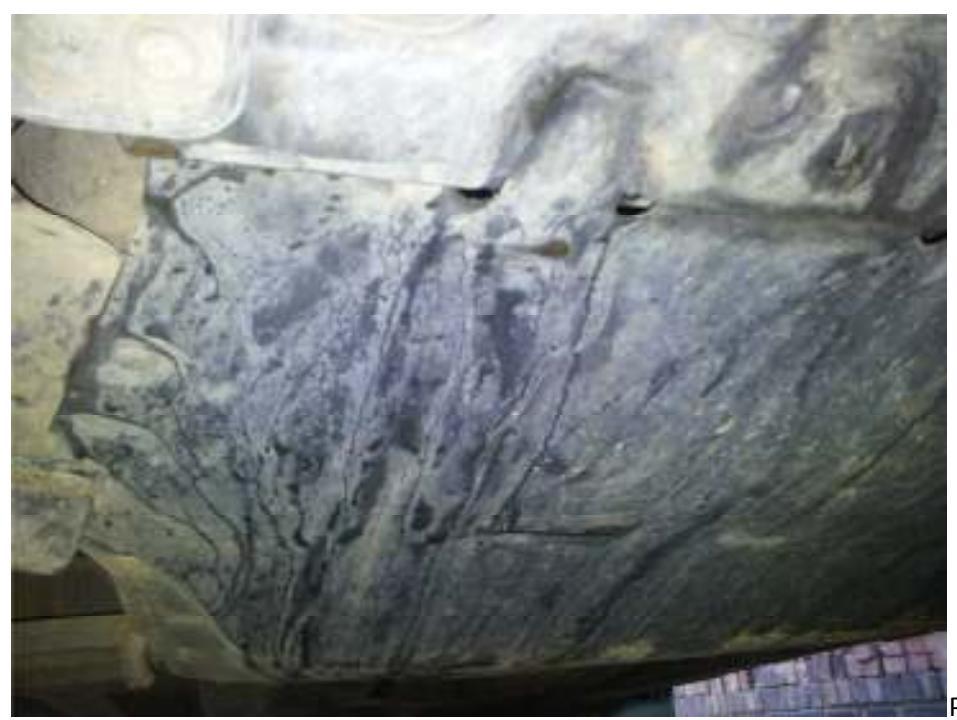
Picture 1

Next day, after doing approx. 70 km, (my daily commute to work and school etc), same thing happened. Alarms Bells, Reservoir empty again. Scheisse. OK, now I started realising something bigger is wrong. Did visual inspection of underside of car. Looked and felt dry, so I was getting more worried that it may be a head gasket problem, something I was not looking forward to. As I did not have a flashlight handy, I missed the streaks of fluid that has dried on the belly cover. The next day I got beneath the car with the camera, see picture No 1.

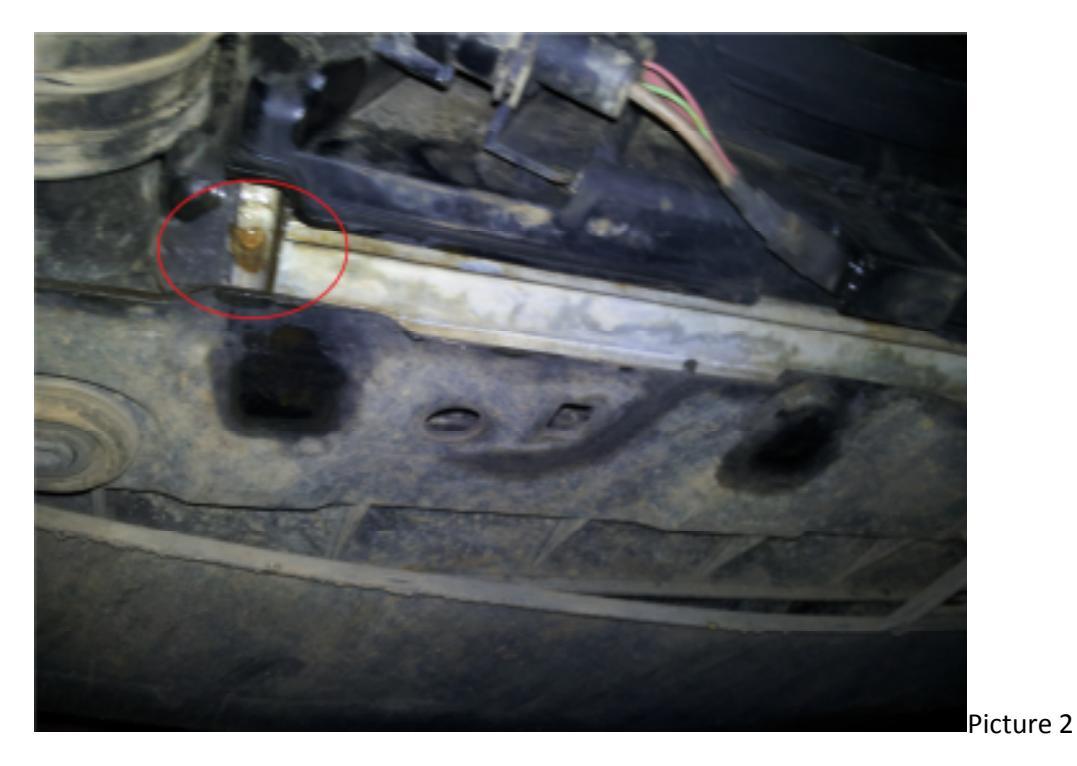
I removed the belly protection and noticed a few drops of fluid (circled in red) at the bottom of the radiator. But where is the leak?...difficult to see, as everything is still covered up, except the bottom of the radiator. Decided to wait till Friday evening to pull the fans etc.

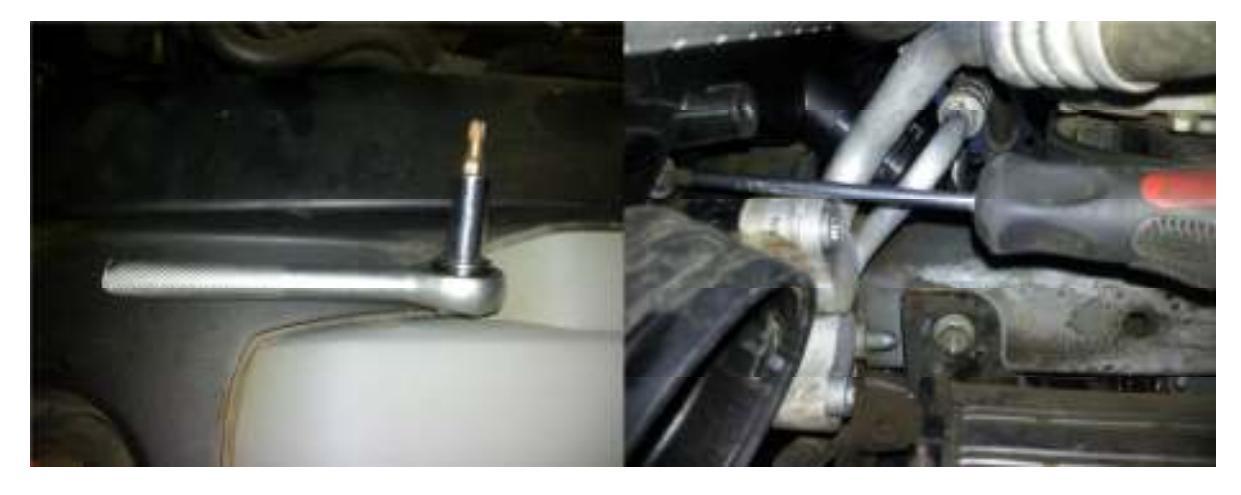
Picture 3

Friday came and started stripping the fan tray. The removal procedure is in a Howto else were on this forum. It has 4 x T30 screws, but you need two tools to do this. One, a T30 screwdriver, and a ¼ inch small ratchet & T30 bit, as in most cases, space is limited. Both tools are pictured below.

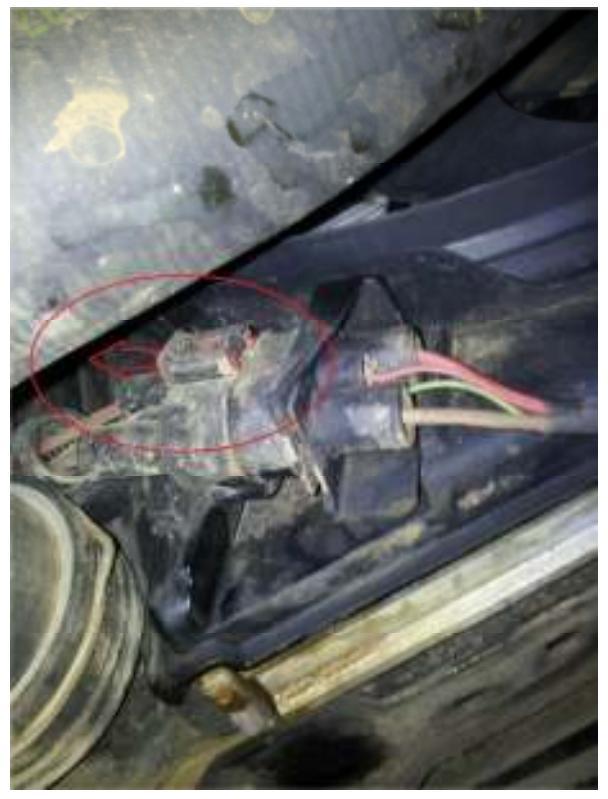
Picture 5

The separation of the Electrical connection of the fan tray is tricky. After moving the red clip, you still need to insert a small flat screwdriver into it to separate.

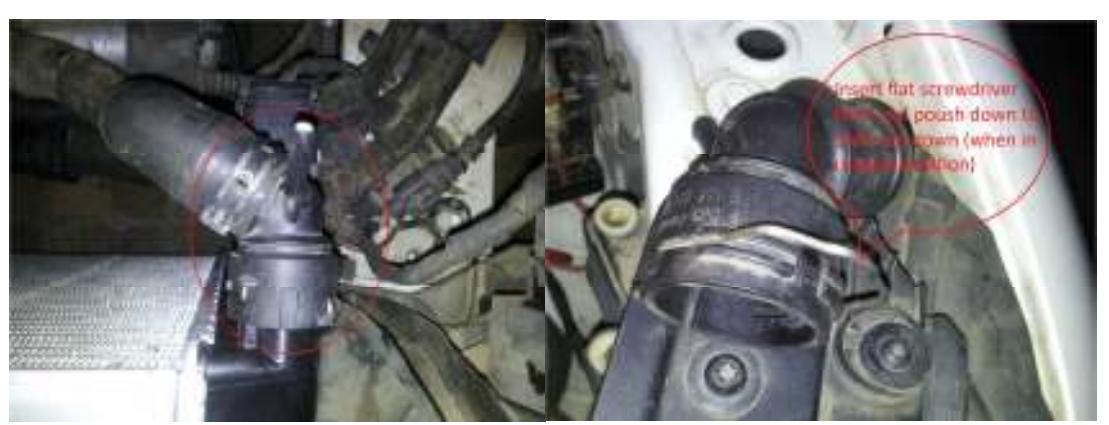
Picture 7

- 8) Remove the 2 right hand side radiator pipes and clamps. 1, 2 below Inset picture here
- 9) Then remove this plastic connector part (between the radiator pipe and the radiator itself). You need to insert a medium flat screwdriver underneath it (the clip), and then push down. This clip does not separate from the fitting, as it has a notch preventing it from going "pinggone"!! The second pic below I've turned it upside down.
- 10)

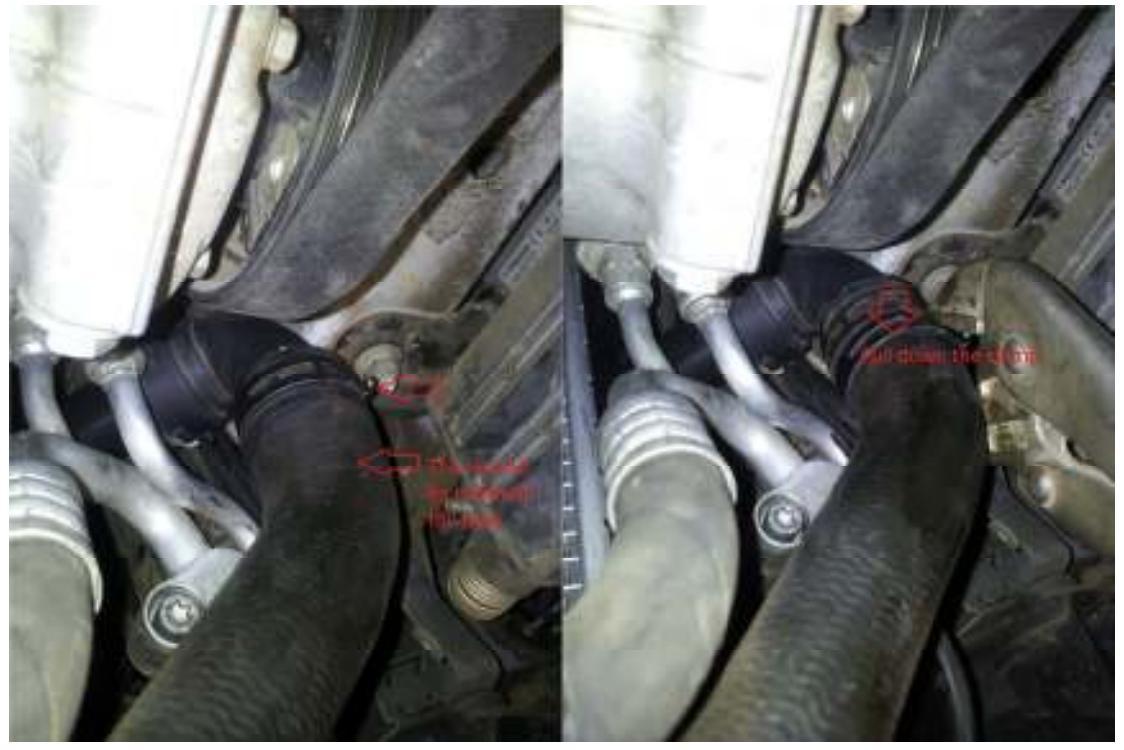
Picture 14

13) To remove the 3rd pipe (the one near the aircon pipes), you will need a bit of patience as well, as space is limited. So much for German Engineering! You will need a strong long nose pliers (or vice grip) with a wide opening jaw. Remove the clamp by gripping the two upturned ends of the clip (it is quite strong) and pulling the pipe when the clamp is loose. It took me several attempts before the pipe completely separated. Once Again, don't force.

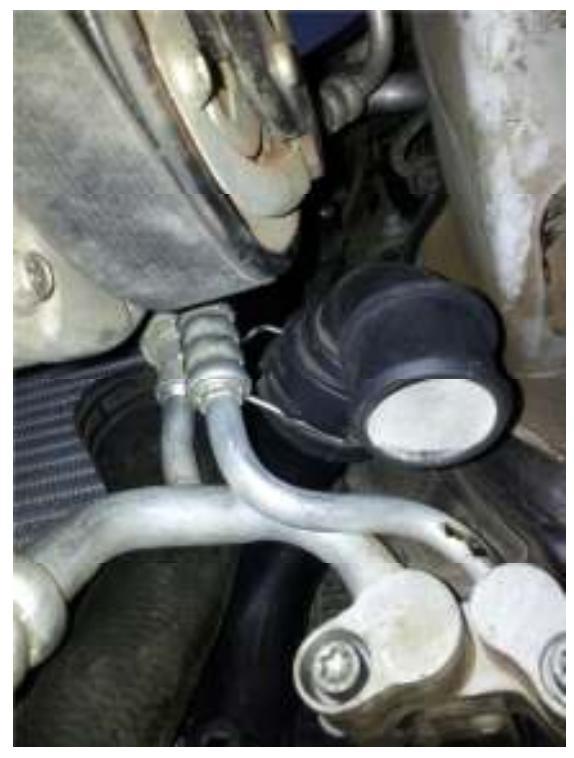
Pipe removed and moved to left. Note Cir-clip has also been moved, but this proved to be a fruitless exercise in try to remove the plastic coupling from the radiator while it is still in positioned in the car.

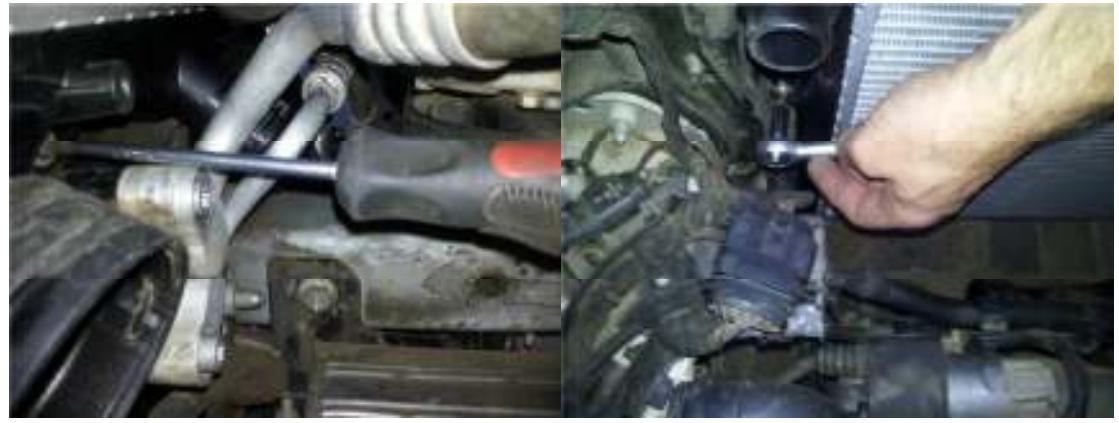
Picture 18

14) Remove the 4 x T40 screws that hold the radiator to the Intercooler. Use the ratchet tool, as the mounting points for the radiator to the intercooler are well inside the place where the fans bolt onto the radiator.

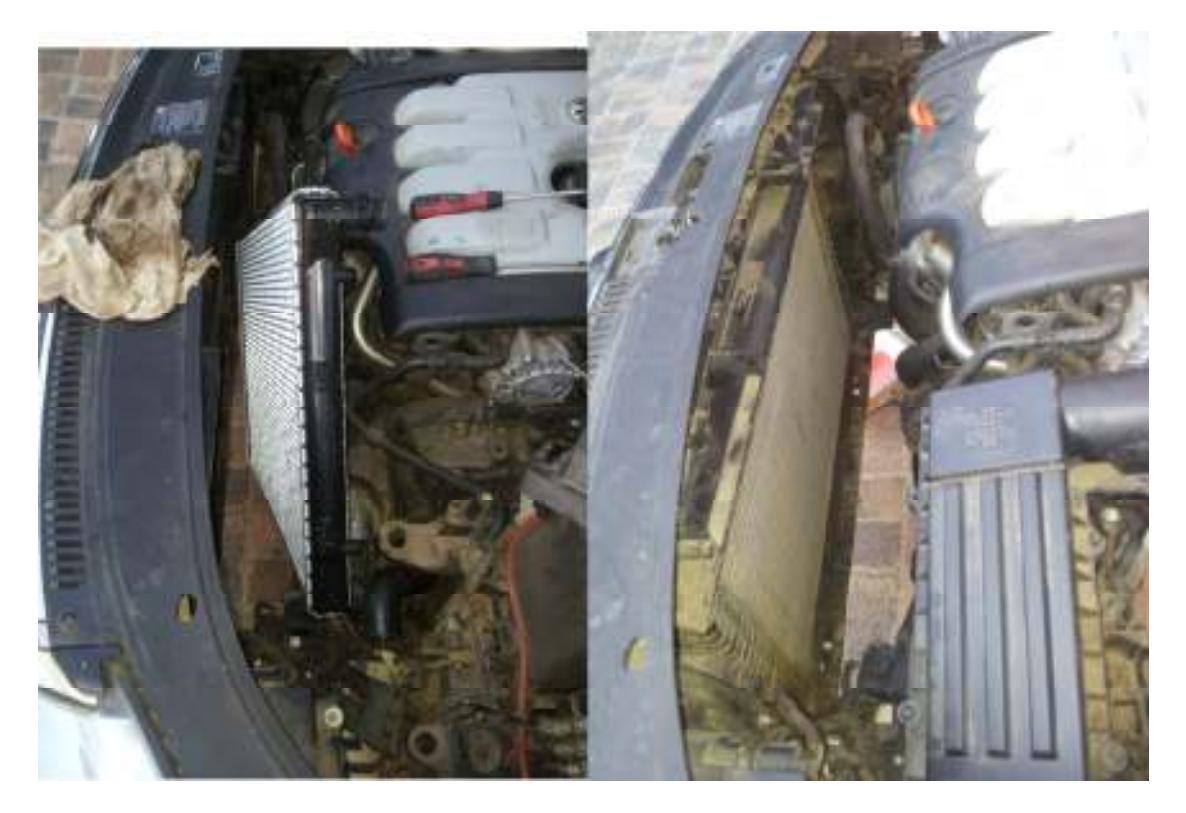
Picture 22

- d. I had to "help" the black plastic elbow past the Alu Aircon pipes. Also, the left top will get stuck at this plastic part, which looks like the same as the intake part on the right hand side. See photo X below. Maybe a 3<sup>rd</sup> hand would make this part of the removal easier, but I was alone!

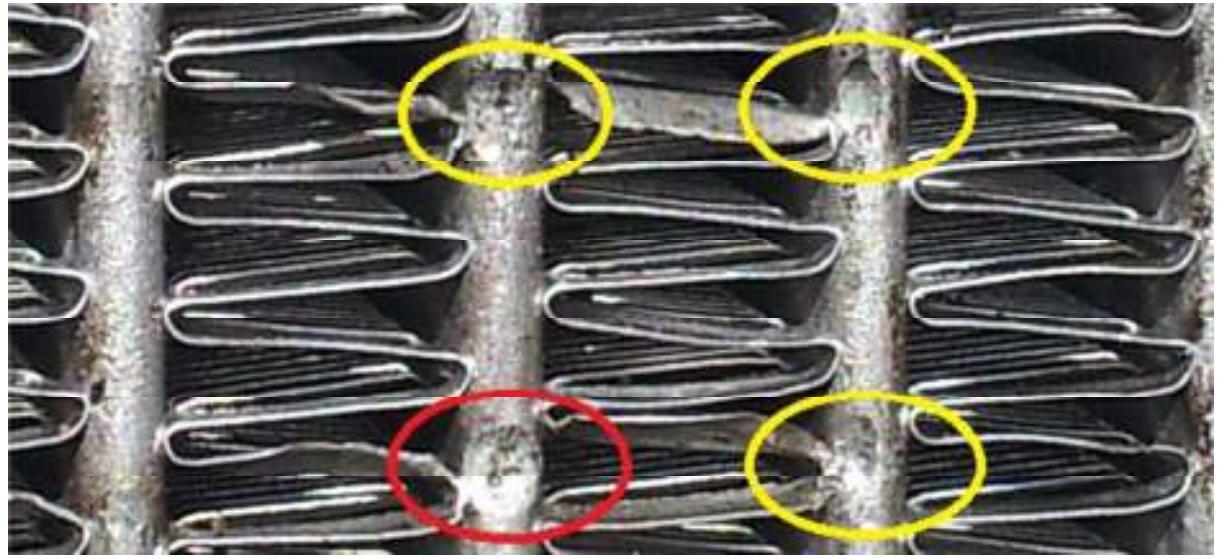
Picture 23

Picture of the four damaged areas, with leak indicated in red.

I also had the leaking radiator repaired by Silverton Radiators Midrand Branch for R450 VAT Incl (\$56). They supplied the New Radiator and repaired the old one on the same day. Good Service received from Caroline.

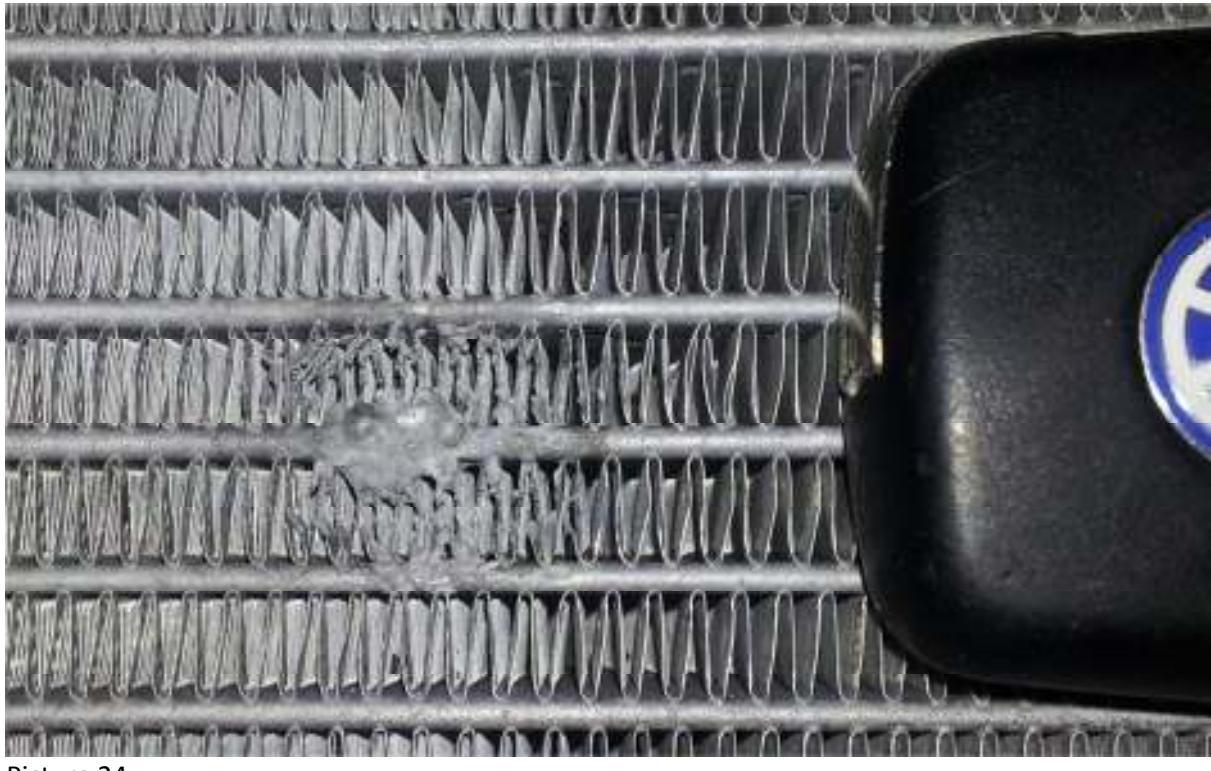
Picture 24

The repaired readiator below. Key FOB as reference.

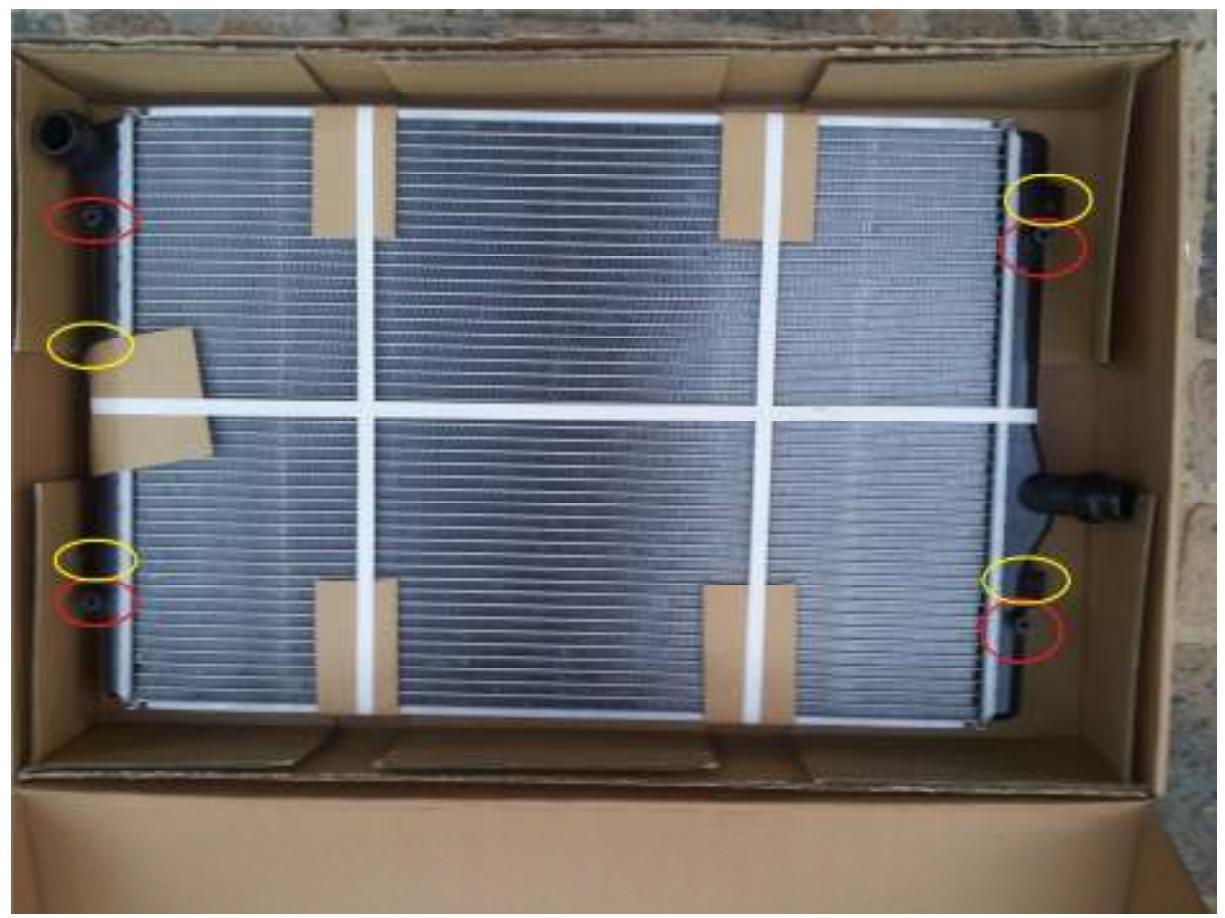
Here is the new radiator I bought.

I saved the box to store the repaired radiator. The Red circles indicate the mounting for the fan tray. The yellow ones are the radiator's mounting hole to the chassis (in front of the Intercooler)

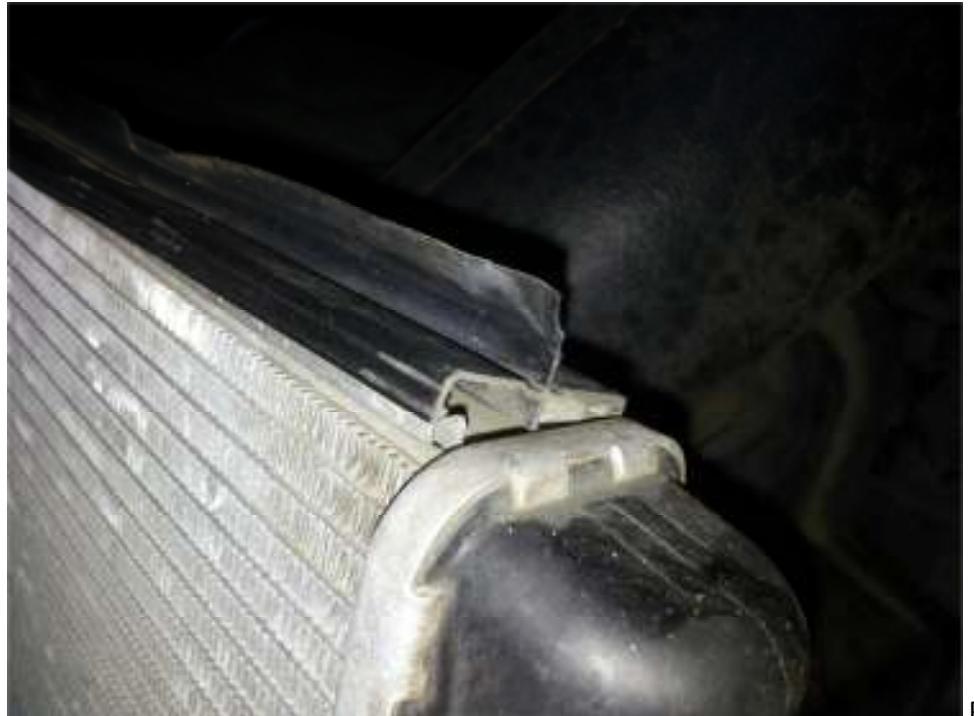
Strip the black plastic cover on top of the old radiator and fix to new one.

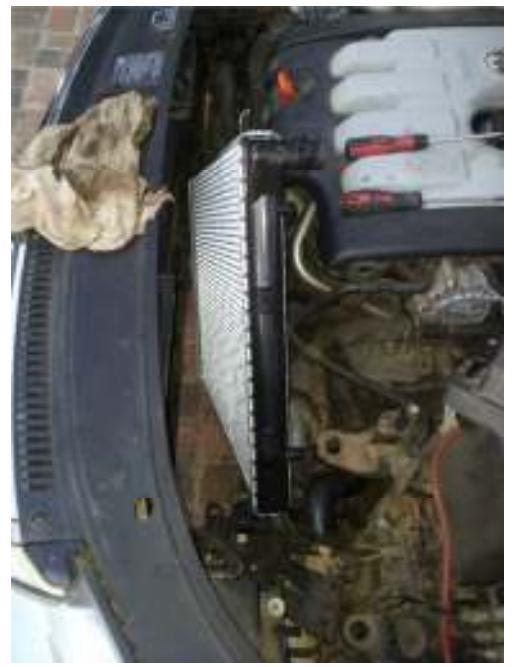
Now insert the radiator into the engine bay.

To get the left hand side elbow into place past the "always in the way" aircon piping is tricky, but doable. Just be patient.
