From part way into a drive to work, March 2016: 2009 Jetta TDI wagon

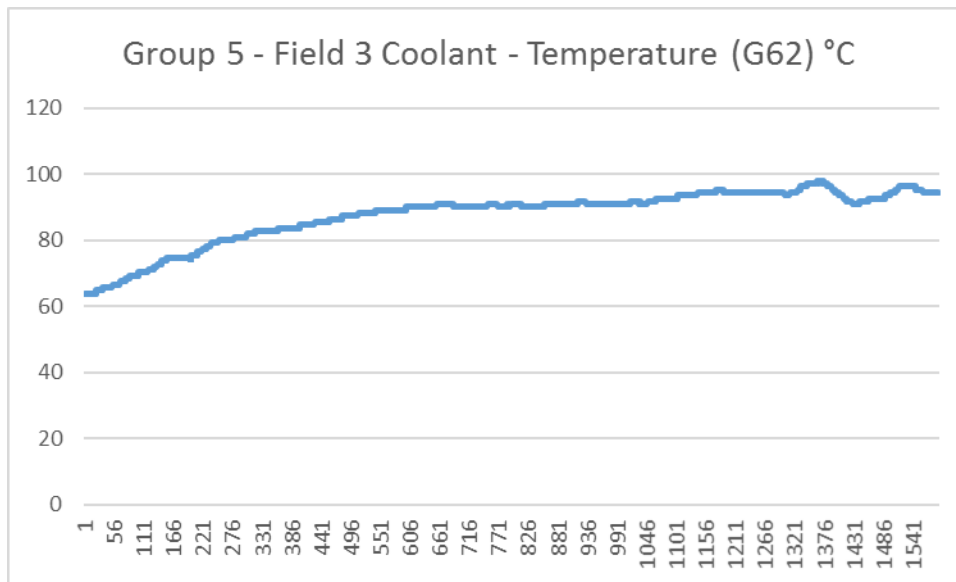
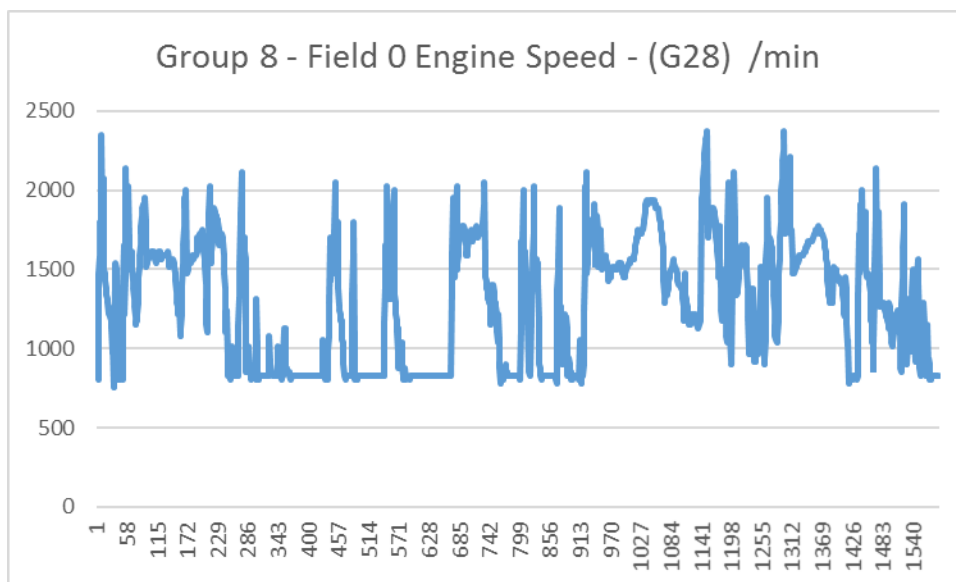
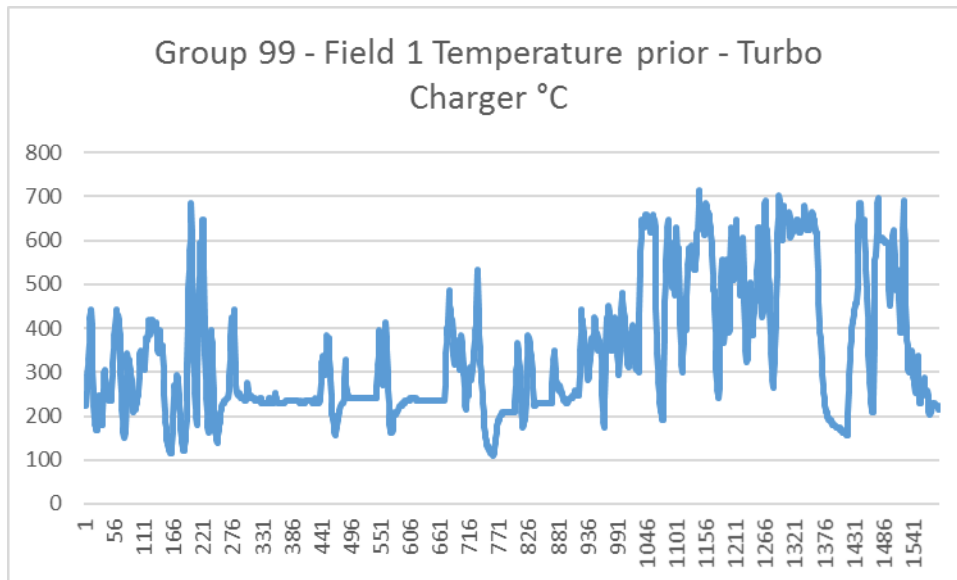
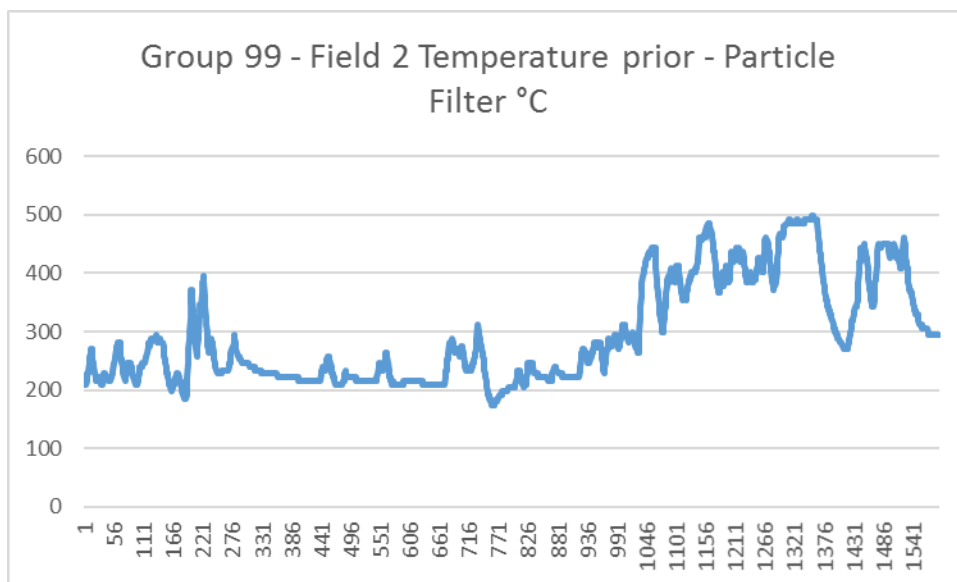
deNOX regen indicated 200-240 (drops out when coasting)

DPF regen 1028-1535
